LiDAR Quality Assessment Report

Materials Received: <input type="text" value="5/15/2012"/>	Project Type: <input type="text" value="GPSC"/>
Project ID: <input type="text" value="San Luis Valley LiDAR"/>	Project Description: <input type="text" value="V13, 1.0 Meter NPS LiDAR"/>
Project Alias(es): <input type="text"/>	Year of Collection: <input type="text" value="2011"/>

San Luis Valley LiDAR

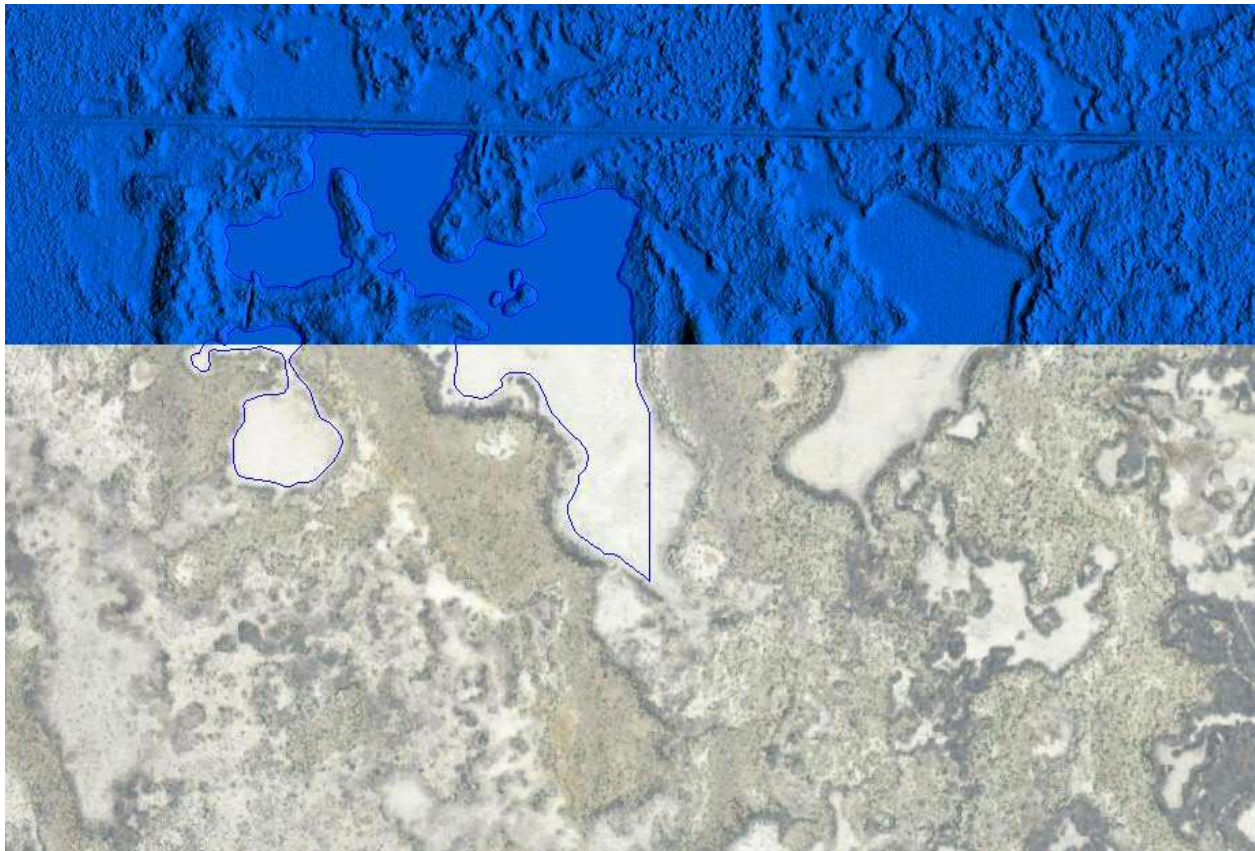
Above, we see we see an instance of waterbodies flattened and their respective breaklines. It is evident from the orthoimagery and DEM that there is a waterbody located to the right that was not flattened; however, there is sufficient density (lack of heavy tinning) within that waterbody to suggest that this feature was either dried up or very shallow at the time the LiDAR was flown. Some of these areas have been marked in the "DEM Error Tags" shapefile. However, unless there is heavy tinning, these areas are acceptable as is.

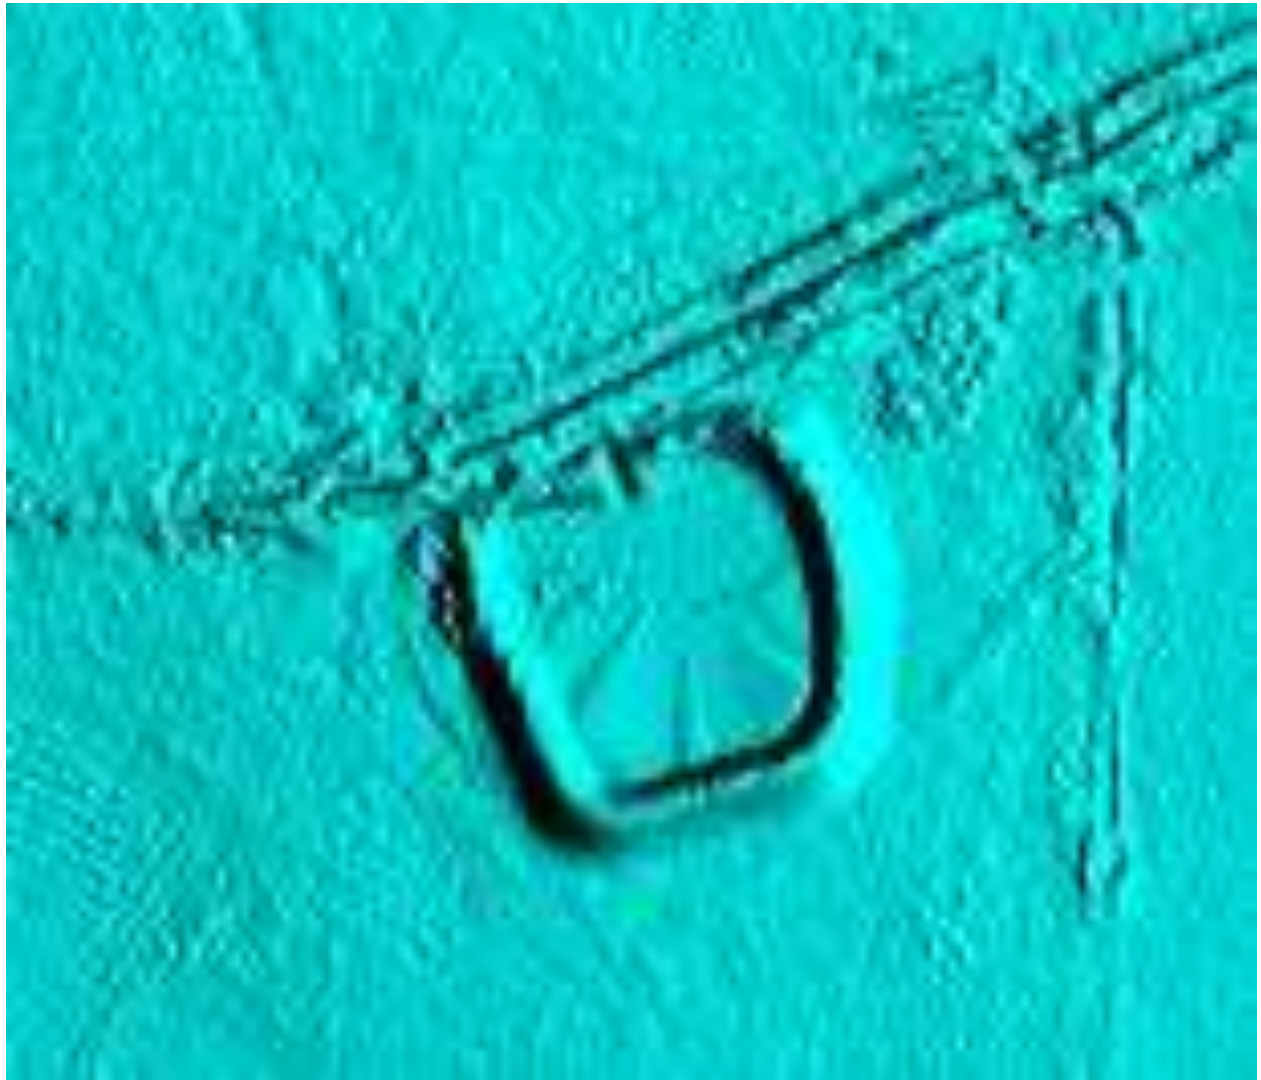
Pictured is a retention pond (there are numerous comparable features in this dataset) which were not flattened. Many are between 1 and 2 Acres, which technically do not require flattening; however a good number are greater than 2 Acres. Some of these ponds showcase clear tinning and should have been flattened; however, a good deal more show little tinning and are indicative of dry conditions or shallow water (the image above is a mixture of tinning and good point density). While some of these instances are marked in the "DEM Error Tags" Shapefile, not all instances have been marked. If ponds are greater than 2 Acres and exhibit tinning they should be flattened.

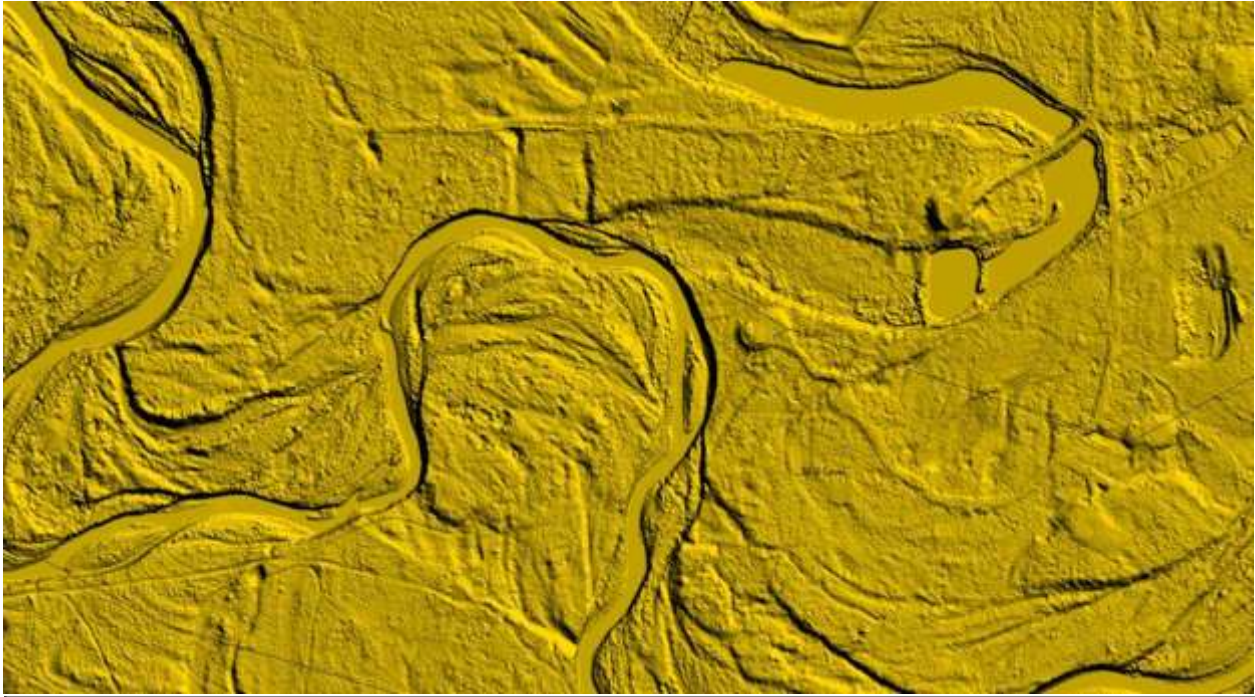
Pictured is an image of the Redelived Data, clearly the Rio Grande was hydro Flattened throughout the dataset and the issues below relating to double-line streams have been corrected.

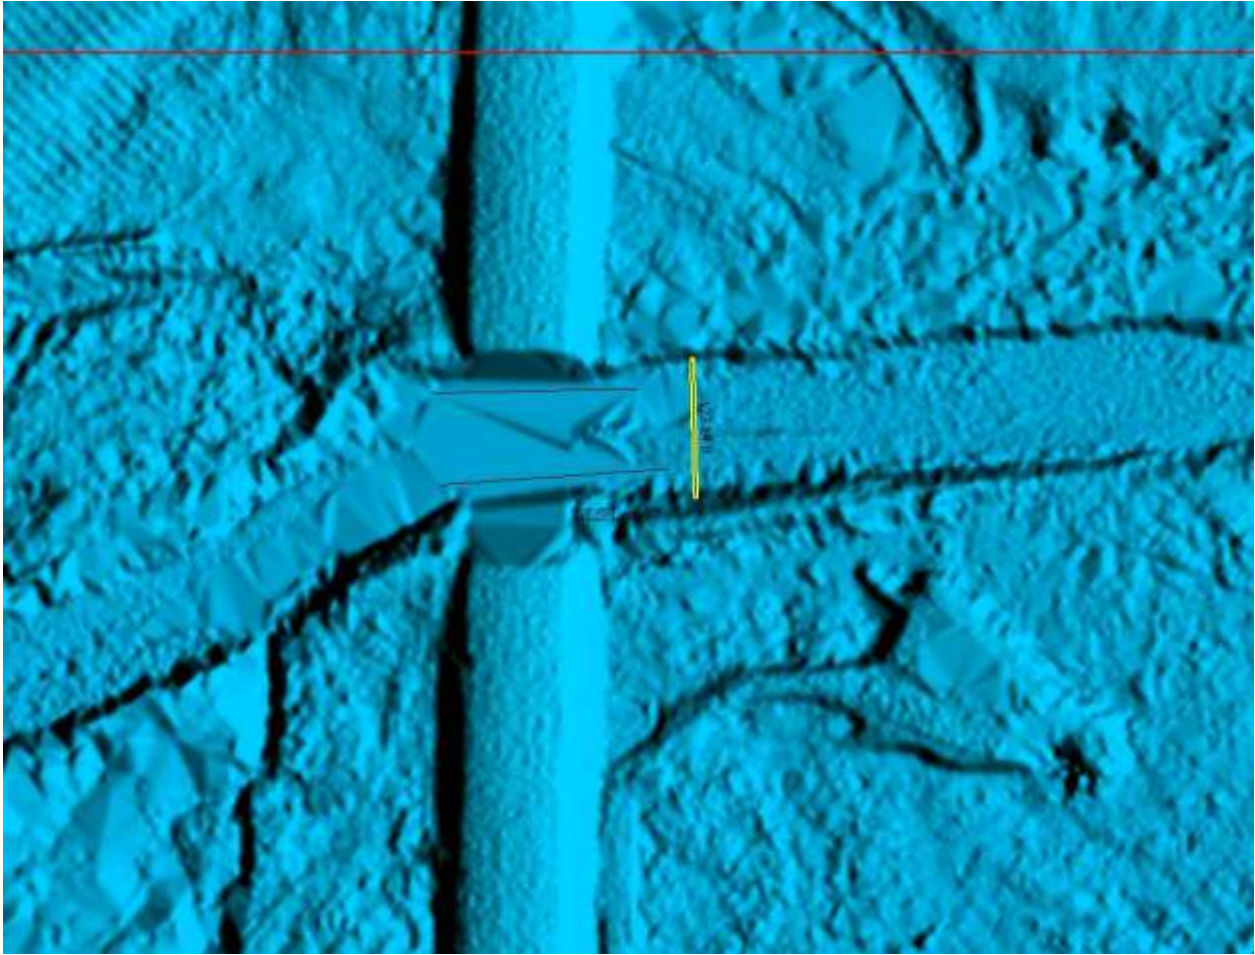
Pictured here is a portion of the Rio Grande River, a Double Line Stream (DLS), this particular section is greater than 100 Ft. across and should have been bank to bank hydro flattened with monotonic flow. The V13 LiDAR specification calls for flattening of streams 100ft across in diameter, even if portions of the stream go under that 100 Ft. metric at times ("100' nominal width: This should not unnecessarily break a stream or river into multiple segments. At times it may squeeze slightly below 100' for short segments.). Further, those portions going under 100 Ft. should still be hydro flattened. While a good portion of the Rio Grande and other rivers were hydro flattened there are still areas not flattened that exhibit heavy tinning. These areas have been marked, in part, in the "DEM Error Tags" Shapefile; however, only in sections to highlight the issue, this is not to say that only those sections need be fixed, the river as a whole needs to be treated.

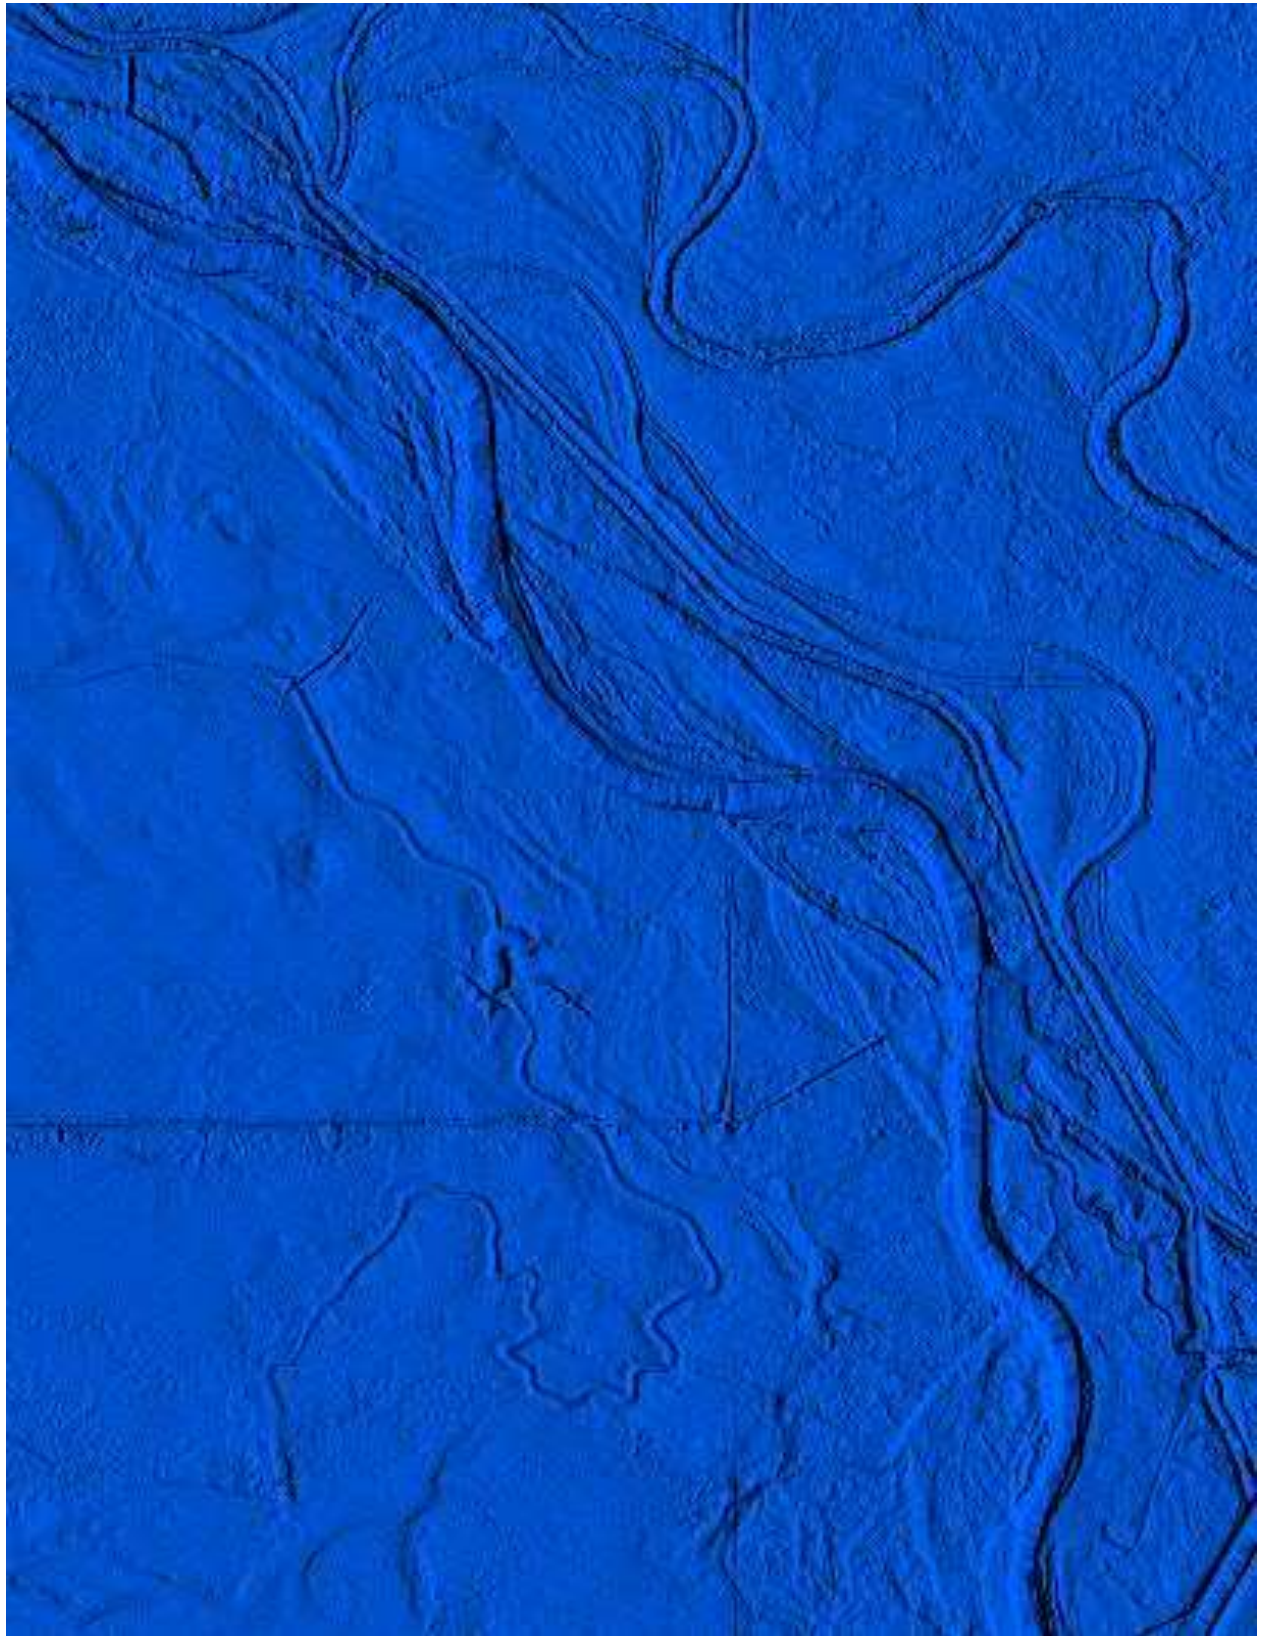
Here is another section of a DLS River that exhibits heaving tinning. In this instance the bank to bank distance is just under 100ft for some distance, but still connects to larger portions of the river further upstream and downstream.

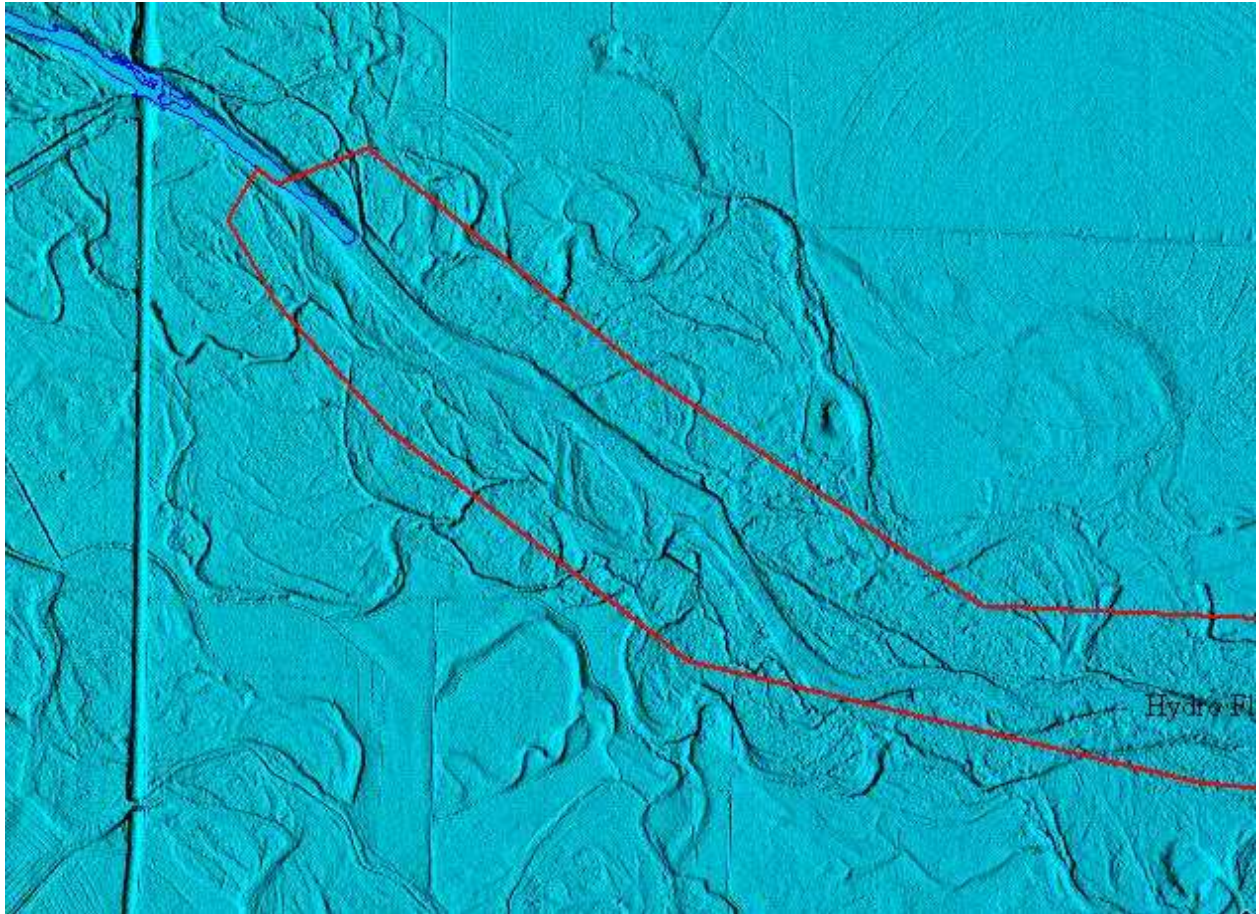
Here is an image showcasing inconsistent treatment of the DLS. The breakline and hydro flattening ends abruptly.

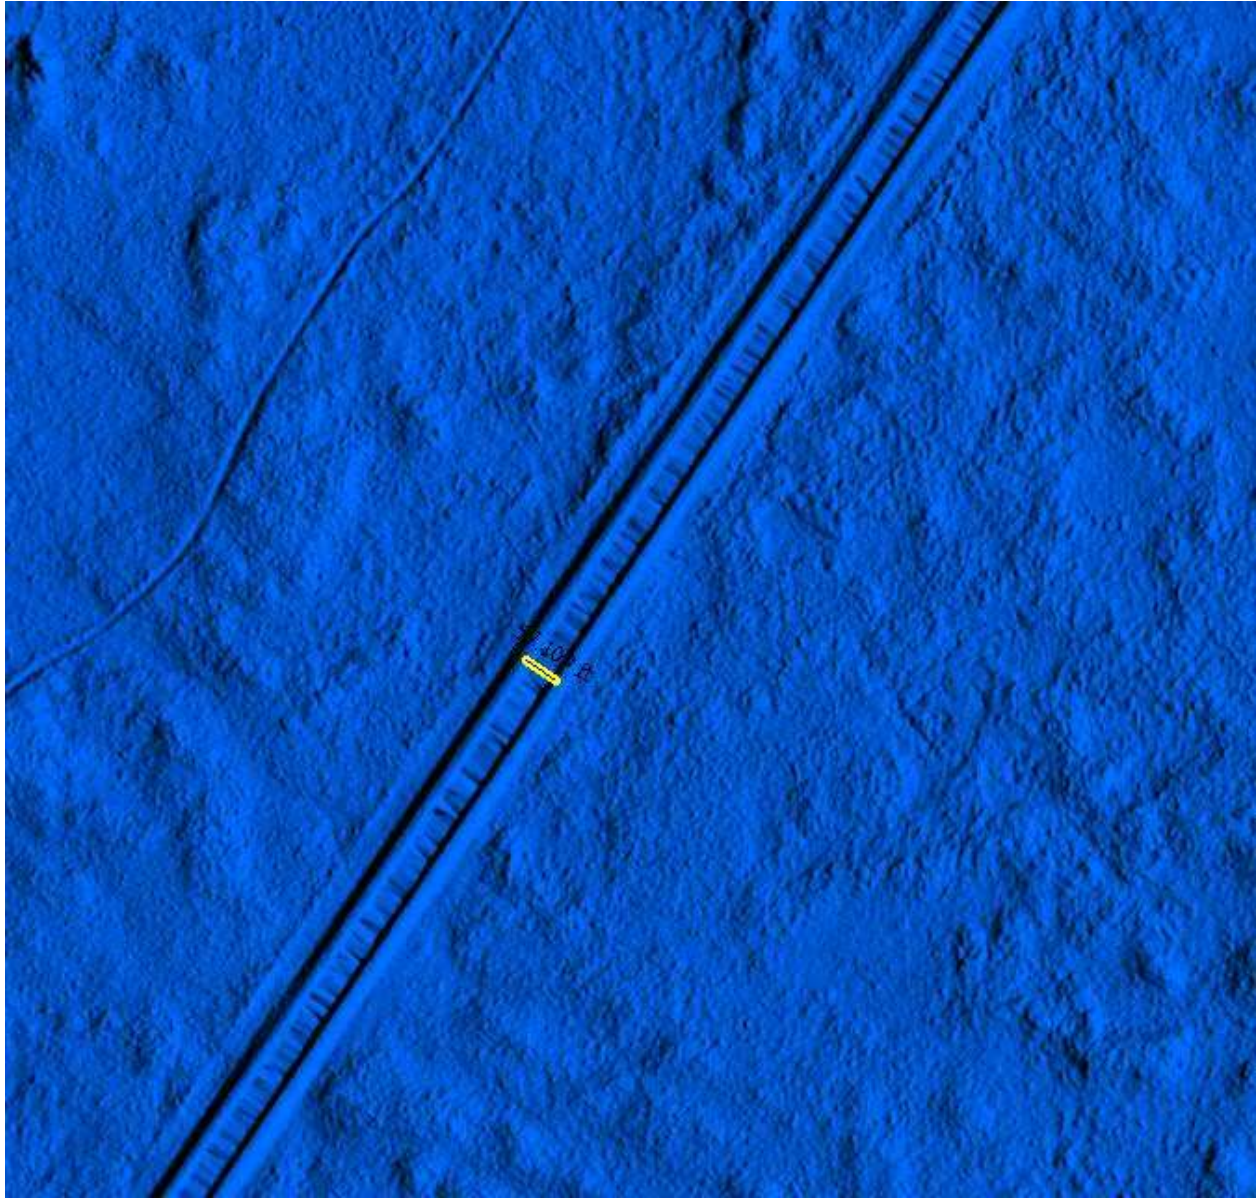
Pictured here is a less than 100ft nominal width Canal which exhibits heavy tinning and does not technically need to be "Hydro Flattened" because it does not grow greater than 100ft at any point.

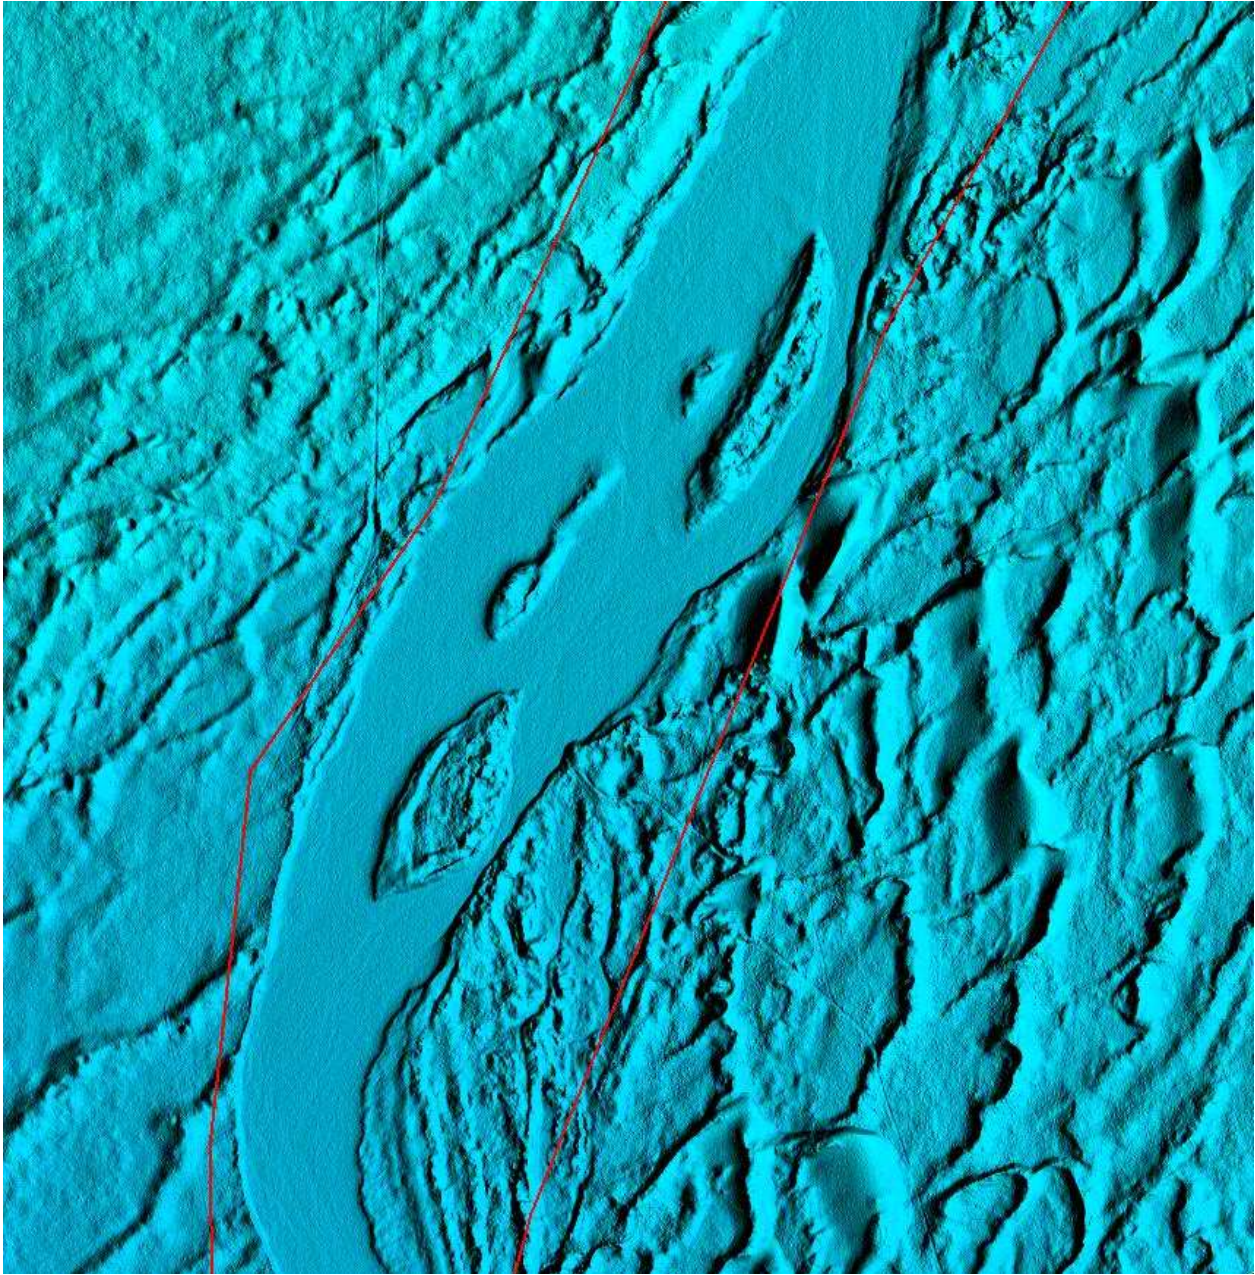
*Determined this is acceptable.
Above is a DLS which has a greater than 100ft nominal width (near the sand dunes), but was not flattened. As with many of the retention ponds and waterbodies, it exhibits higher point density and little tinning indication dry or shallow conditions and need not be flattened.

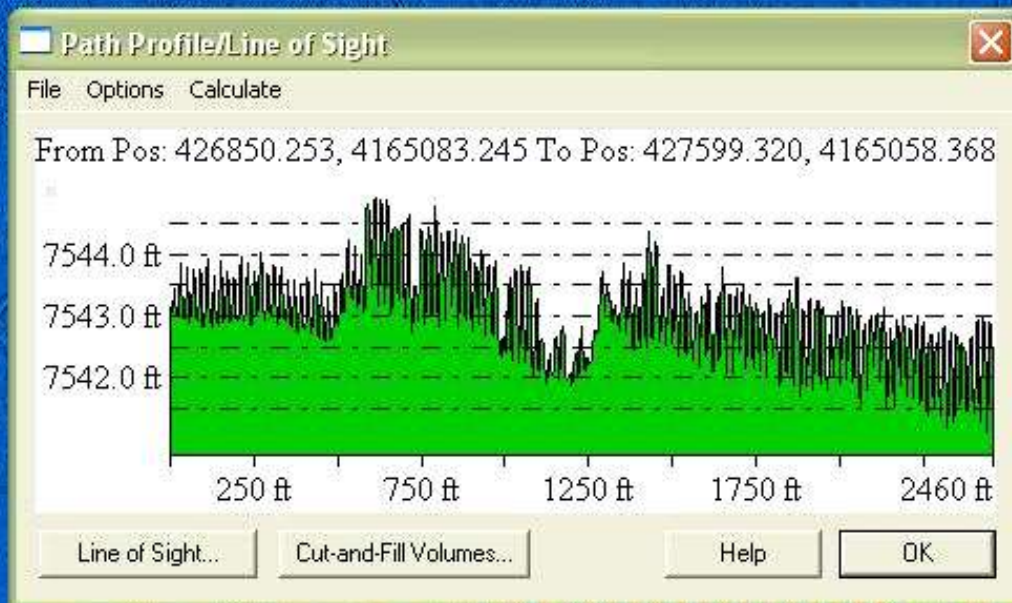
The Vendor provided the USGS with the statement that this project was flown over multiple dates and during crop harvest, leaving some strange patterns in many of the crop circles. Of concern however, is how well filtered the point cloud was in order to derive the Bare Earth in these areas, if only last returns and first and only returns were used, then there may be little the vendor could do to make the elevations more consistent as last returns and first and only returns will unavoidable not all penetrate to the actual ground. However, the profile graph pictured above does beg the question of if some more extensive manual editing could be performed to eliminate the spikes pictured above. Many, though by no means all of these are marked in the "DEM Error Tags" Shapefile.

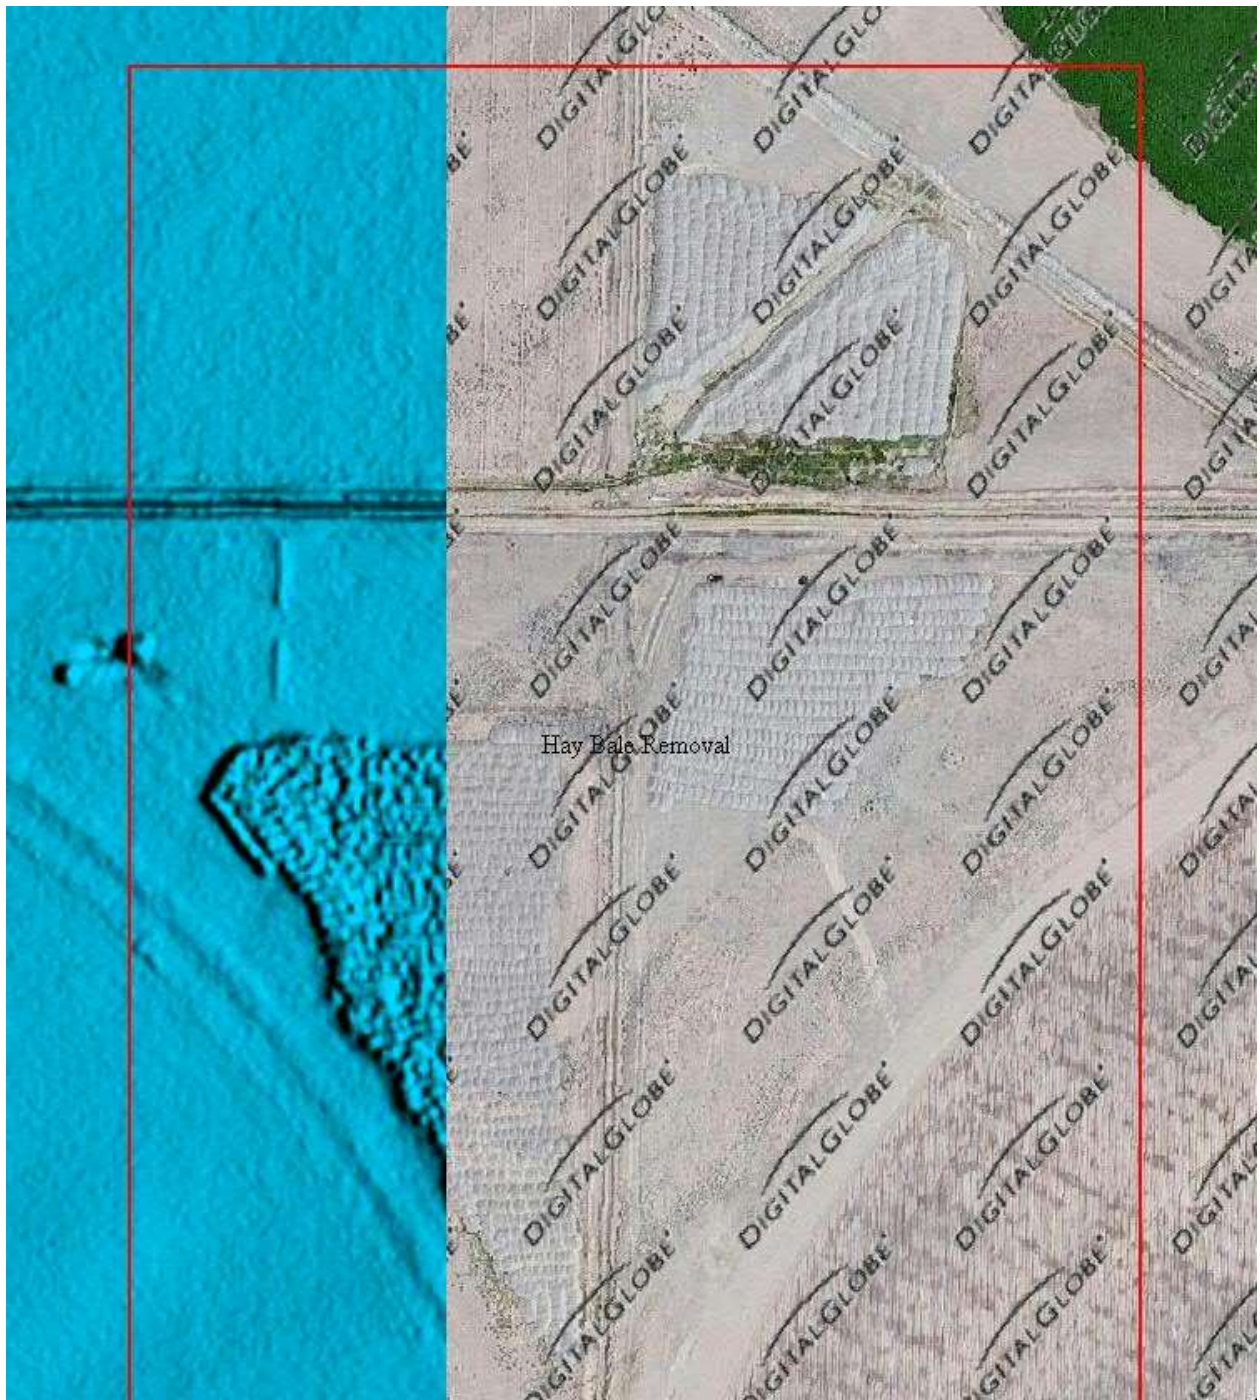
Also relating the harvest is the issue of suspected hay bales near many of the farms and highways. Several Ortho Images and profile graphs suggest the presence of hay bales in the DEMs. Feedback on the treatment of these features in this dataset would be welcome.

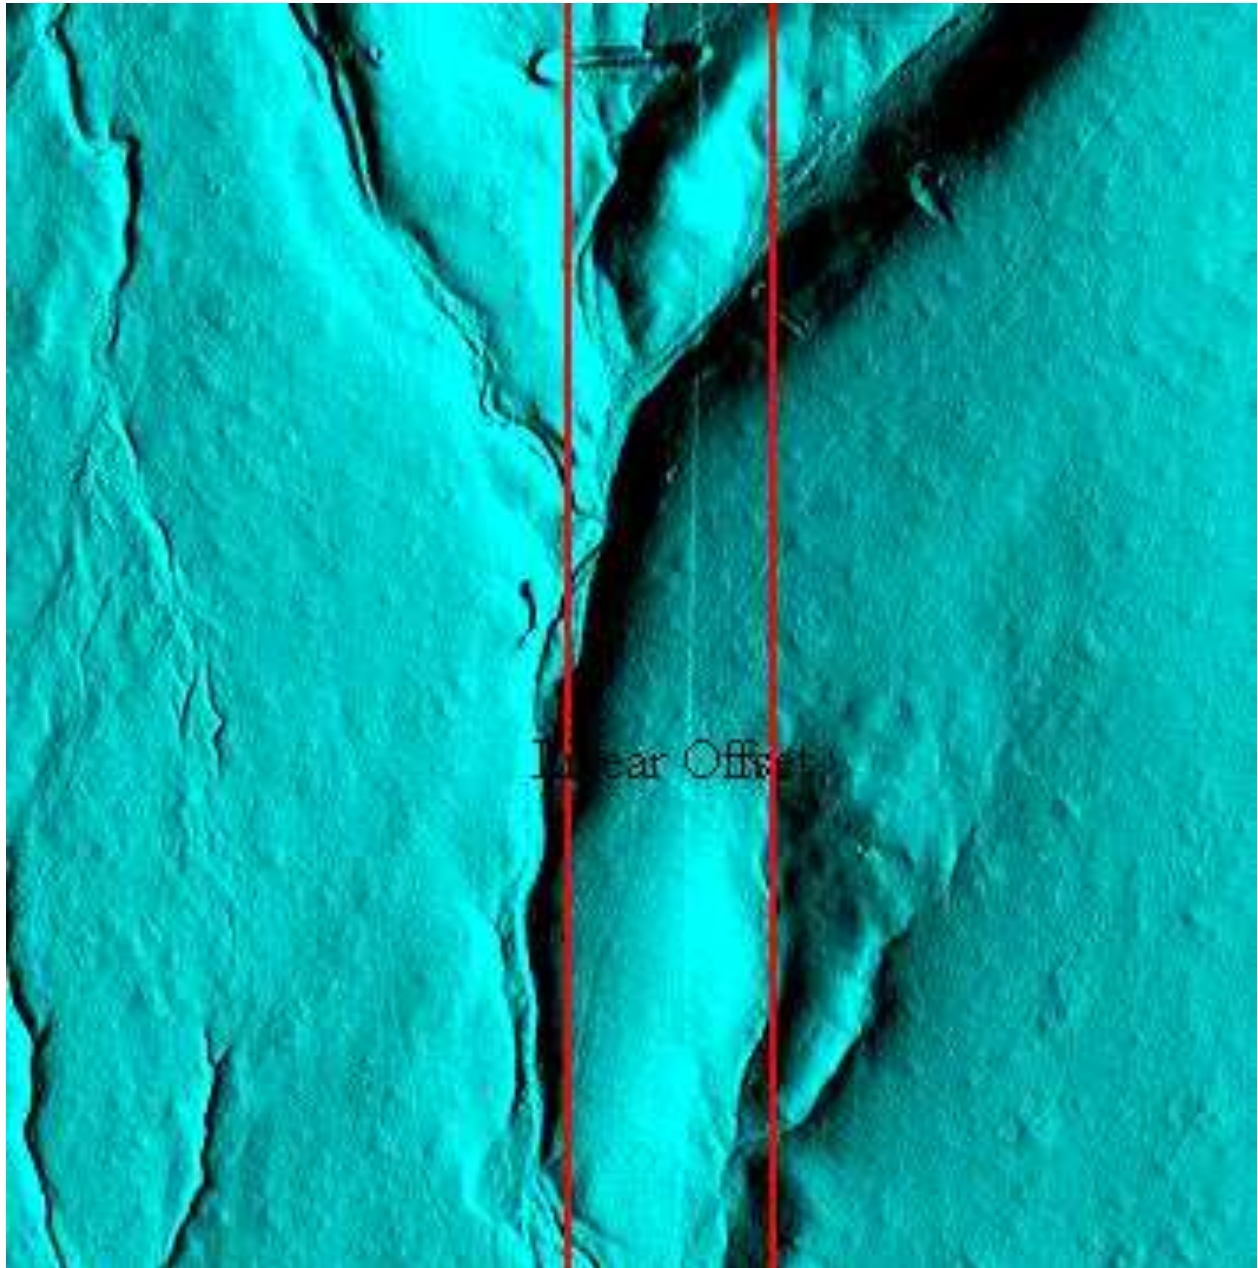
Linear offsets such as the one pictured are rare in the dataset and do not significantly effect the elevations in the DEM. Moreover, it is not clear if this is caused by a genuine calibration/registration issue, natural fault, or software visualization, but the events have been noted and tagged.

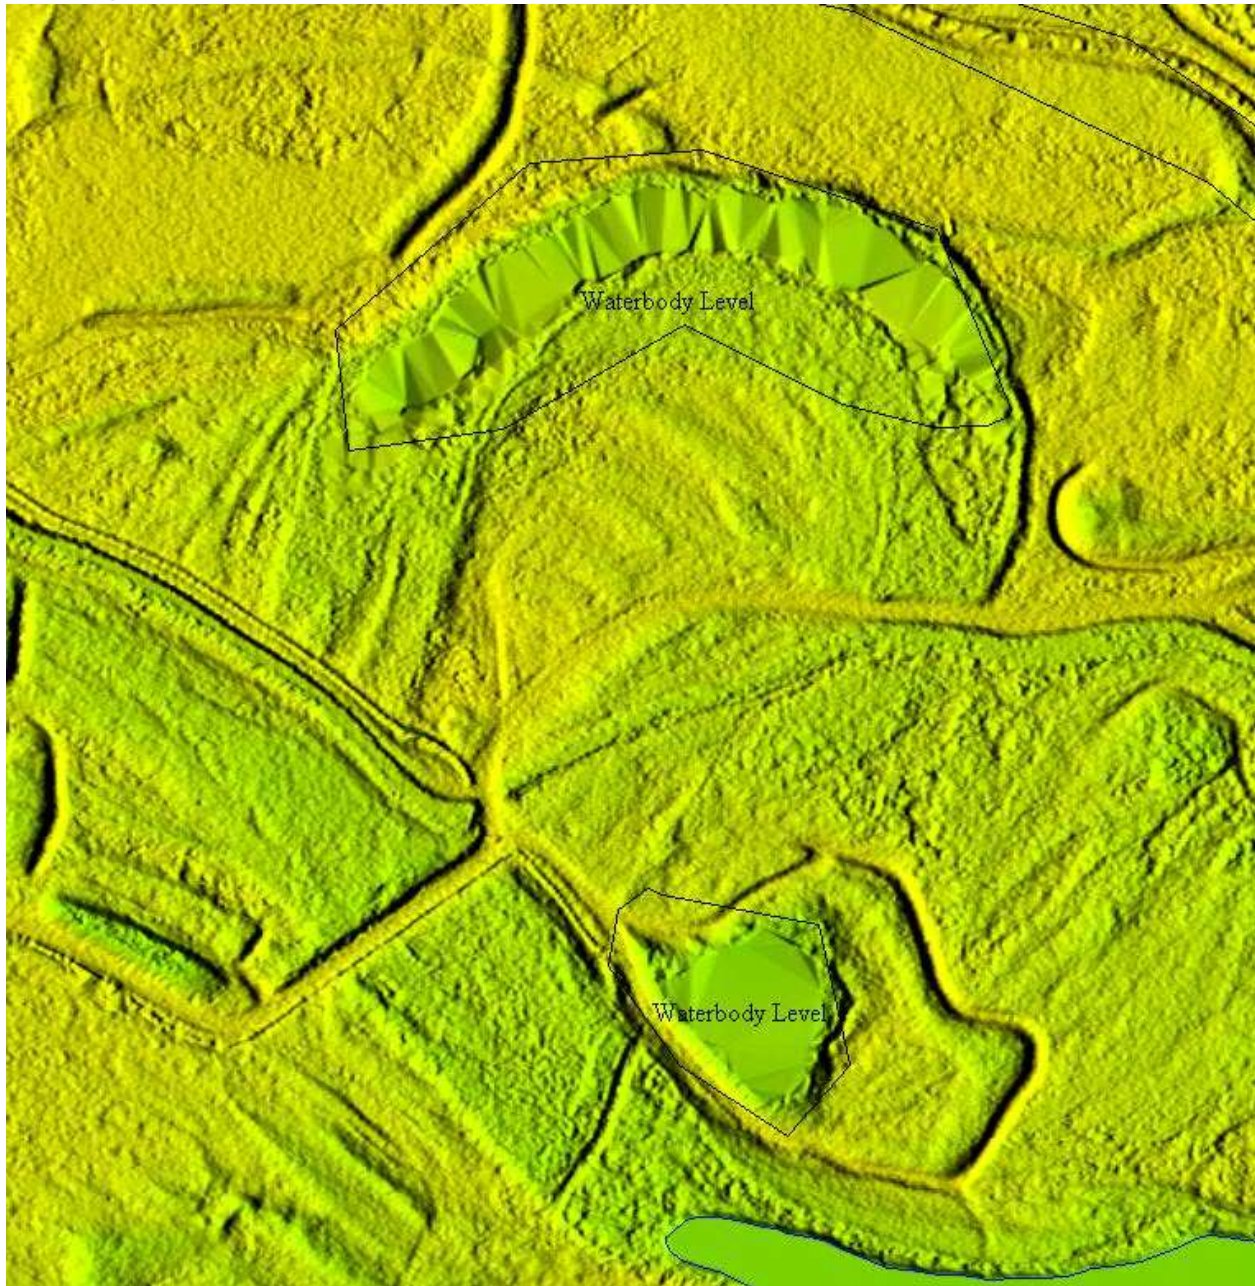
Leveling of Waterbodies.

*Update FEMA areas were given full hydro enforcement via the use of additional breaklines and the issues in the images below have been largely corrected. As for the FEMA Area DEMs, they were contracted as to be "Hydro Enforced", which implies heavy use of breaklines to achieve a surface well suited for hydrologic modeling of flow connectivity and flood risk assessment. For this reason, attention to use of breaklines in heavily tinned areas should be especially rigorous. There are quite a few tinned areas in these DEMs which should be appropriately leveled (Waterbodies and Double Line Streams). As well as a few culverts that should be removed. Please see the FEMA_DEM_Error_Tags Shapefile for more information and images below for more information.

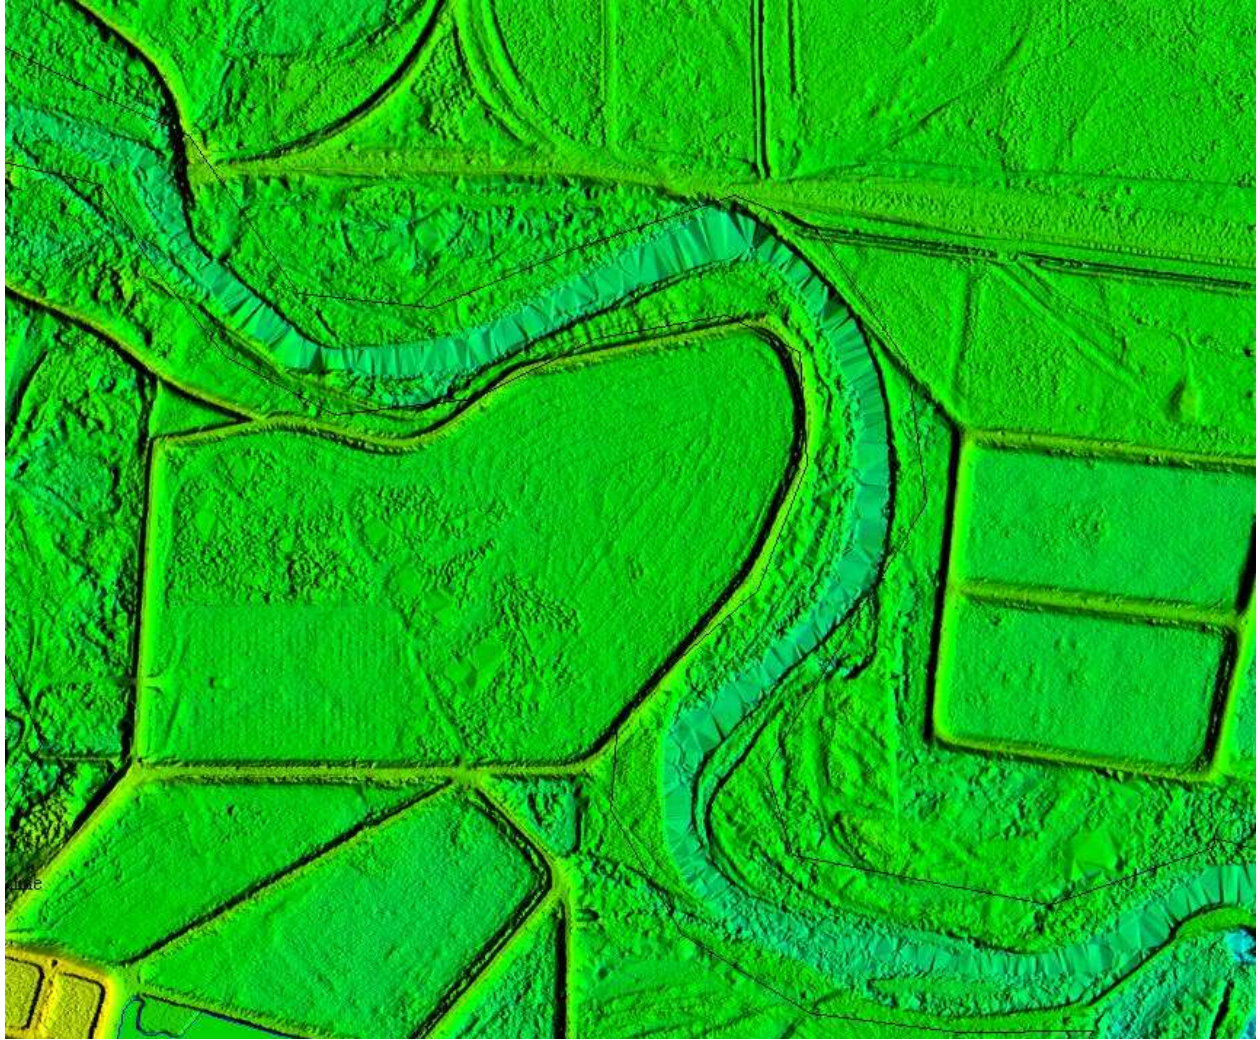
Leveling of Double Line Streams

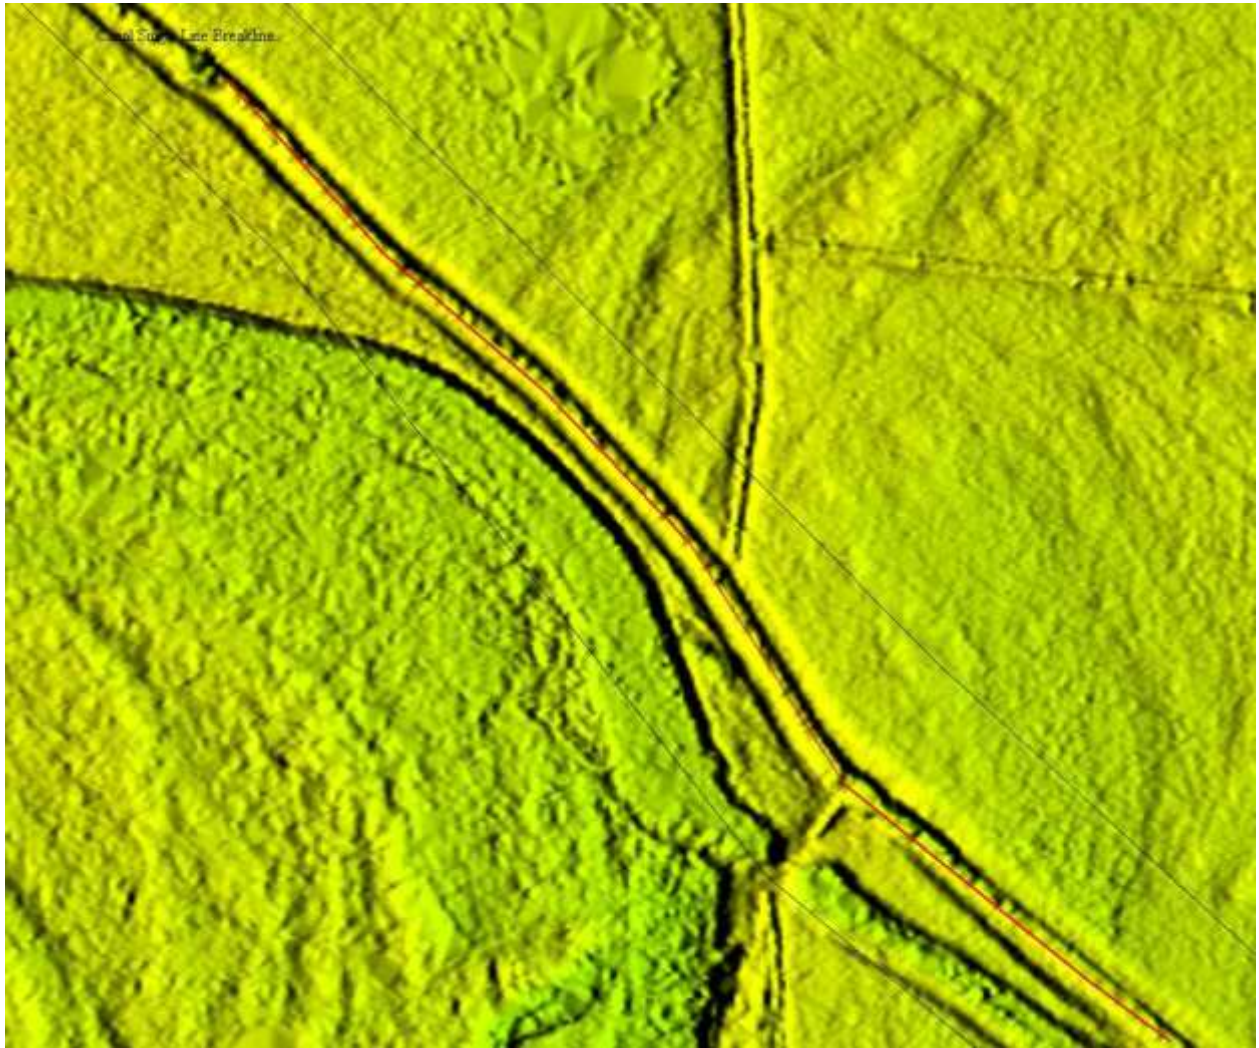
As I understand the term "Hydro Enforced" DEMs/DTMs should make use of single line breaklines to better model flow along narrow channels and canals.

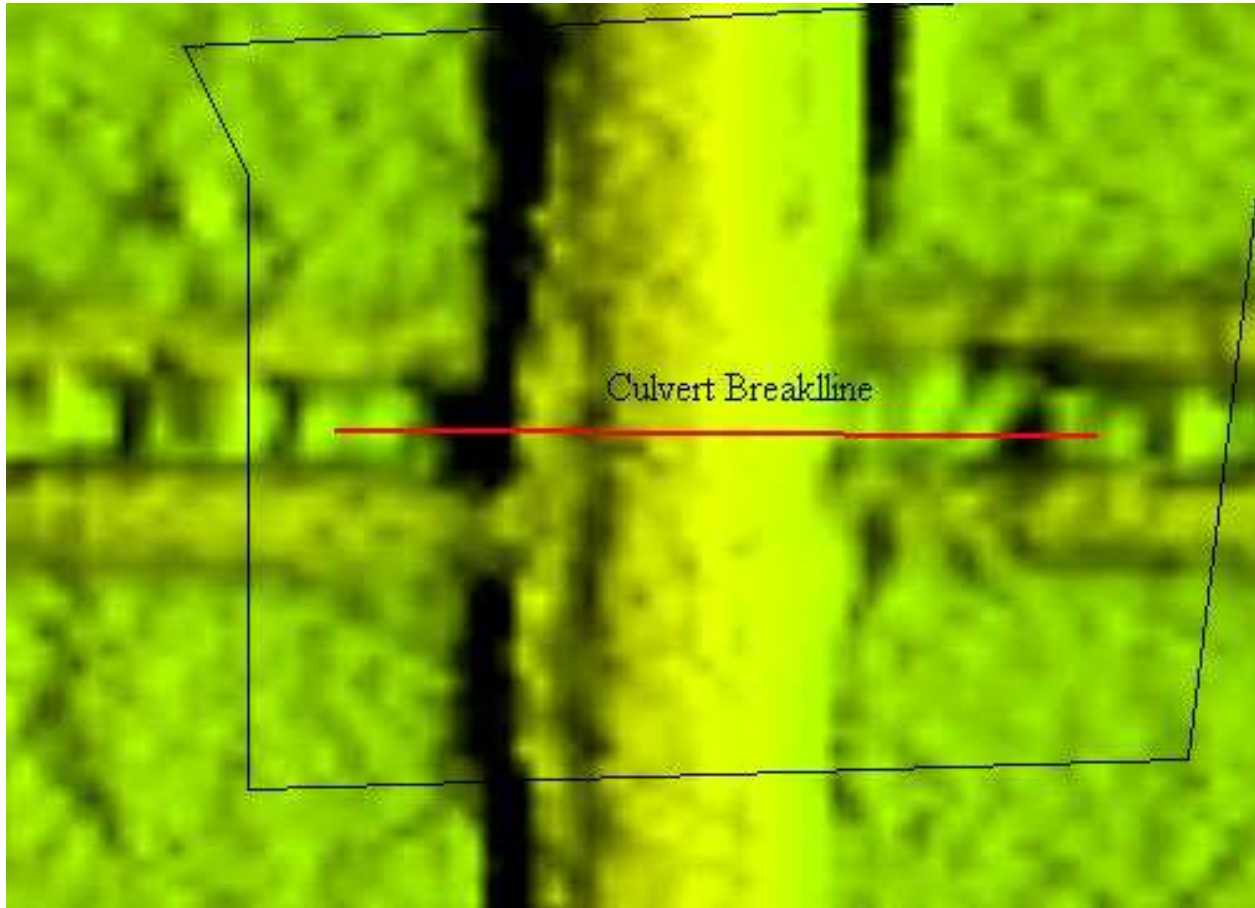
In accordance with the Previous Comment, "Hydro Enforced" models should have connectivity in through features like culverts, meaning the road would be removed at this location and the canal would continue through. In other words, a "Hydro Enforced" DEM depicts hydrographic connection over topographic features; whereas, a "Hydro Flattened" DEM places the onus on Topography over Hydrography.
