## **LiDAR Quality Assessment Report**

Materials Received: 7/24/2012	Project Type: NSDI Agreement
Project ID:	Project Description:
IN_Statewide-TiptonCo_2011	
Project Alias(es): Indiana Central Tier	Year of Collection: 2011
Lot 1 of 1 lots.	
Project Extent:

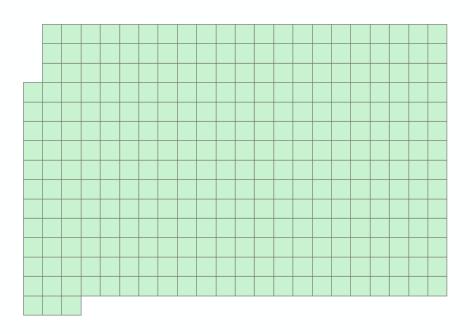
✓ Project Tiling Scheme image?

Project Tiling Scheme:

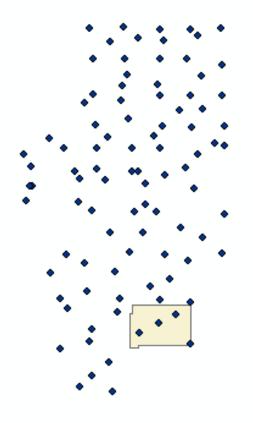
Checkpoint Shapefile or Geodatabase: Checkpoint Distribution Image?

not apply):
☑ Bare Earth
▼ Tall Weeds and Crops
☐ Brush Lands and Low Trees
☐ Forested Areas Fully Covered by Trees
☐ Urban Areas with Dense Man-Made Structures
There are a minimum of 20 checkpoints for each land cover class represented. Points within each class are uniformly distributed throughout the dataset. USGS <u>wasable</u> to locate independent checkpoints for this analysis. USGS <u>accepts</u> the quality of the checkpoint data for these LiDAR datasets.
Errors, Anomalies, Other Issues to document?   Yes  No
□ Image?
"Airborne LiDAR Report" lists independent control points used to test vertical
accuracy in shapefile format as a required deliverable, however, no control points were delivered to reviewer at NGTOC. Reviewer at NGTOC contacted David Nail on 9/28/12 and again on 12/11/12 requesting delivery of control point shapefile. All available checkpoints delivered to NGTOC on 2/11/13, and 3/19/13.
