LiDAR Quality Assessment Report

KS_Area3-Southeast_2012

KS_25 COUNTIES LIDAR #1

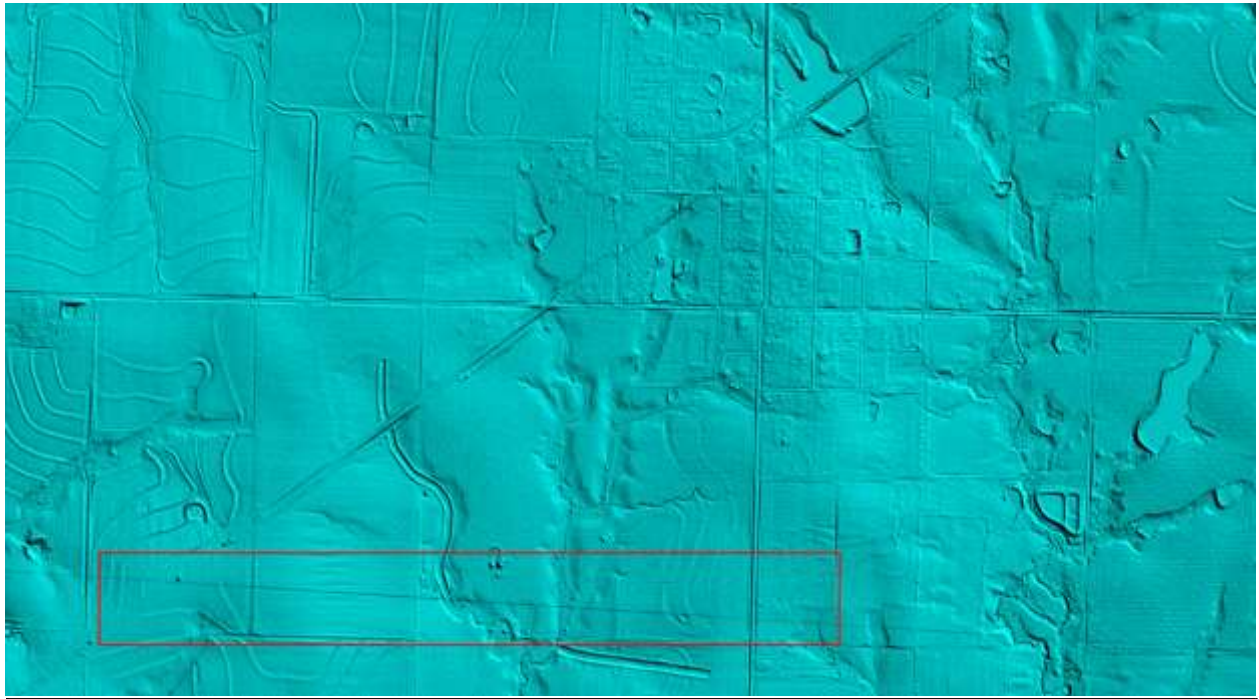
Visual anomaly in the DEM, however, not visible when hillshade turned off. Location at 37° 39' 12.9171" N, 94° 58' 36.7622" W. Does not affect the DEM.
