LiDAR Quality Assessment Report

MN_MNRRiverBasin-Phase1_2010

Kandiyohi County is one of the 25 counties as part of the Minnesota River Basin - Phase 1 lidar project.

MN_KandiyohiCo_2010

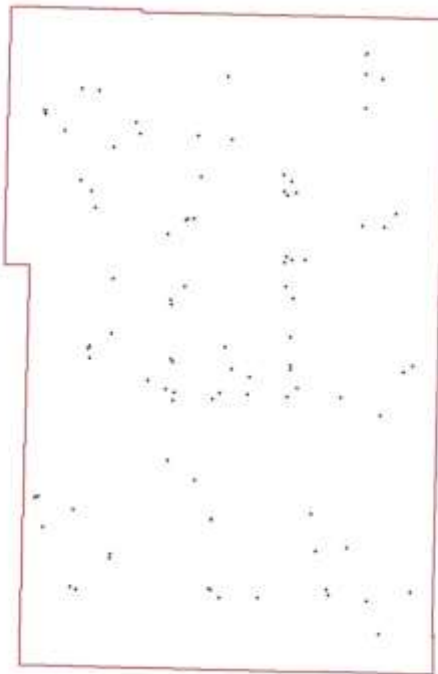
- Checkpoint Distribution Image?

There are a minimum of 20 checkpoints for each land cover class represented. Points within each class are uniformly distributed throughout the dataset. USGS was able to locate independent checkpoints for this analysis. USGS accepts the quality of the checkpoint data for these LiDAR datasets.

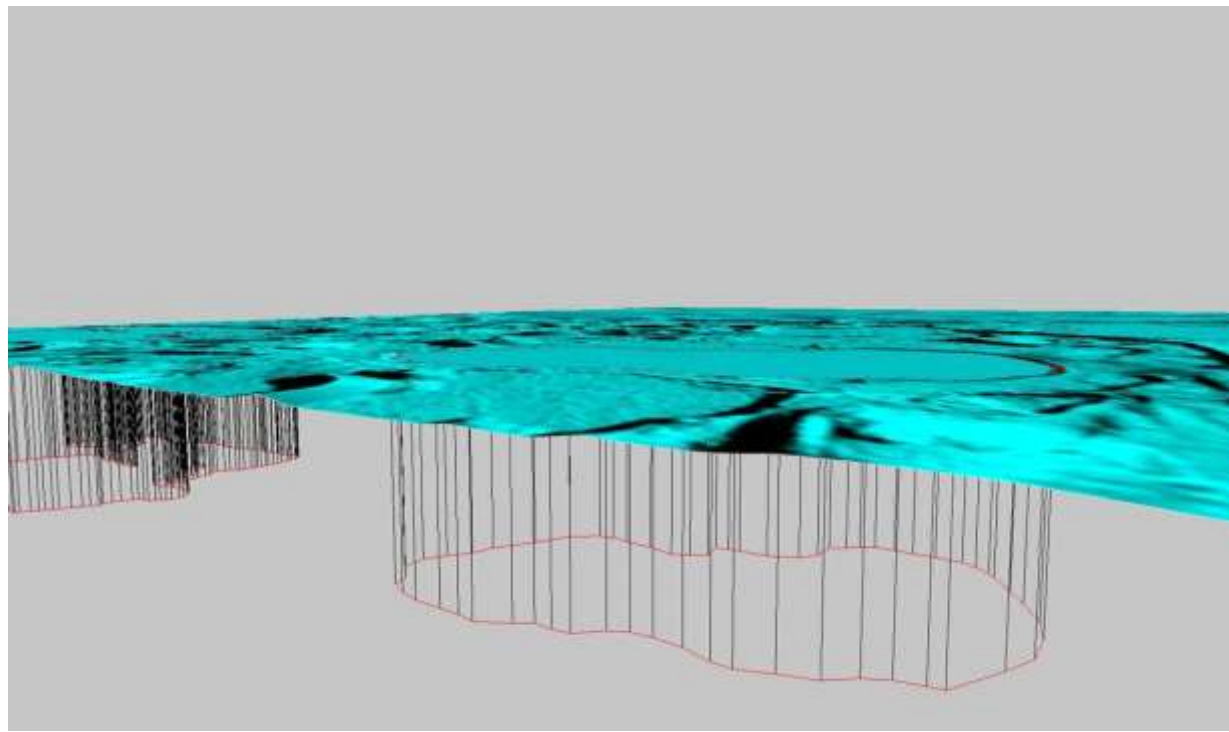
Image for error?

Breaklines are Polygon ZM, however there is no elevation information associated with them. Water bodies are flattened.

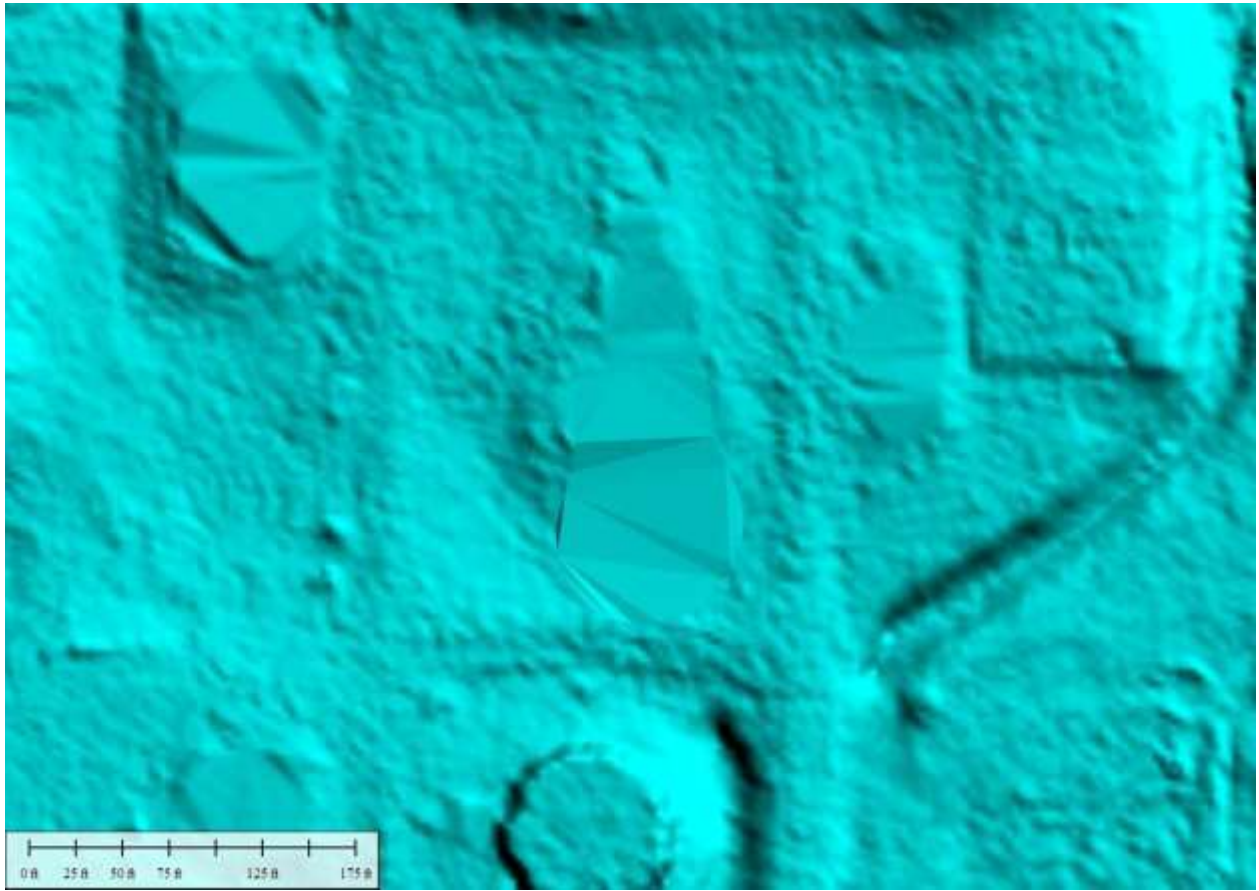
Image?

building and pit: Error remedied.

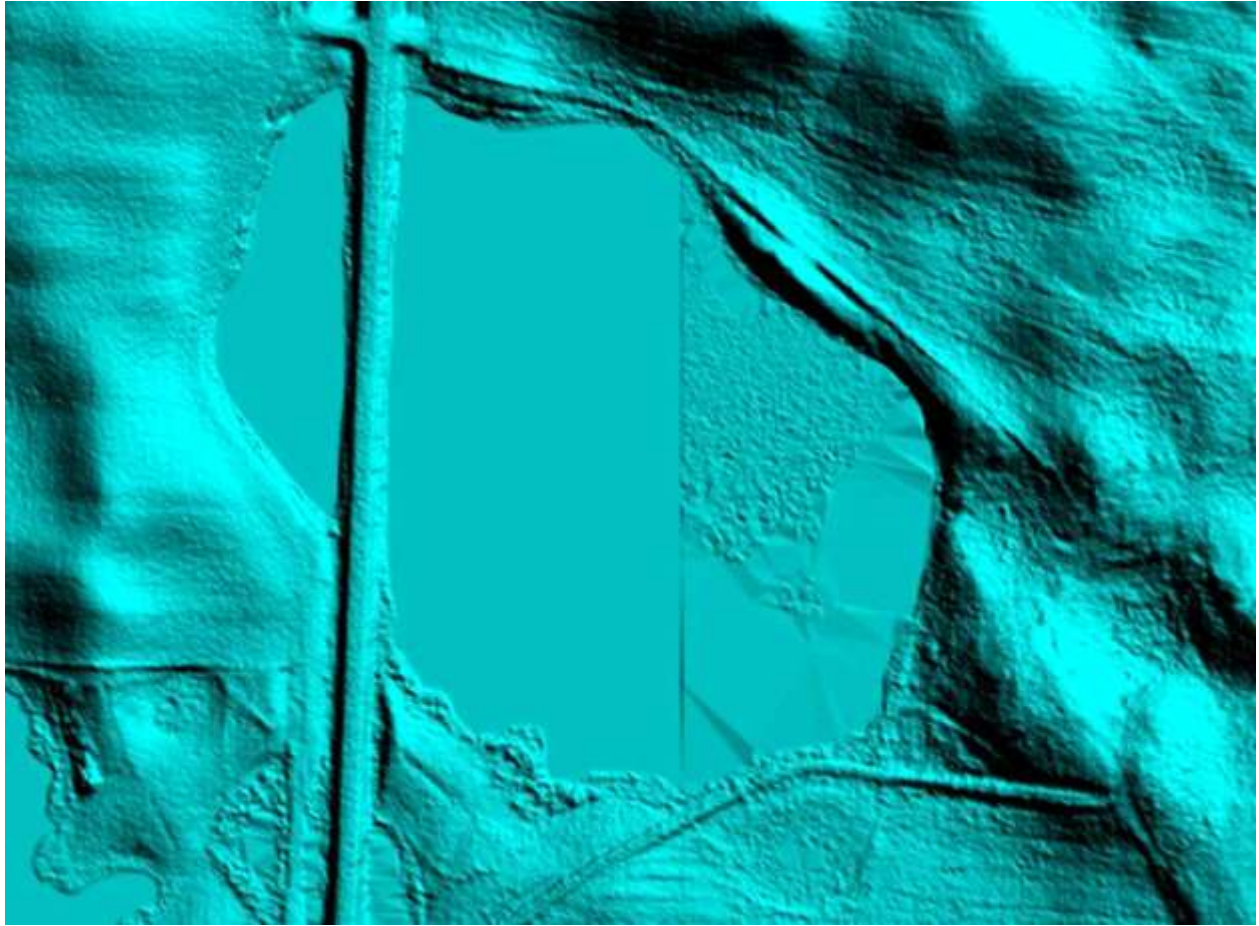
Image?

TIN_1: Portion of water body is TIN'd; this error was 'fixed', in the DEM only, by NGTOC personnel. See image below for results.

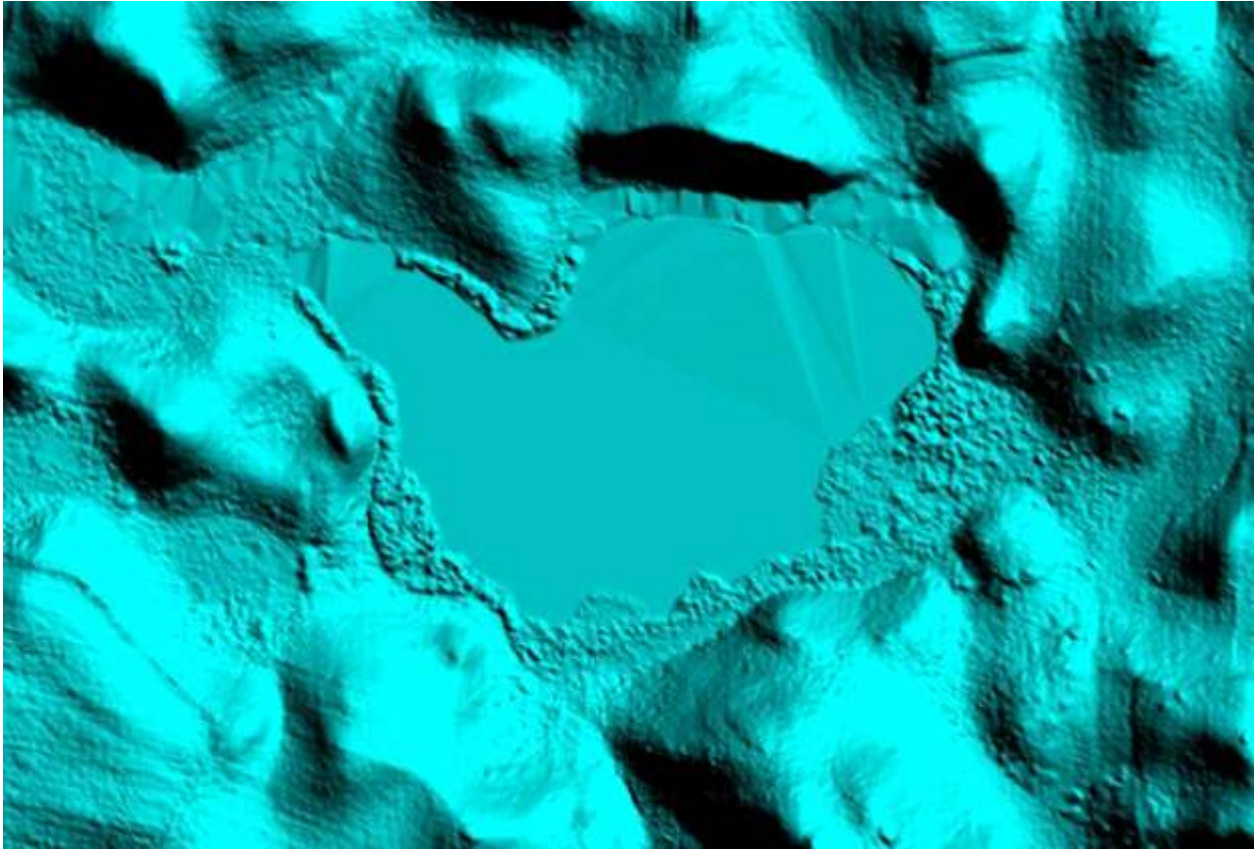
Image?

TIN_2: Two portions of this water body are TIN'd (upper left, upper right). These errors were 'fixed', in the DEM only, by NGTOC personnel. See image below for results.

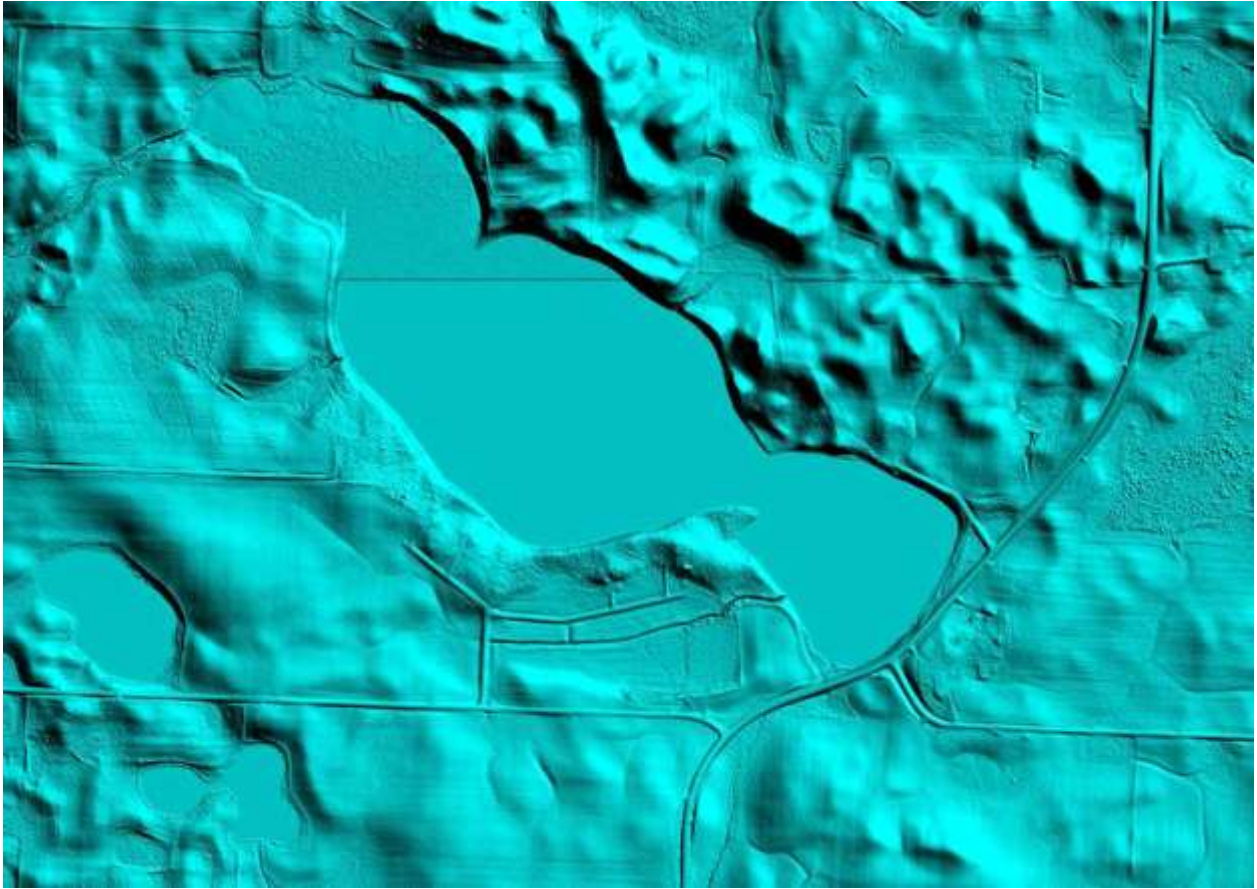
Image?

TIN_3_seam: Upper portion of this lake is TIN'd and a seam is very apparent. This error was 'fixed', in the DEM only, by NGTOC personnel. See image below for results.
