# LiDAR Quality Assessment Report

MO\_Monroe-Audrain-MontgomeryCos\_2011

Monroe, Audrain, and Montgomery Counties are part of the Missouri Grand 2011 LiDAR dataset. The St. Louis District of the United States Army Corps of Engineers (USACE) contracted with Surdex Corporation in the fall of 2011 to collect high resolution LiDAR elevation data over multiple counties as part of the Missouri Grand Counties Lidar Project. This project consists of 4 delivery blocks including all or part of Howard, Cooper, Montgomery, Livingston, Randolph, Monroe, Audrain, Lincoln, Macon, Adair, Sullivan, Putnam, and St. Louis City and County. There is additional coverage within Ray, Gasconade, St. Francois and Jackson Counties. The project combines the varied interests of the NRCS, USGS, USACE and State Emergency Management Agency (SEMA) totaling over 6287 square miles into a unified collection and processing project to benefit the US Government. The NRCS shall serve as the technical point of contact with the USACE St Louis District.

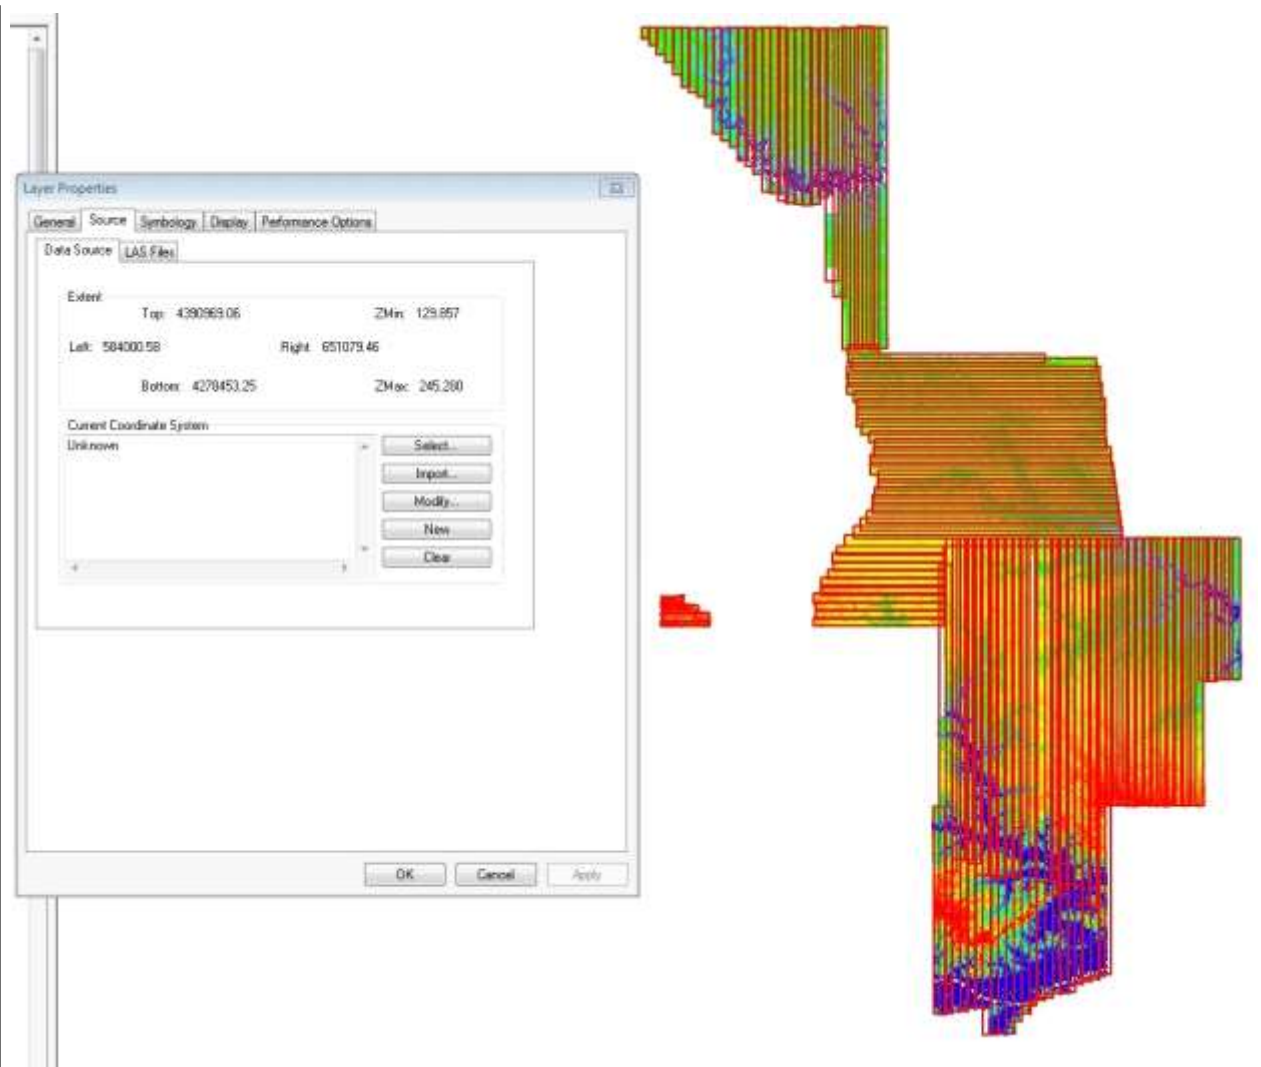
Swath LAS reads "Unknown Coordinate System".

\*\*Error corrected by contractor (5/31/2013).

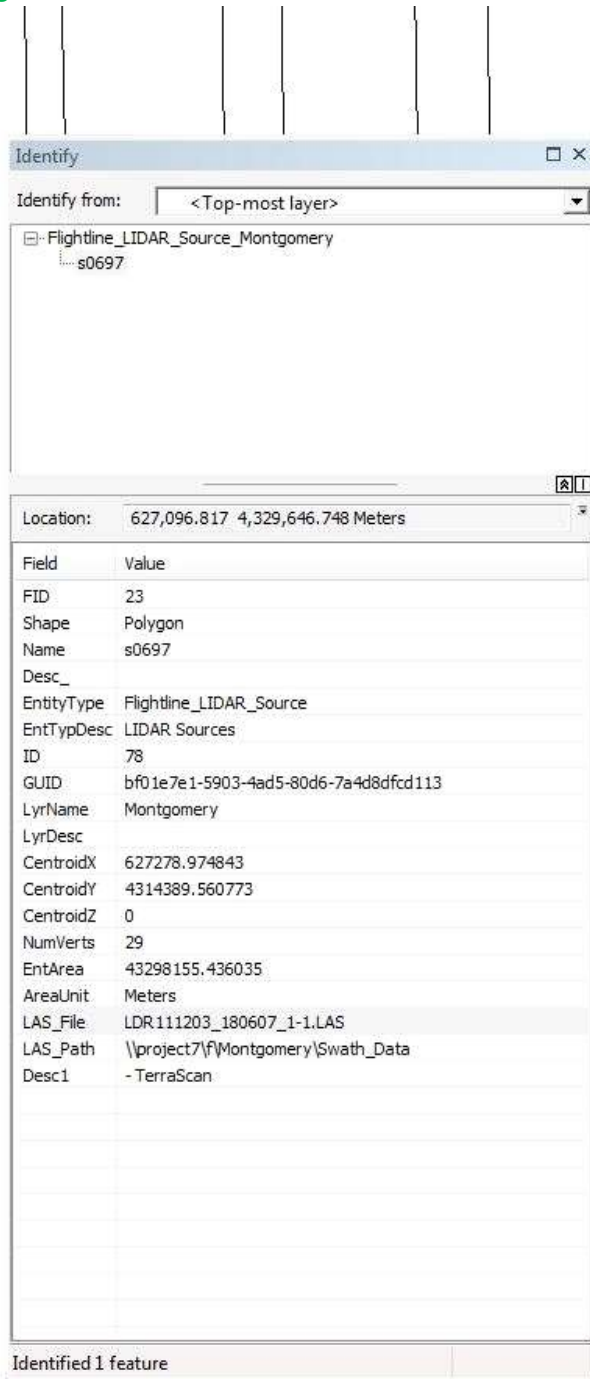
The screenshot shows the ArcMap Identify window with the following details:

- Identify from: <Top-most layer>
- Feature: Flightline\_LIDAR\_Source\_Montgomery (s0697)
- Location: 627,096.817 4,329,646.748 Meters
- Field Value table:

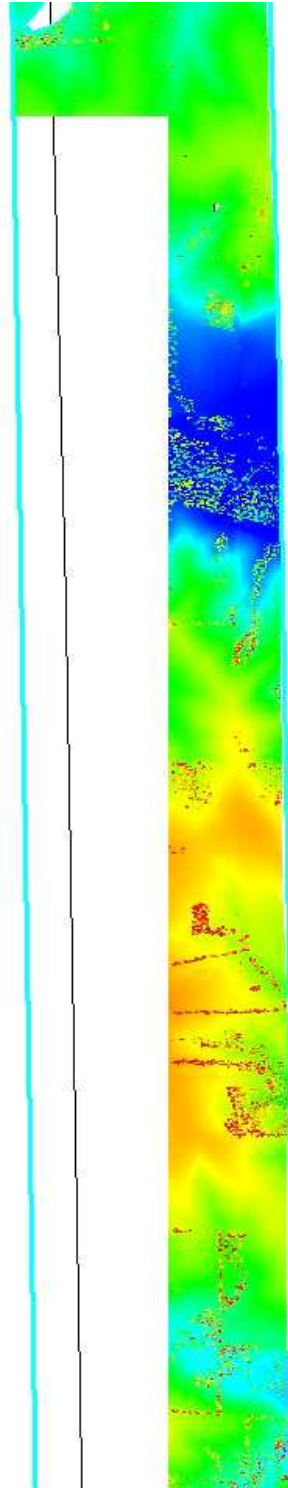
Swath LAS file LDR11203\_180607\_1 is missing points. This image shows the north-south flight line tiles and a LAS file which is missing points. The missing points are

part on Montgomery County, Missouri (2011).

\*\*This tile had been replaced by contractor - T Jerris 6/10/2012

Swath LAS file LDR111208\_143323\_1 is missing points. The project is recommended for the NED, however, the swath LAS is rejected due to missing points. An image of this error can be viewed above - in the LAS Swath File Review section of this report.

Swath LAS file LDR111208\_143323\_1 has been resubmitted, verified by NGTOC, and accepted.

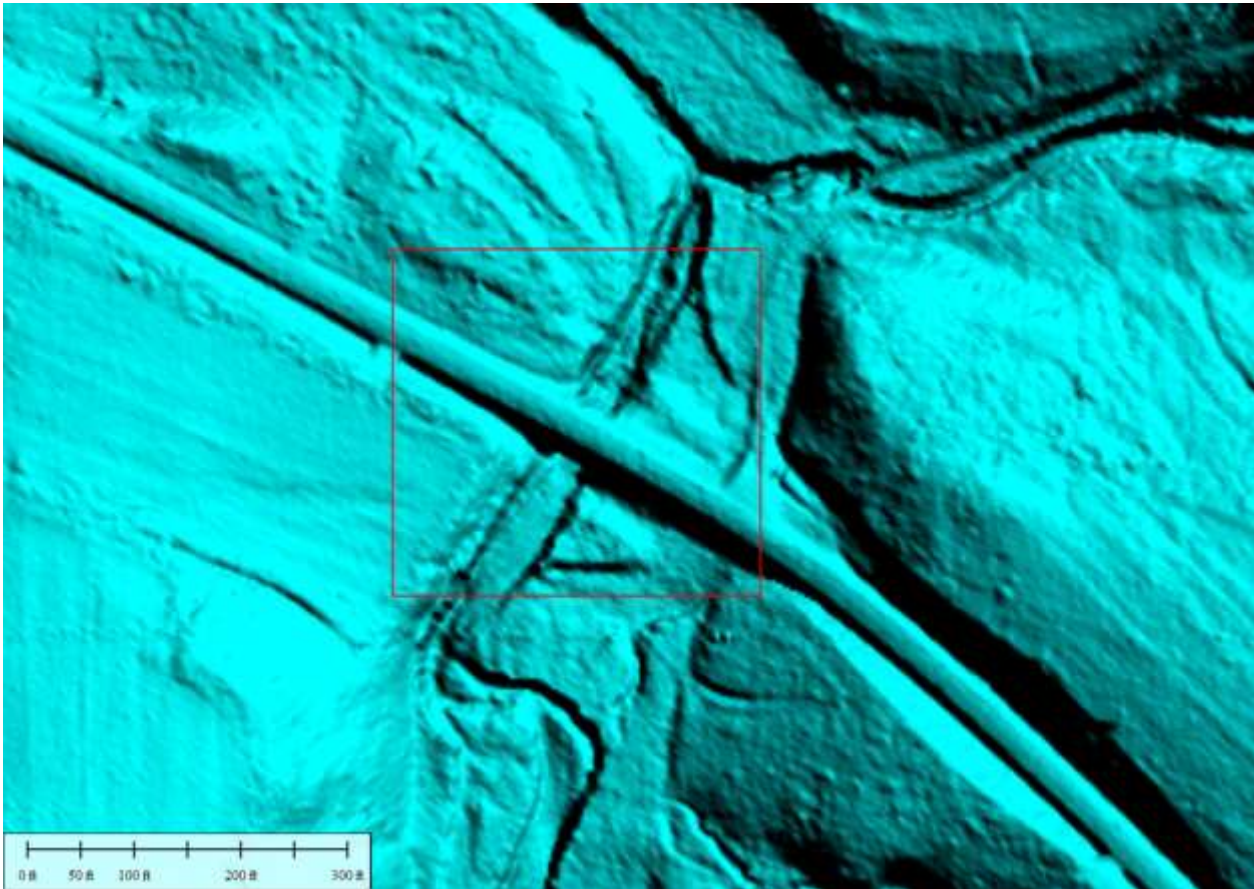
bridge: Imagery suggests the roadway above the waterbody (stream) is a bridge; roadway above waterbody should be removed. There are two of this error-type

\*\*These errors have been corrected by the contractor (5/31/2013).

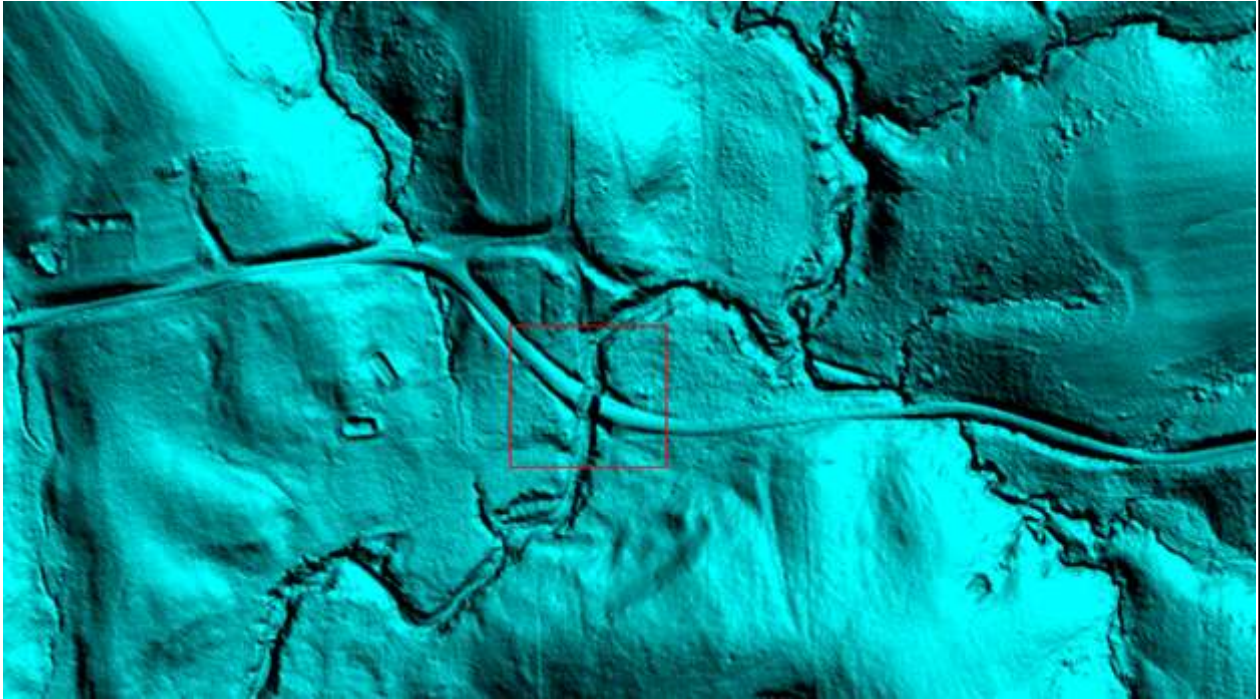
culvert\_1: This is a representative image of the error-type 'culvert', whereas the roadway was removed above a waterbody (stream). Roadways above culverts should not be removed. 104 culvert-errors have been identified within this dataset.

\*\*These errors have been corrected by the contractor (5/31/2013).

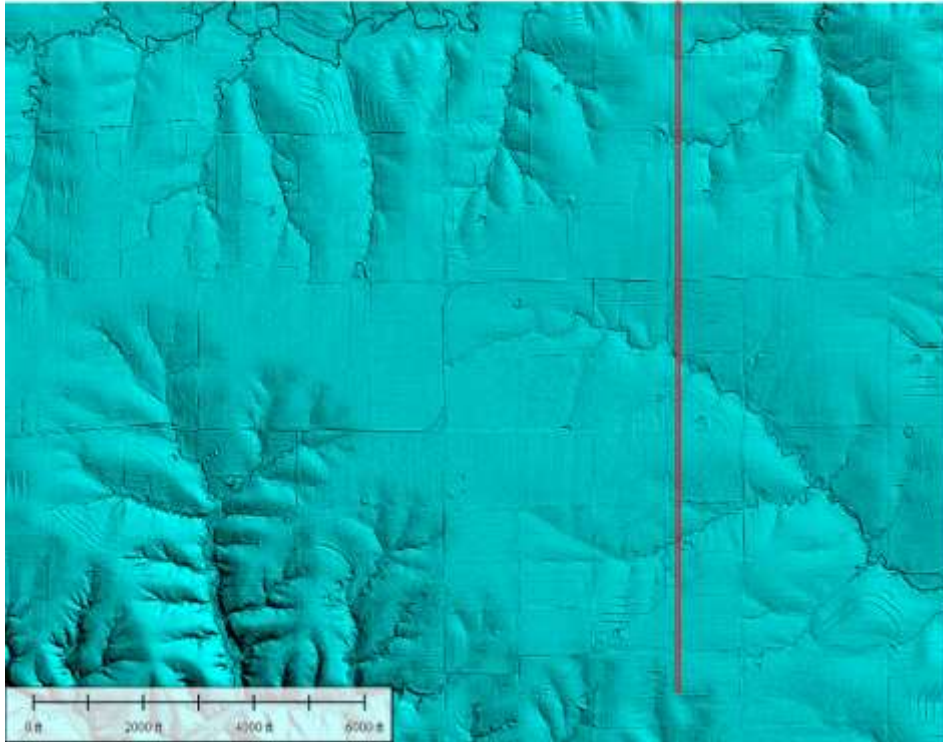
linear\_anomaly: The area in red shows the extent of a north-south trending anomaly within the DEM. The image below shows in detail this lineation. There are two of this error-type. Both errors follow the same longitude.

\*\*These errors have been corrected by the contractor (5/31/2013).

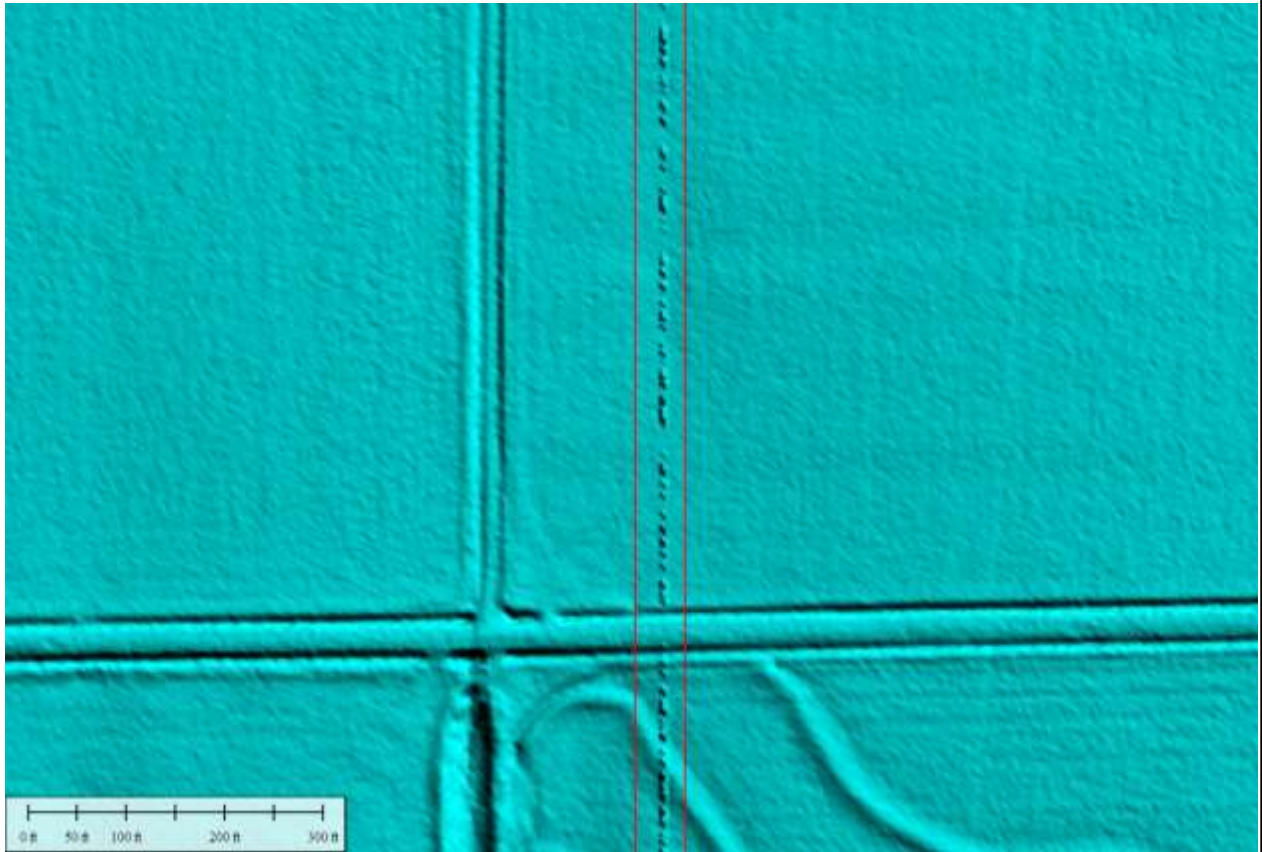
linear\_anomaly\_close-up: This image clearly shows the linear anomaly in the DEM.

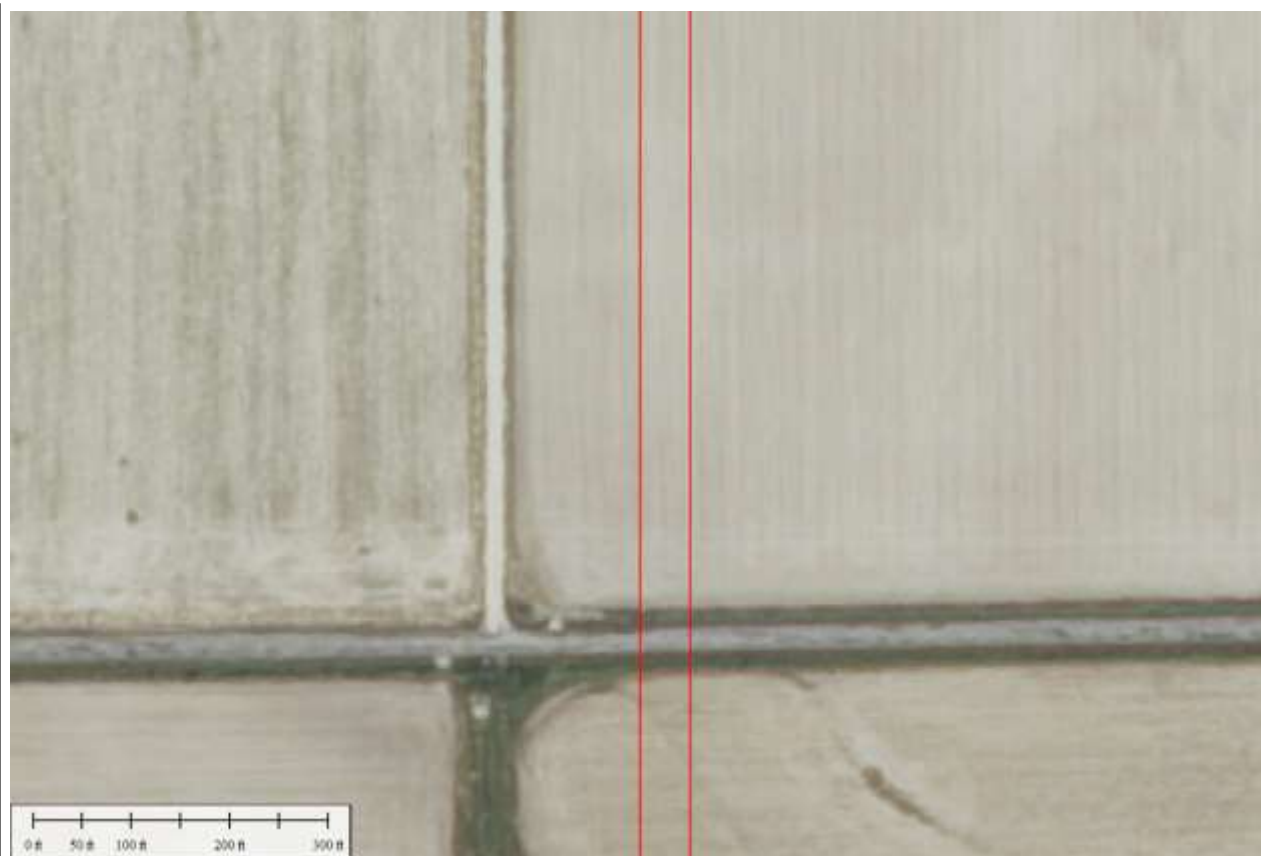
linear\_anomaly\_close-up\_NAIP: This NAIP image shows the same area of the image above. The lineation does not appear to be natural but a DEM processing error.
