# LiDAR Quality Assessment Report

MO\_StLouis\_2012

St. Louis City and County, Collected January 29&30 and February 1, 2012 (Part of Delivery 2 of 4 for the MO Grand Project)

Surdex Corporation

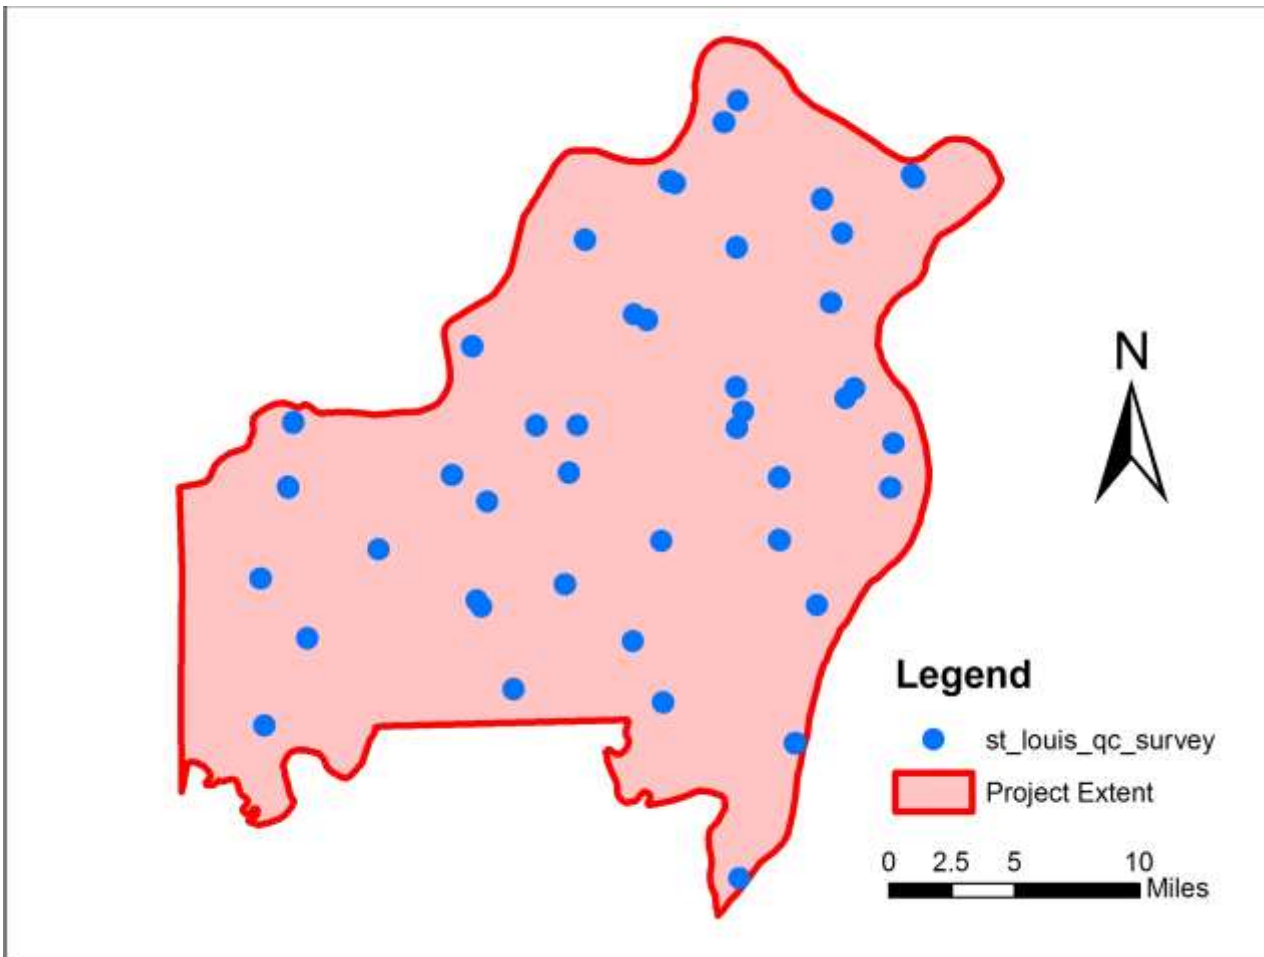
Checkpoint Distribution Image?

There are a minimum of 20 checkpoints for each land cover class represented. Points within each class are uniformly distributed throughout the dataset. USGS was able to locate independent checkpoints for this analysis. USGS accepts the quality of the checkpoint data for these LiDAR datasets.

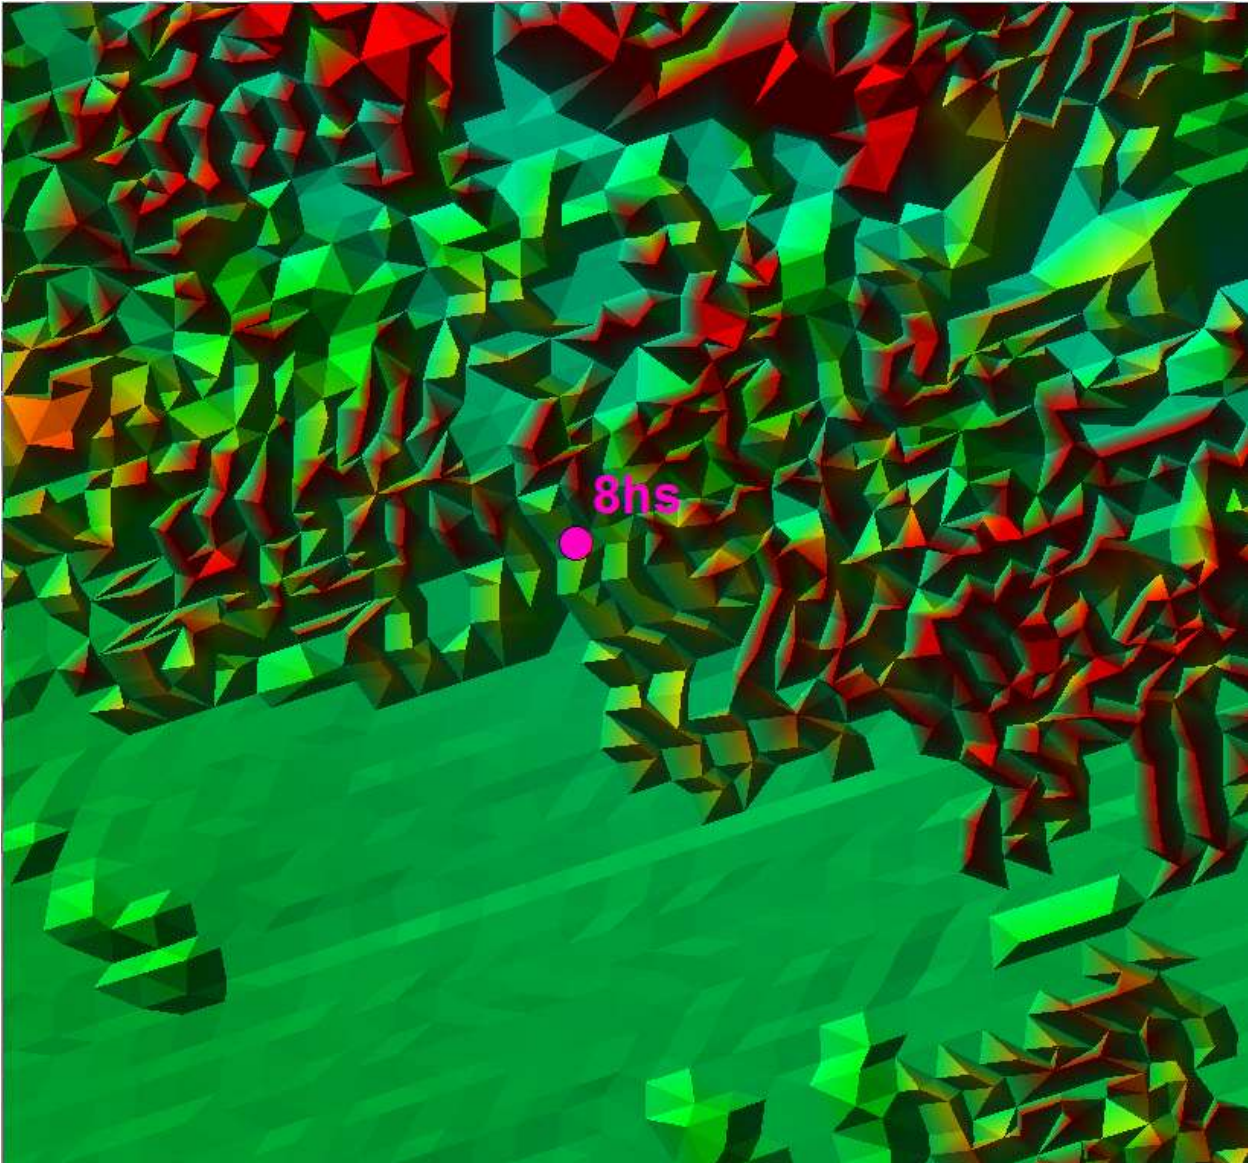
The FVA of the Swath LAS Data is 62.3 meters (NSSDA, 95% Confidence Interval). The swath data needs to be calibrated to meet the FVA requirement of .245 meters or less.

UPDATE: The swath data was calibrated and the FVA is now 0.187 meters at the 95% Confidence Interval; however, one survey point had to be removed due to its location in a forested area. The removed point is "8hs". The image above shows a TIN of the swath LAS points and the location of the removed point. This point had a Z Error of -4.914 meters, which indicates that the survey ground elevation is 4.914 meters less than the swath LAS TIN surface elevation. Swath LAS files have an Unknown Coordinate System.

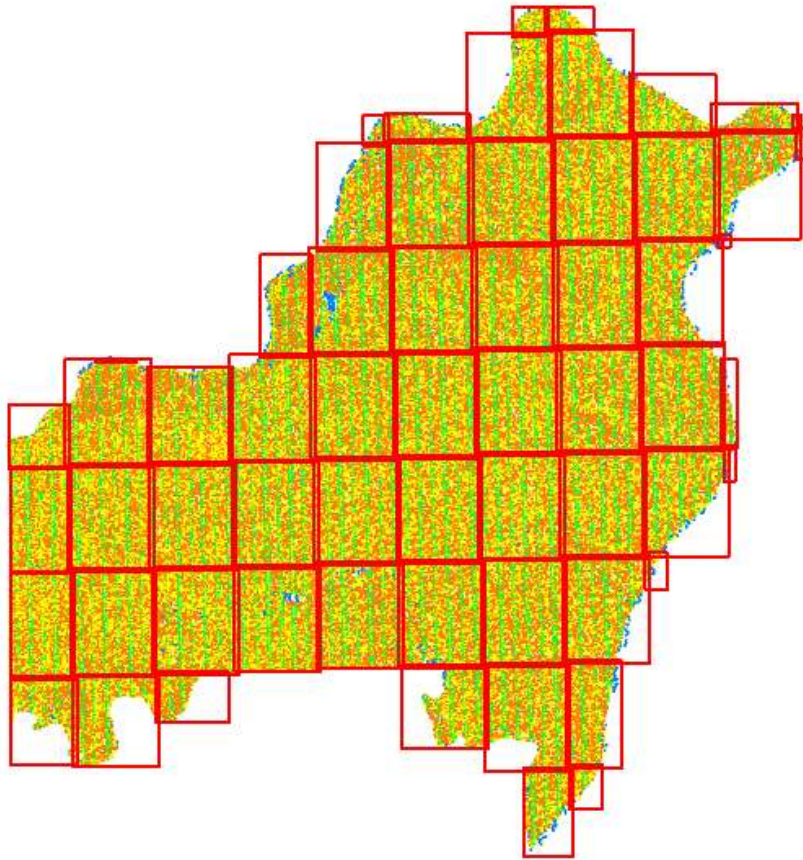
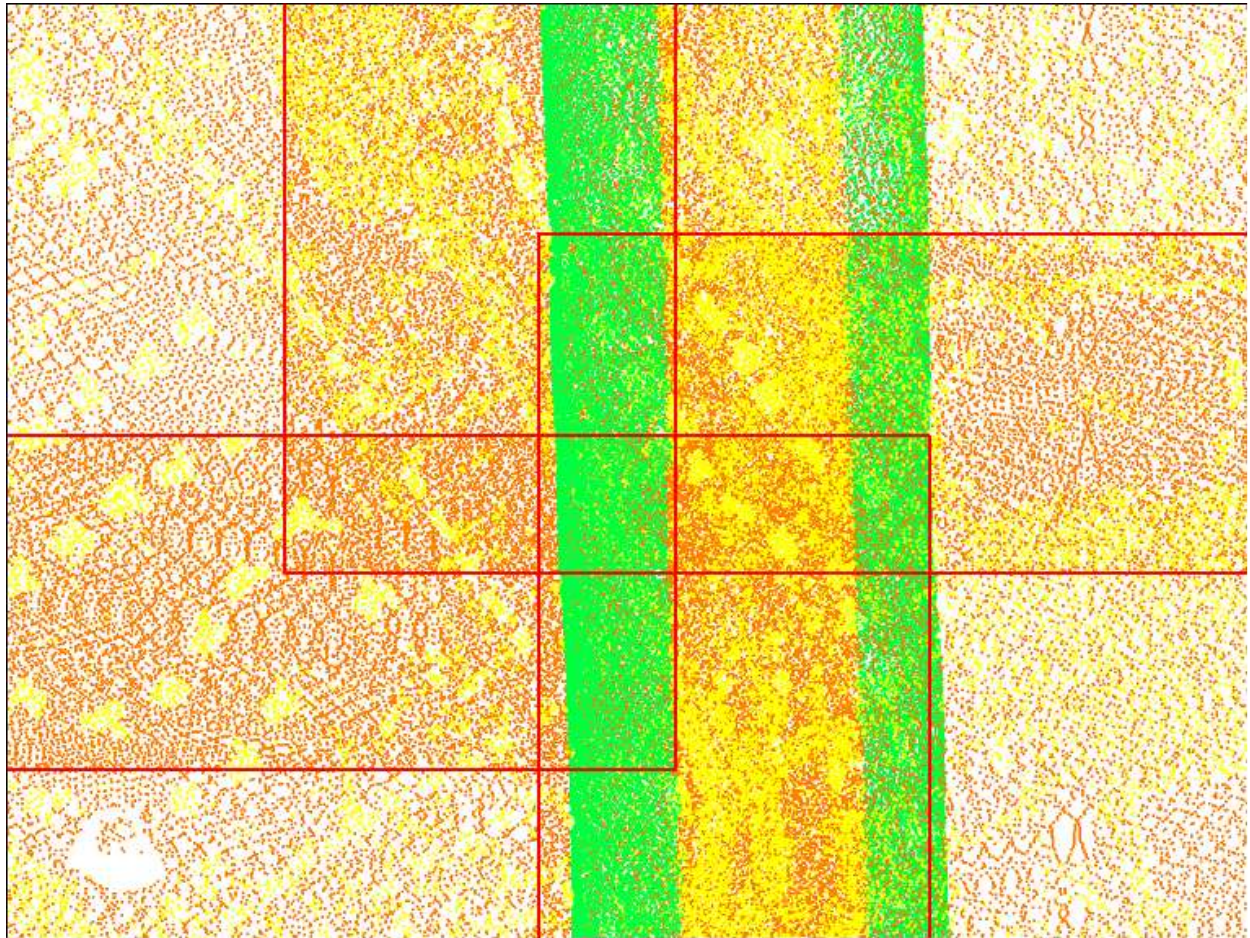
Classified LAS tile files overlap.

UPDATE: Classified LAS tiles no longer overlap.

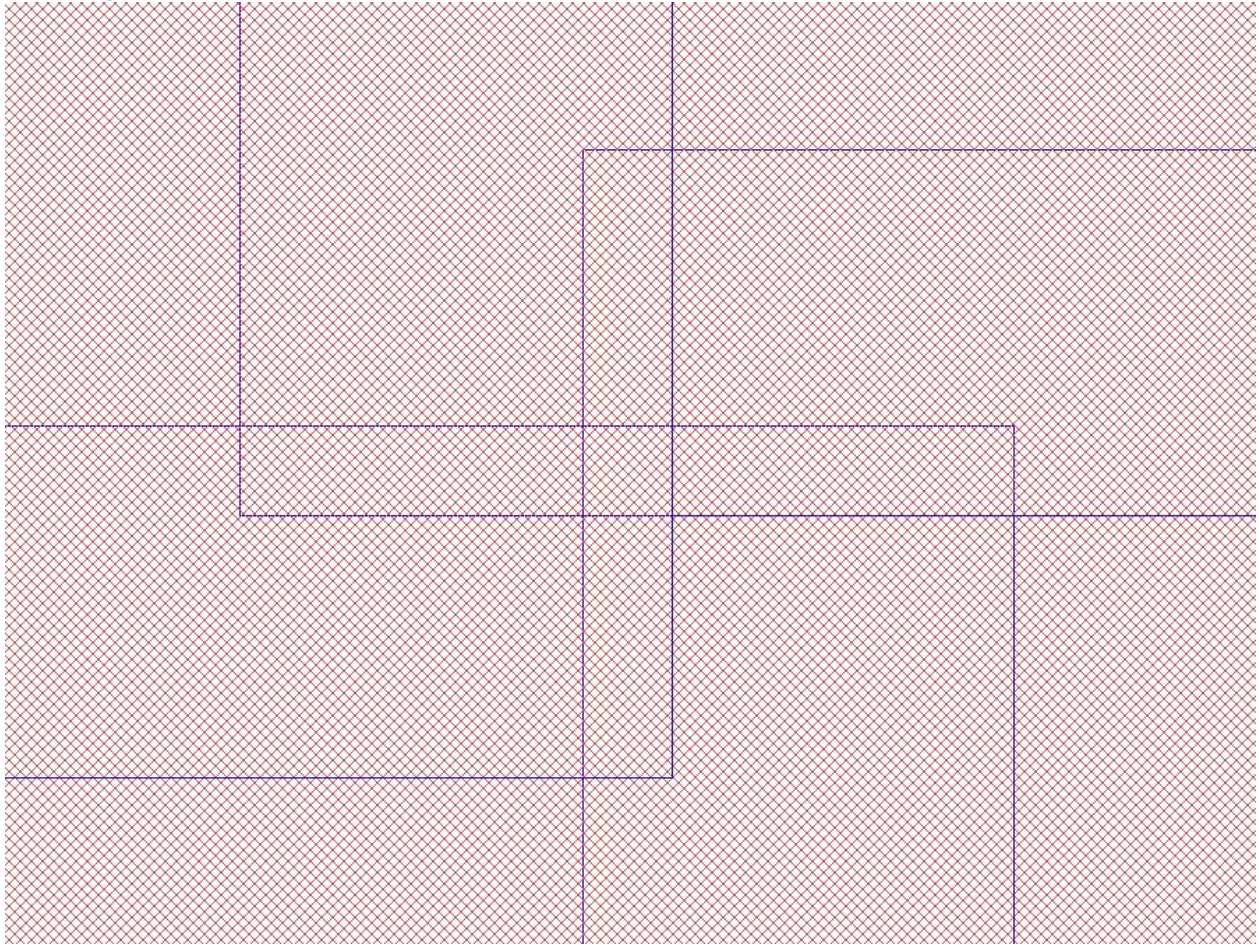
No project tiling scheme was provided. DEM files overlap.

UPDATE: All DEM errors have been corrected, and the DEM tiles no longer overlap.

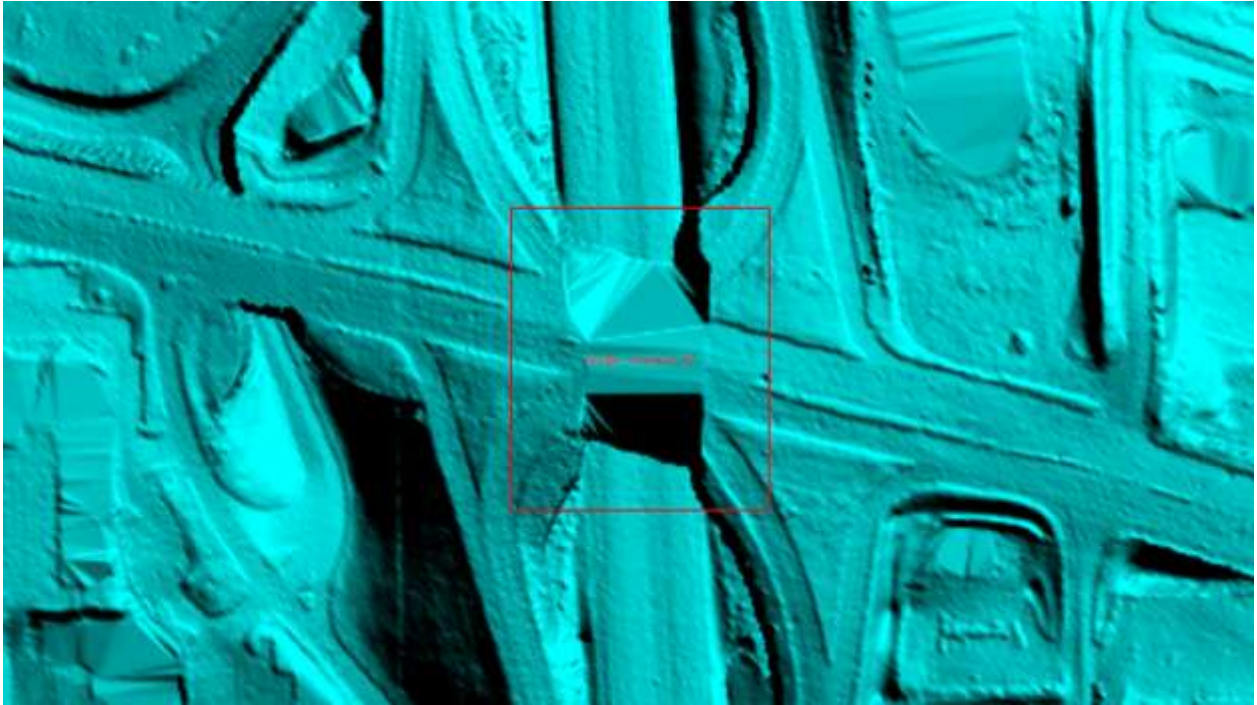
There are a total of five bridges that were not adequately removed. ALL BRIDGES HAVE BEEN REMOVED, WITH THE EXCEPTION OF SEVERAL BRIDGE SADDLES. NO FURTHER ACTION REQUIRED. (10/12/2012)

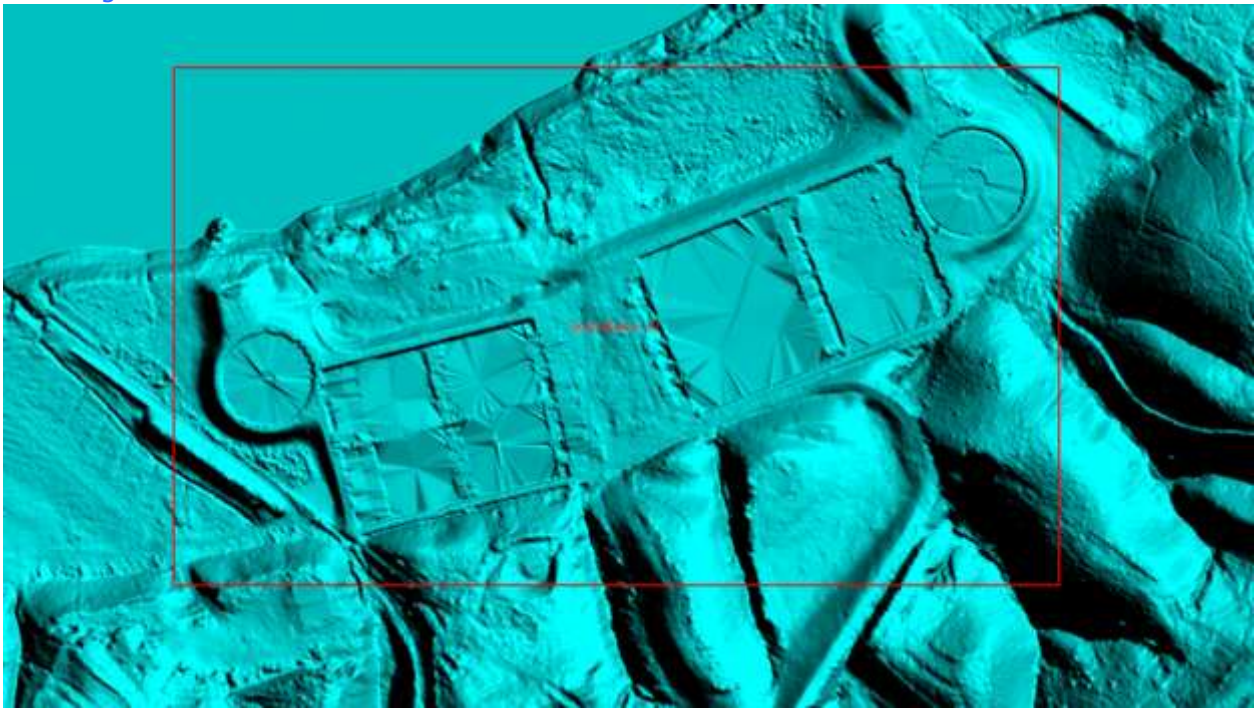
There are ten water bodies that have not been hydroflattened. The majority of the water bodies are water treatment plants, the remaining water bodies are small ponds, greater than 2 acres in size. NINE OF TEN WATER BODIES HAVE BEEN HYDROFLATTENED. NO FURTHER ACTION REQUIRED. (10/12/2012)

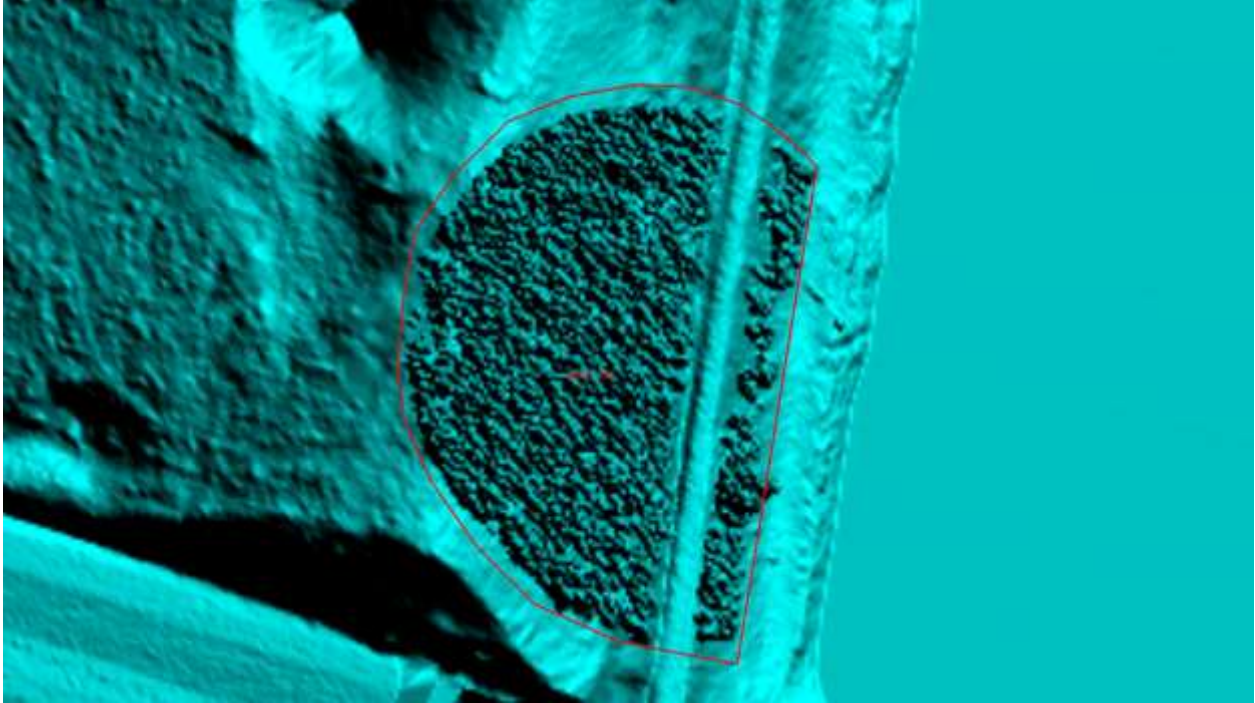
There is one area where lidar returns from trees were misclassified as ground, and were therefore included when the DEM was created. THIS ISSUE HAS BEEN CORRECTED. NO FURTHER ACTION REQUIRED. (10/12/2012)

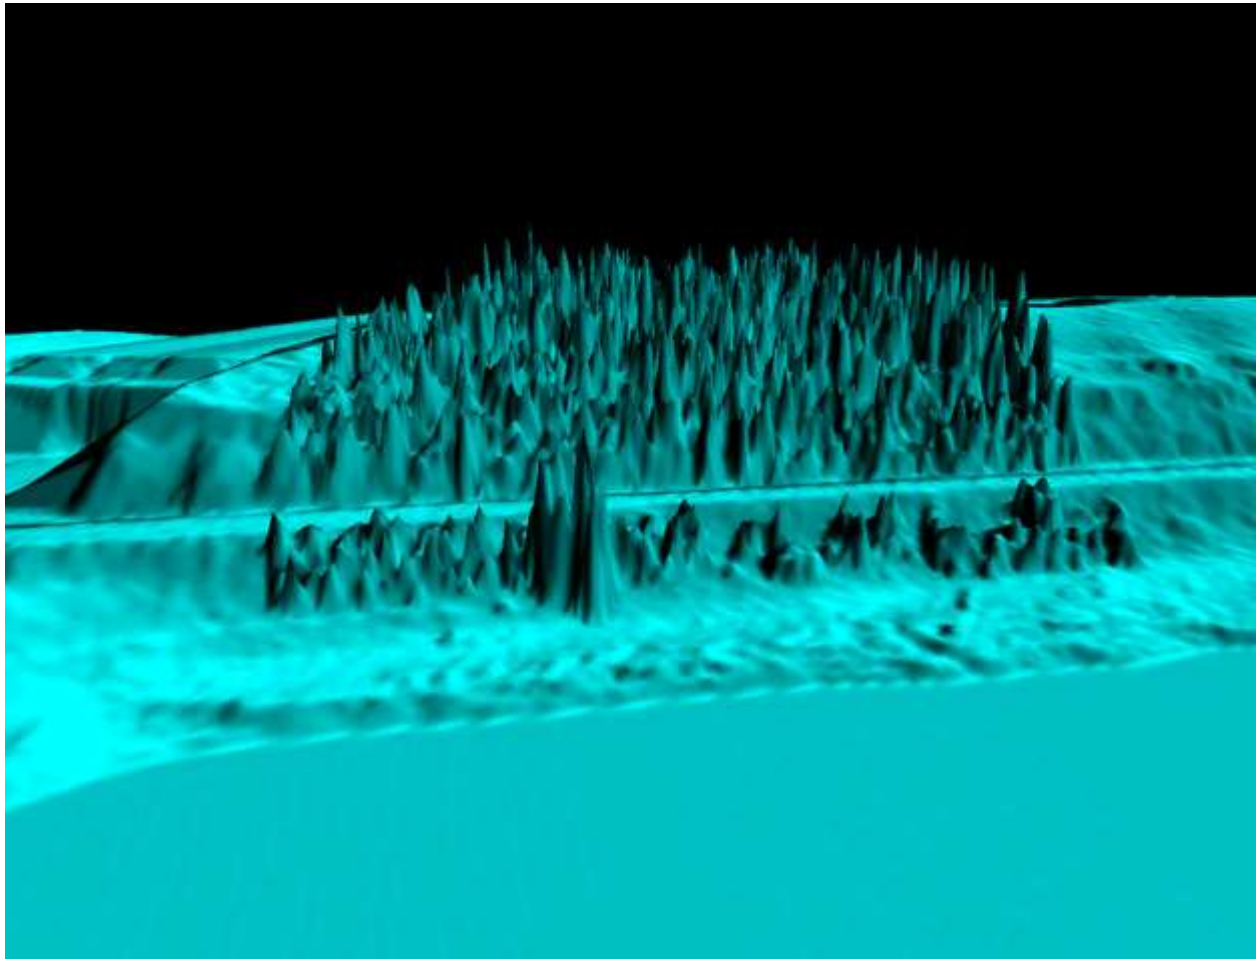
Trees 3D.
