LiDAR Quality Assurance (QA) Final Report
Sub-project 1: Platte River Corridor
Nebraska/Kansas LiDAR
January 13, 2010

Submitted to:
USDA-NRCS-Nebraska/
U.S. Army Corps of Engineers

**Dewberry**
Fairfax, VA

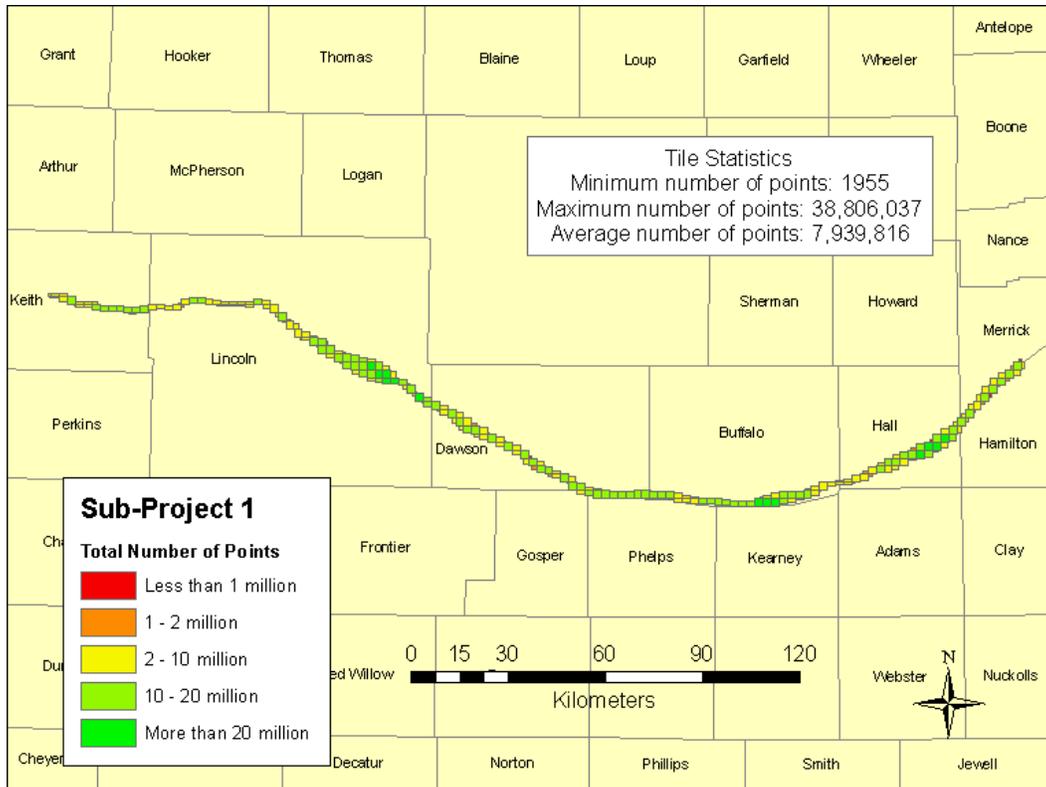
Figure 2: Number of points per tile.

Each tile was queried to extract the number of LiDAR points. With a nominal point spacing of 0.7 meters, the number of points per tile should be approximately 8 million. The mean in Sub-project 1 is approximately 7.9 million, which is as expected. All tiles are within the anticipated size range except for those on the edge of the project boundary (Figure 2).

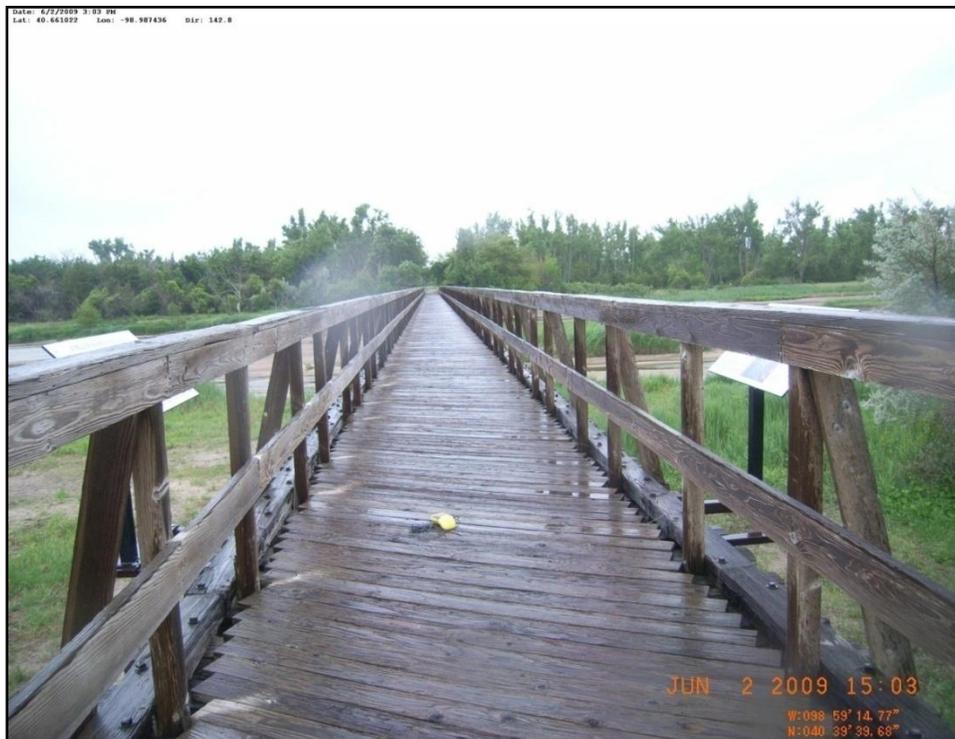
Figure 4: Checkpoint BM-14-8-15C located on a bridge

The Nebraska Partners elected to use pre-existing survey points for LiDAR accuracy testing. 53 checkpoints were made available by USDA-NRCS-Nebraska for assessment by Dewberry. Of these 53 points, 29 were used in the final assessment after it was determined that 24 points were not suitable for analysis. Checkpoints are deemed unsuitable for analysis when they are determined to be located on a surface that is not ground, such as a bridge, culvert or other man-made feature. Checkpoints may also be invalidated if they are located on terrain with an incline greater than 20 degrees, or if the ground has been disturbed between the time of checkpoint measurement and the LiDAR collection, such as burial or relocation of the point due to land development. The photo in Figure 4 shows a checkpoint surveyed on a footbridge, a feature that is removed from the surface model when conducting the accuracy assessment.

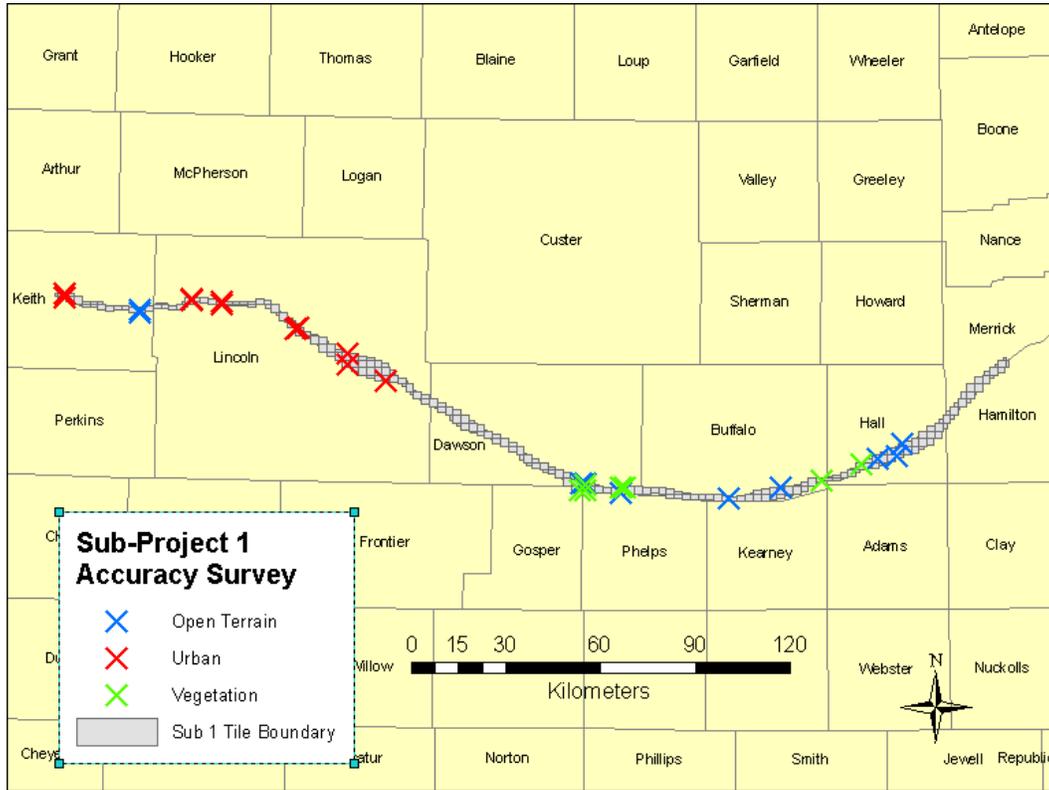
Figure 5: Sub-project 1 survey checkpoints provided by USDA-NRCS-Nebraska

Figure 5 shows the point distribution across the Platte River Channel. The checkpoints are well distributed overall, though the distribution within each land cover category is not as wide as desired. The urban checkpoints are concentrated in the western half of the dataset, while the vegetation checkpoints are concentrated in the eastern half. The accuracy scores were good

for all land cover categories, regardless of their spatial distribution, indicating high accuracy throughout the dataset.

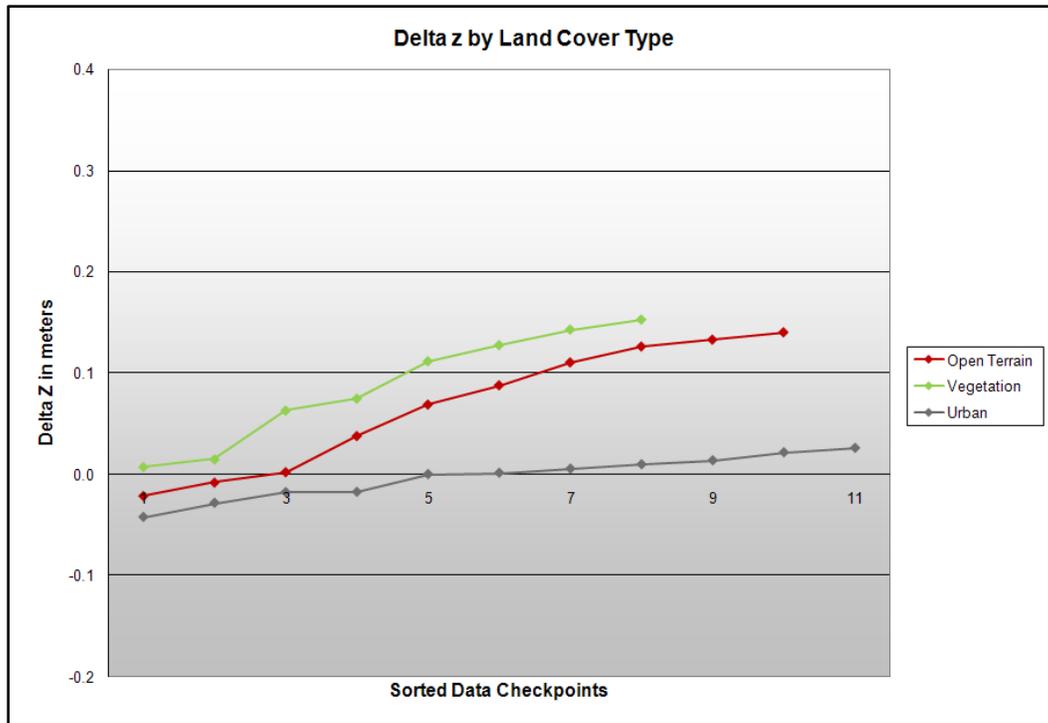
Figure 6: Checkpoint distribution sorted by error value (delta Z)

Figure 6 illustrates the distribution of the elevation differences between the LiDAR data and the surveyed checkpoints. The slight majority of delta Z values are above zero which indicates a slightly positive error distribution.

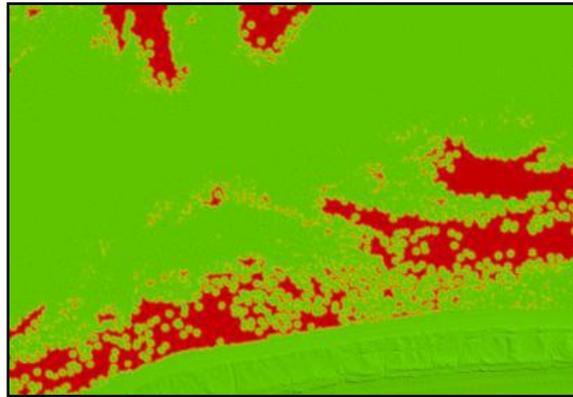
Figure 7: Stock example of low point density (red areas)

One of the variables established when creating the models is the threshold for missing data. For each individual triangle, the point density information is stored; if it meets the threshold, the corresponding surface will be displayed in green, if not it will be displayed in red (Figure 7).

Please note that if this density model is created with ground points only, low density areas are expected where buildings, water, and/or heavy vegetation were classified out of the ground. Dewberry did not identify any areas of poor LiDAR penetration at the extent illustrated by the sample figure above. The LiDAR was collected to meet the 0.7 m nominal point spacing and therefore maintained sufficient density throughout the sub-project area.

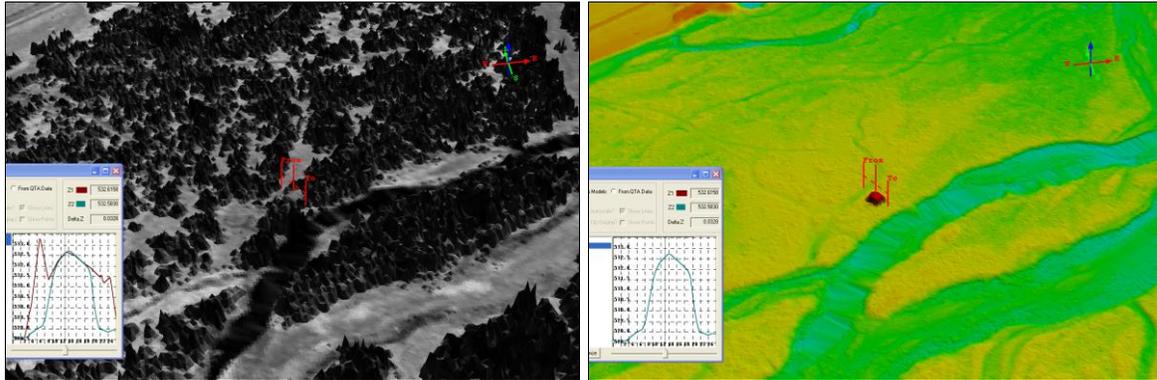
Figure 8: tile 14T NL 7504-2 with a building in the ground classification

While reviewing the dataset, several buildings were found classified as ground. There is a 2% allowance for building artifacts; therefore these errors do not need to be reprocessed. Figure 8 shows the building remaining in the ground classification. The image on the left shows the full point cloud colored by intensity and the model on the right shows the ground classification colored by elevation. The profile graph shows the full point cloud in red and ground in blue. Please refer to Appendix A for screenshot thumbnails.

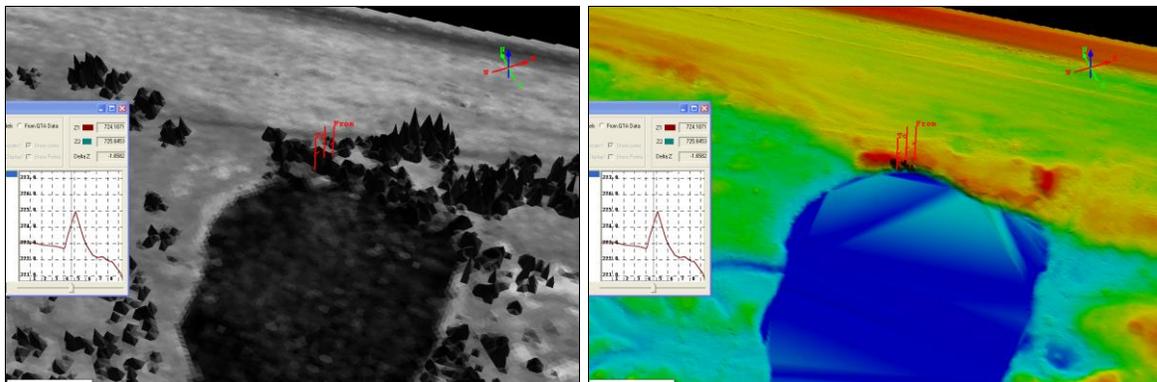
Figure 9: tile 14T ML 4005-1 with vegetation in the ground classification

Dewberry also identified one case of vegetation remaining in the ground classification. There is a 5% allowance for vegetation in the project area so this error does not need to be reprocessed. Figure 9 shows the full point cloud colored by intensity on the left and the ground classification colored by elevation on the right. The profile graph shows the height of the artifact in the ground model.

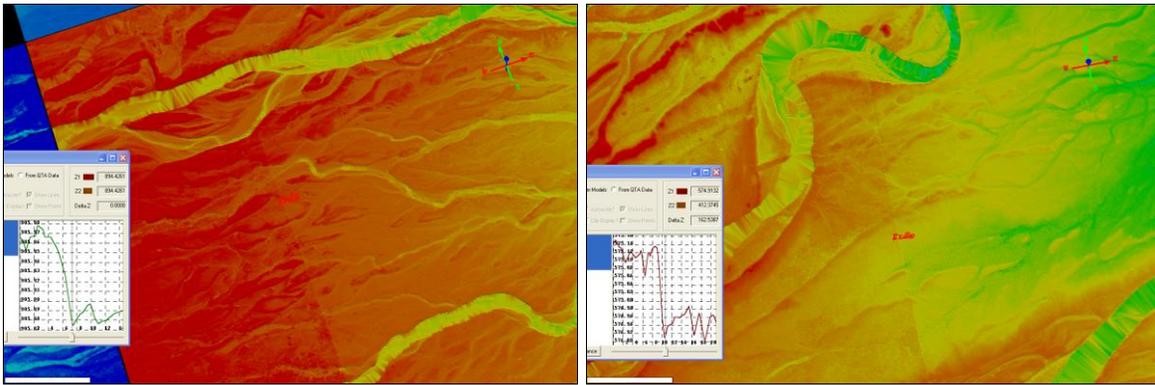
Figure 10: tile 14T LL 1060-4 (left) and tile 14T NL 5015-1 showing small ridges

Dewberry identified two ridges in the LAS data. The first, in tile 14T LL 1060-4, does not seem to be caused by collection anomalies such as flight line mismatch, point bunching or spreading, etc. The second, in tile 14T NL 5015-1, follows a flight line seam and probably the result of the slight elevation error along the edge of the collection swath. The ridges are relatively small in height and should not present any major issues with quality or accuracy. In Figure 10 the image on the left shows a ridge in the ground classification that is approximately 6cm high and the image on the right shows a ridge that is approximately 14cm high. Please refer to Appendix A for screenshot thumbnails.

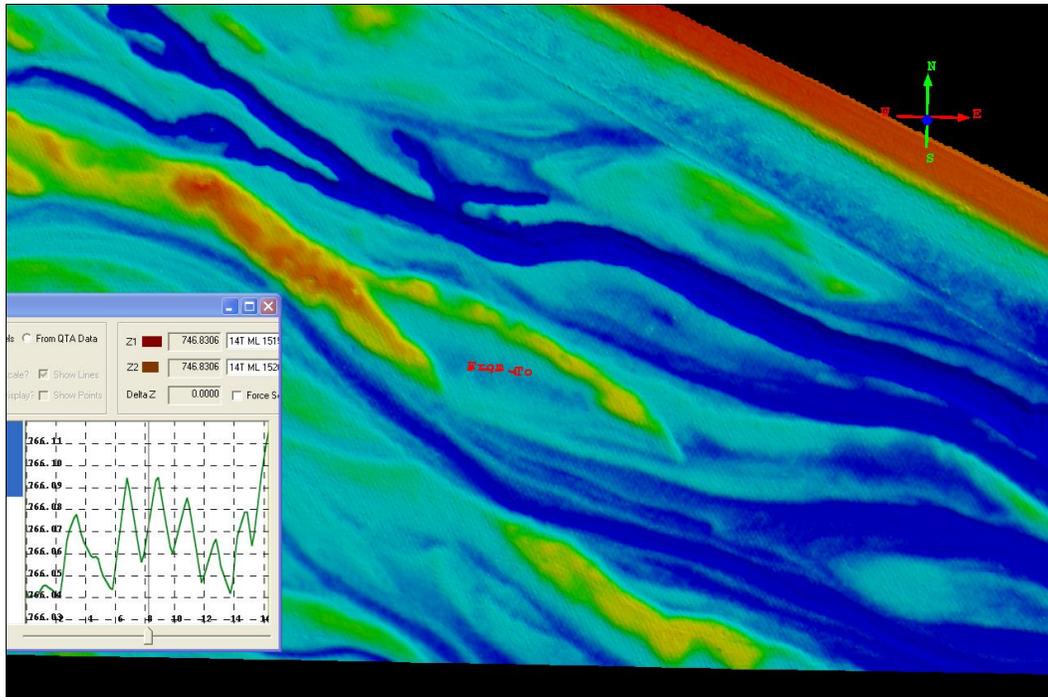
Figure 11: tile 14T ML 1025-3 with noise in the flight line overlap area

Noise due to small elevation differences between flight lines is a minor error found throughout the dataset. In areas where two or more flight lines overlap, the ground model appears more rough (noisy) as illustrated in Figure 11. All the noisy areas had elevation differences between flight lines of less than 10cm, which is relatively minor and should not affect the usability of the data. Please refer to Appendix A for screenshot thumbnails.

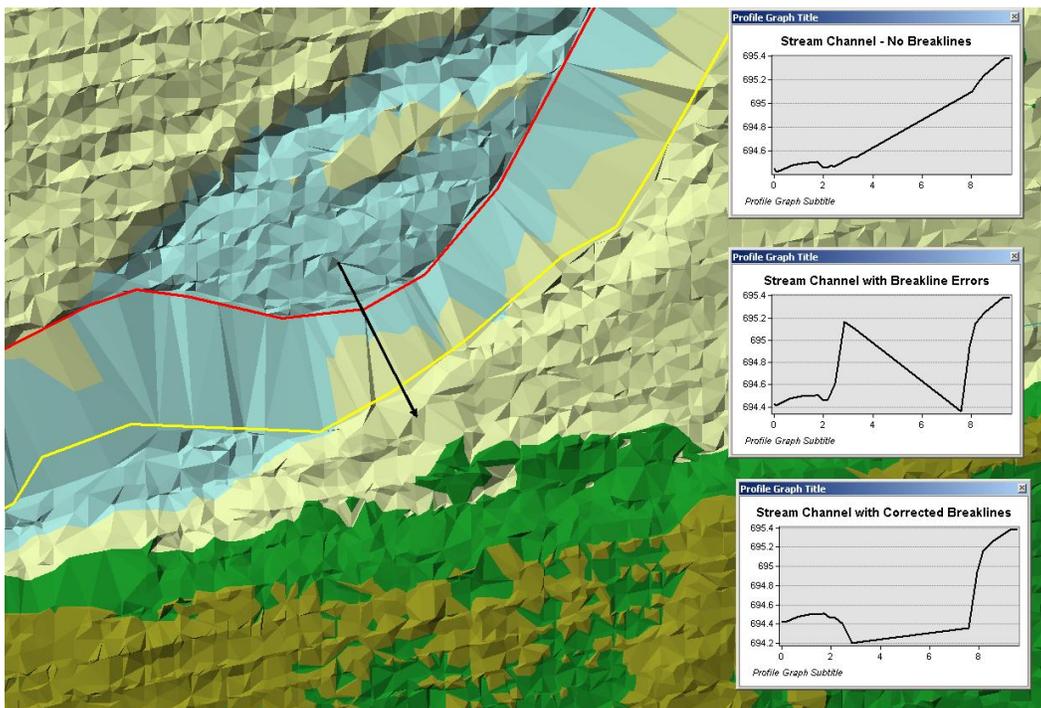
Figure 12: Terrain created without breaklines

When an error like this occurs, the LiDAR provider will assign the elevation from the previous vertex to each subsequent vertex until it reaches a vertex that has suitable ground points around it, thereby maintaining monotonicity. Unfortunately, this causes a different type of error, where the breaklines will “float” above the LiDAR or “burn” into the LiDAR. The following images show how the breaklines affect the creation of a terrain. Figure 12 shows a terrain created with LiDAR ground points only. Note the profile graph on the top right; the LiDAR points on either side of the stream channel have different elevations so the channel is not smooth.

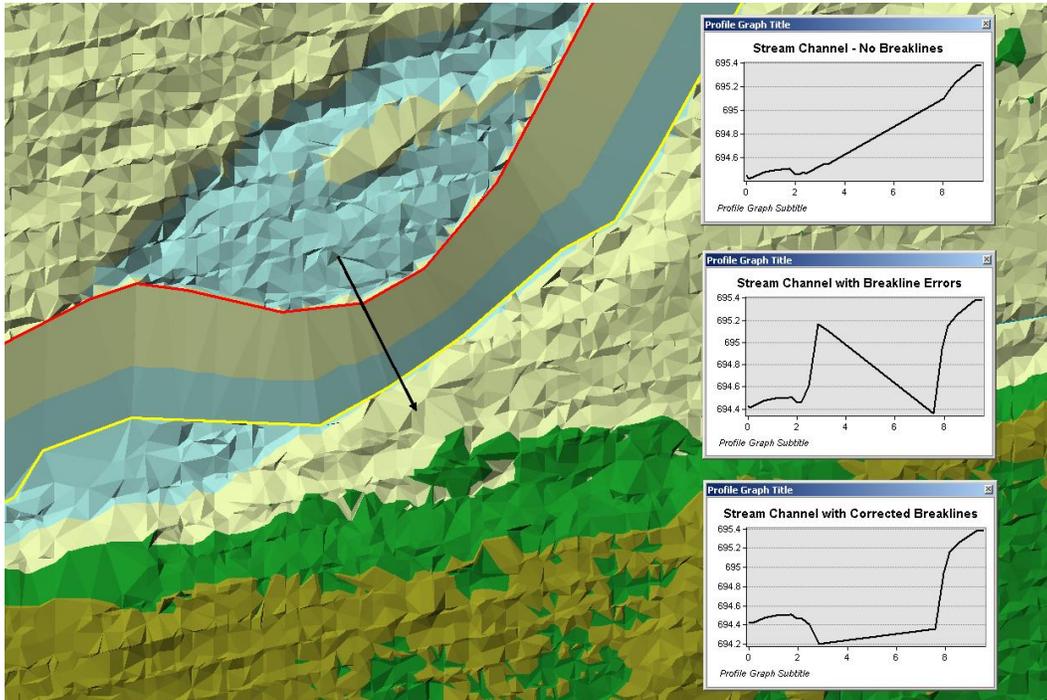
Figure 13: Terrain created with breaklines (with elevation errors)

Figure 13 shows a terrain created with the LiDAR ground points and the breaklines. Note how the channel geometry changed due to the influence of the breakline vertex elevations. In the profile graph (middle right), the breakline on the northern bank (left side of the graph) has elevations that are much higher than the LiDAR. This causes the edge of the stream to be

almost a meter higher than the surrounding land, which is unsuitable for hydro modeling. On the southern bank (right side of the profile graph), the breakline elevations are slightly lower than the surrounding LiDAR, causing a trench-like effect. This error is still not desirable, but will cause less of a problem than the “floating” breakline.

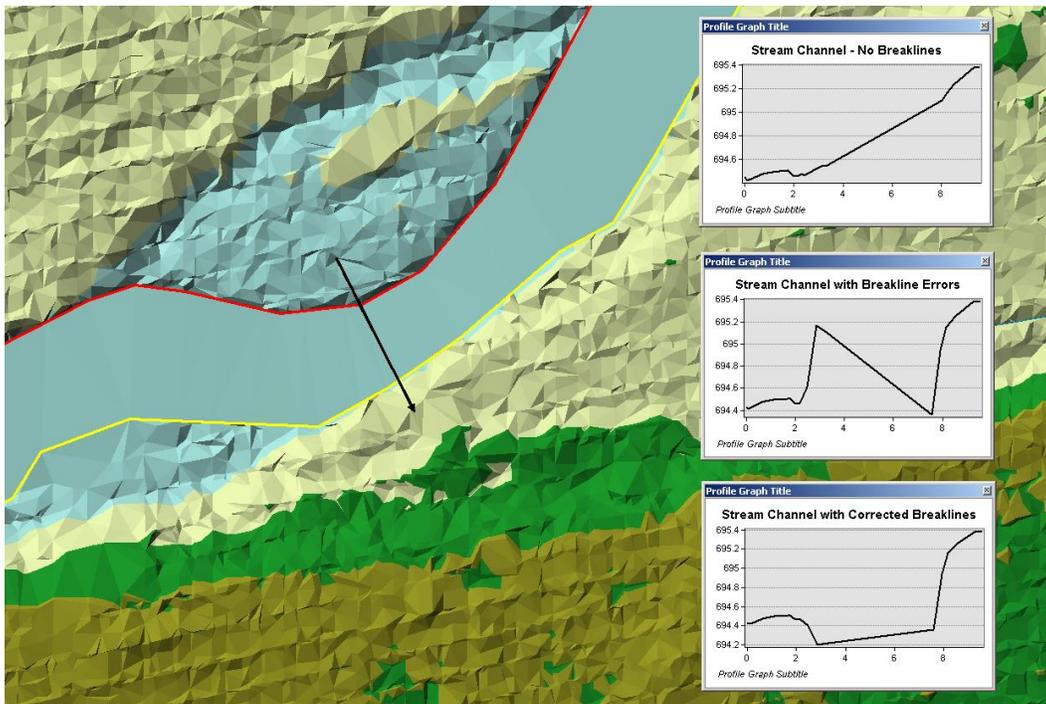
Figure 14: Terrain created with corrected breaklines

The final example in Figure 14 shows a terrain created with the breaklines after Merrick corrected several of the most pronounced vertex elevation errors. The profile graph shows a well defined stream channel where the breakline is the lowest point on each side of the stream. While there still are small elevation differences between the LiDAR and the breaklines, this provides the best model of the land surface for hydro modeling.
