LiDAR Project Report
South New Jersey
2008

Submitted to:
USGS

**Dewberry**

QAQC REPORT

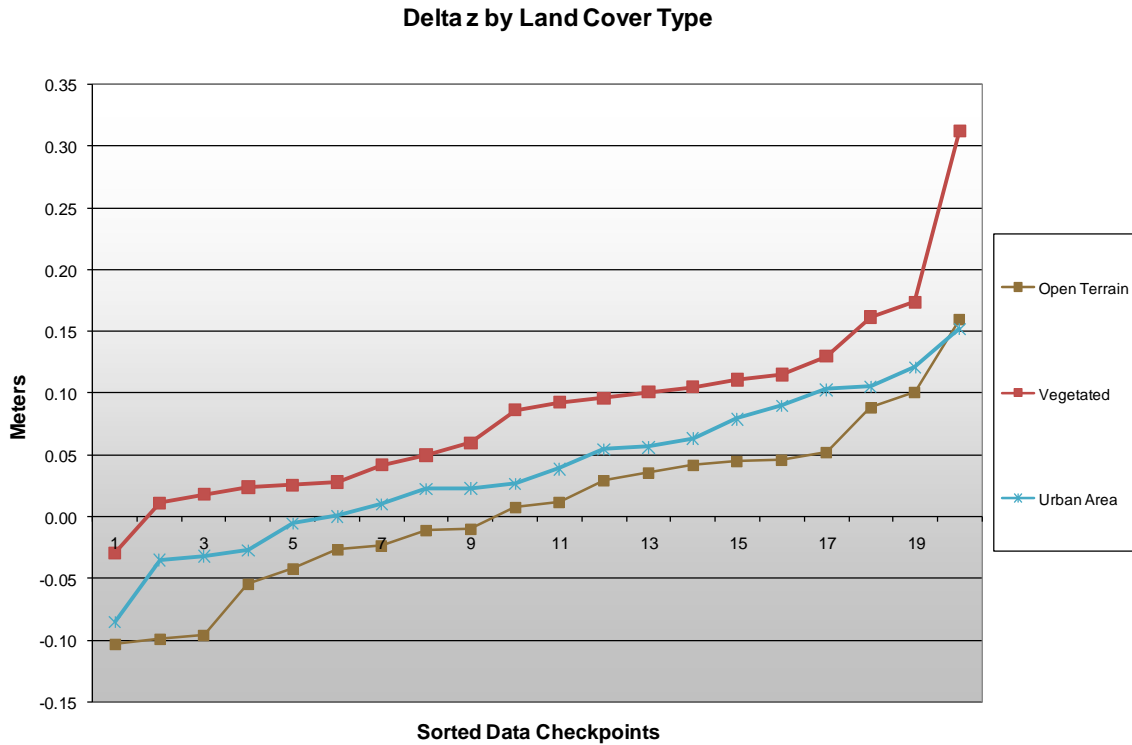
Figure 12 – Sorted checkpoint errors

Figure 12 illustrates the distribution of the elevation differences between the LiDAR data and the surveyed points. The points are almost all above zero indicating a slightly positive Z bias which remains acceptable.

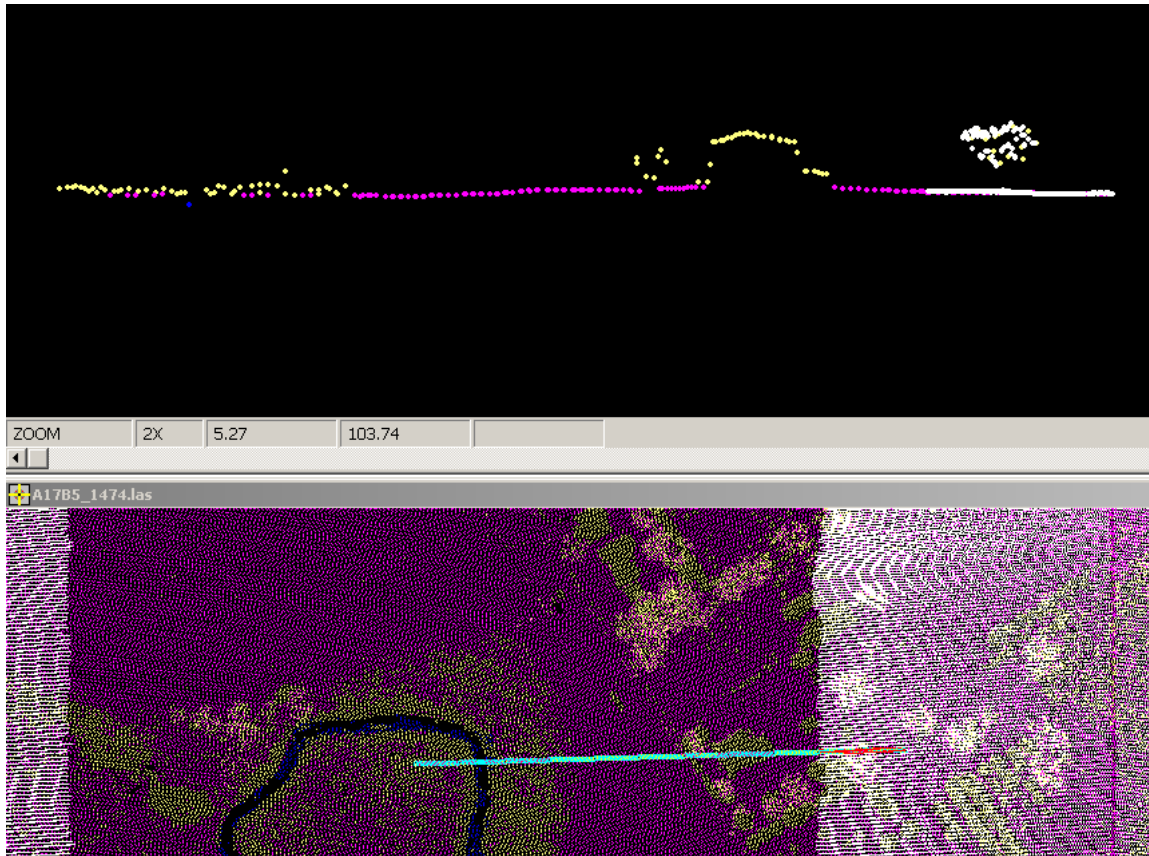
Figure 15 – Full point cloud colored by class (white: overlap, pink: ground, yellow: non-ground, blue: water)

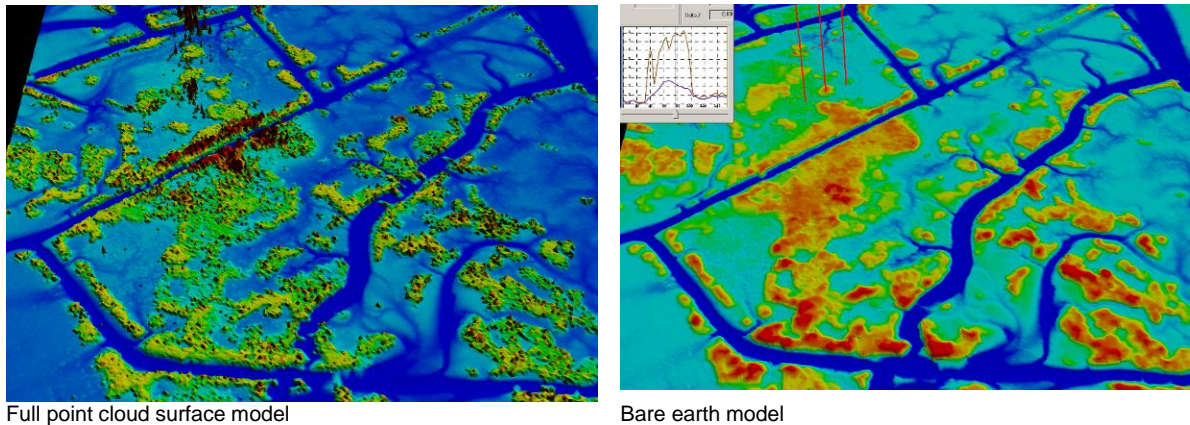
Figure 18 and Figure 19 illustrate potential vegetation artifacts based on the visual inspections of the bare-earth terrain. However, there is a good chance that the ground actually exhibits these irregular mounds. None of these tiles have been ground-truthed and therefore are identified only as potential issues. Moreover, it is evident that these potential areas are relatively small and easily within the specification of being 95% cleaned of vegetation artifacts.

Figure 18 – Tile A17D9: Possible vegetation artifacts

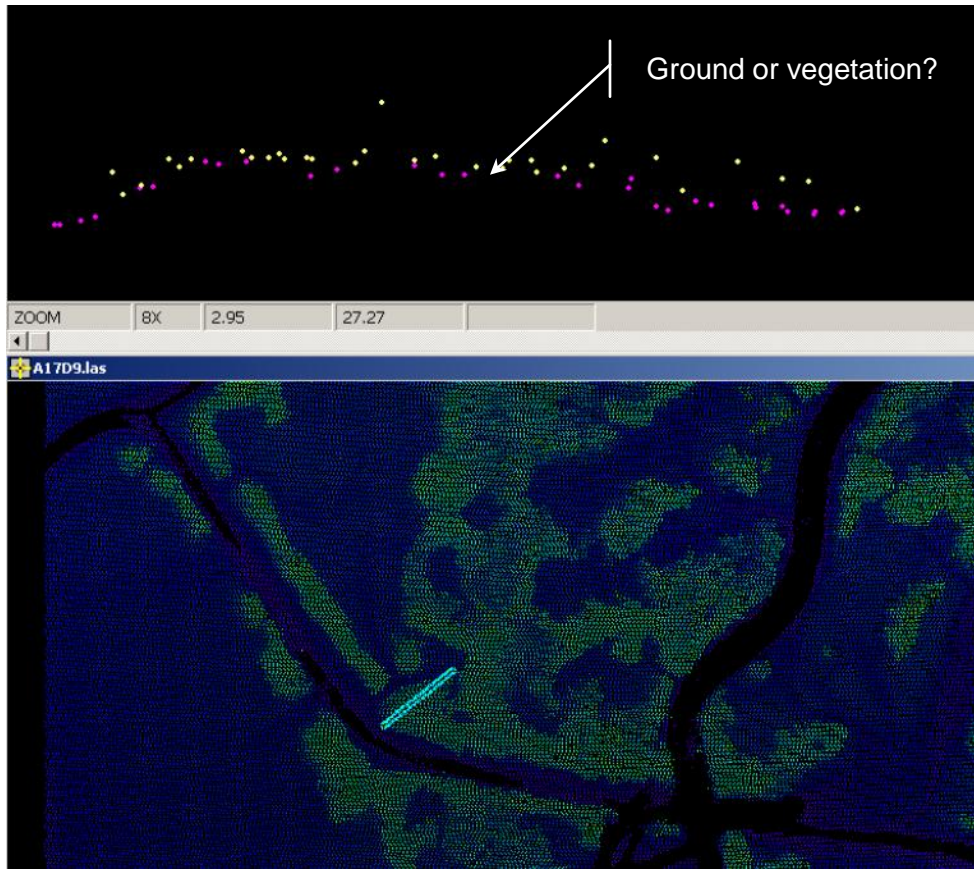
Figure 19 – Tile A17D9: Possible vegetation artifacts. Same area as Figure 18. Bottom: full point cloud displayed by elevation. Top: cross section, points colored by class (pink=2 ground; yellow=1 unclassified). Ground points elevated compared to adjacent areas are these vegetation remains?

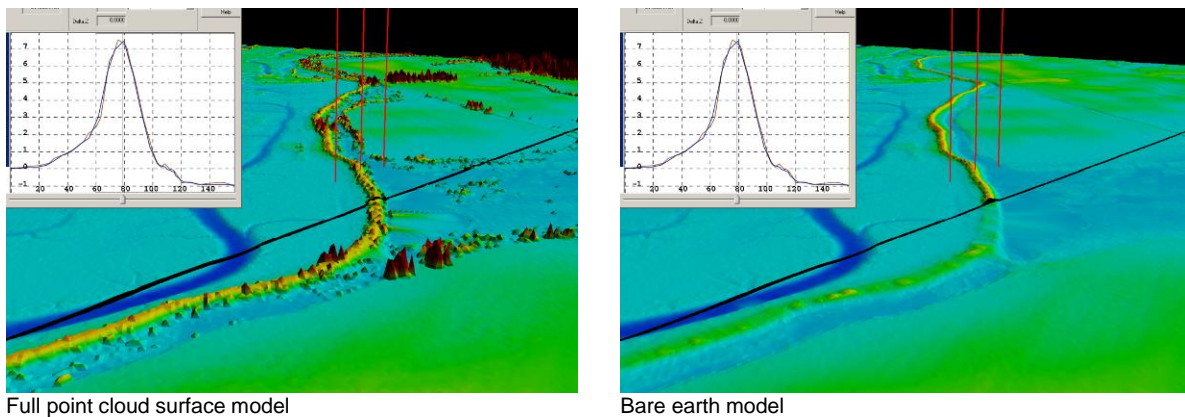
We also noticed that sections of narrow elevated ground (some sort of levee) were sometimes inconsistently removed (Figure 20). Since they are likely not to be manmade structures, one could argue that they should be kept in the bare earth model. However, it's more the consistency along the same structure that we assessed here.

Figure 20 - A18B1 to A18B2: Inconsistent editing across tiles

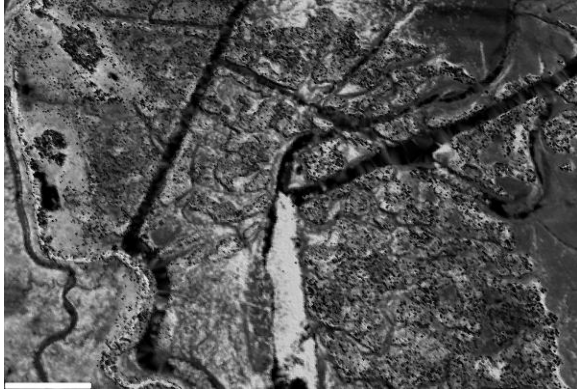
A problem that we often found is patches with lower density of ground points. When the vegetation is very dense, the LiDAR may not penetrate the canopy all the way to the ground; another possibility is that when the soil is really wet no reflection occurs since except at angles close to nadir, the Near Infrared LiDAR beam is usually not reflected by water. Therefore in both cases only a few ground points remain after classification of the vegetation. Nevertheless, as soon as a few points are present, a 3D model can be built with an acceptable reliability, especially in flat areas. However, the definition of the surface is often of poorer quality; this is illustrated in Figure 22.

Figure 22 – Tile A17C12: Poor LiDAR penetration in marshy area

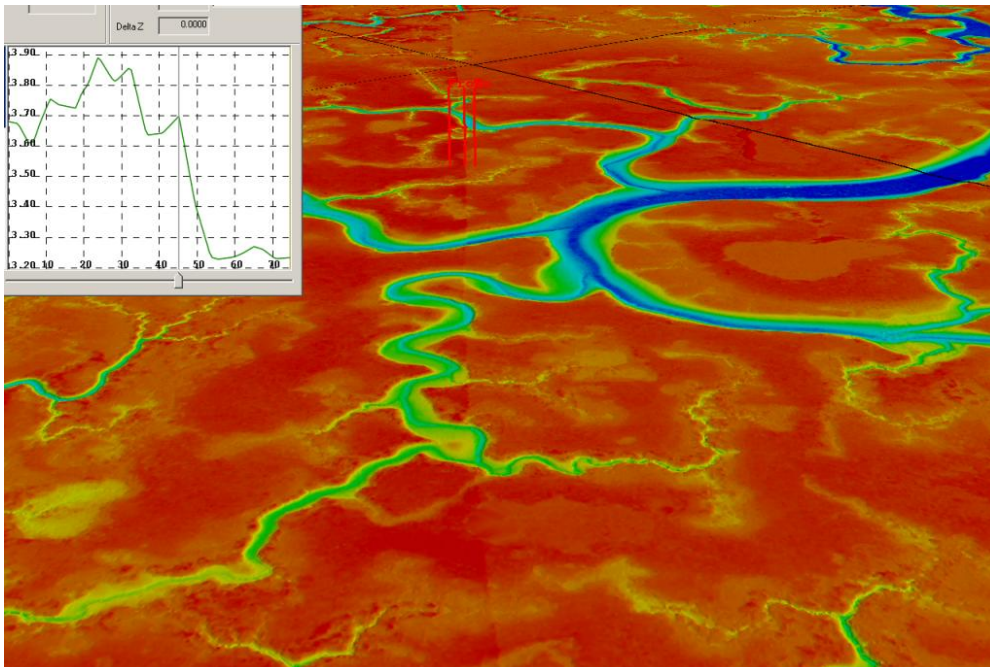
We noticed ridges at seamlines caused by a vertical mismatch between 2 adjacent flightlines. Since the overlap is stored in a different class, no real blending of flightlines is done. A seamline is used to cut the data from one line to the next so when two flightlines do not perfectly match vertically a false edge is visible. Although they are easily visible in the shaded ground model, these ridges are below the commonly accepted threshold of 20cm and are therefore negligible.

Figure 23 – Tile B19D12: Ridge between 2 adjacent flightlines (0.5ft)

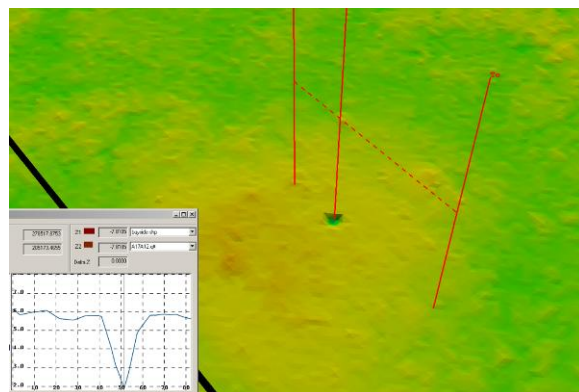
There were few instances of divots visible in the bare earth models. They were minor however, less than 4 feet.

Figure 25 – Tile A17A8: Divot (4 feet deep)

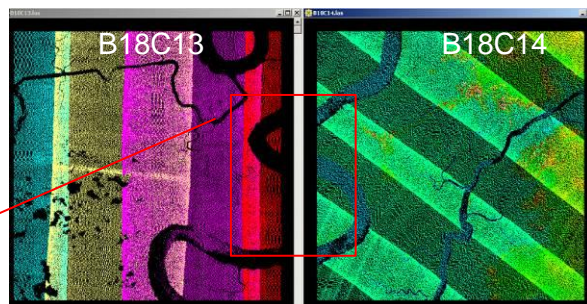
The acquisition specifications required the dataset to be flown at low tide which was actually the case. Nevertheless it is still possible that between two adjacent flightlines acquired at two different dates there was a discrepancy of water level. This is illustrated at Figure 26. In this case, the two tiles are from distinct missions because the flightline orientation changes from one tile to the other. For each instance, we checked the relative accuracy on the ground at the flightline edge or the tile which was always within the 20cm tolerance commonly accepted.

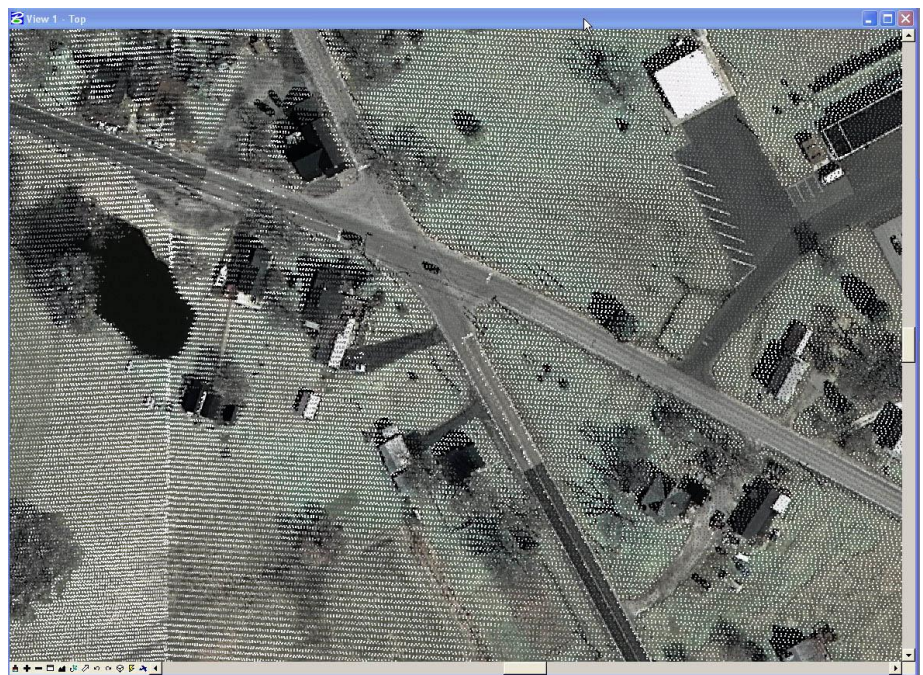
overlap areas. You should notice the cutline, lake, and structure in the left center portion of the graphic. This is the same structure shown in Figure 1 above. Mainly we are looking at paint striping on roadways and parking lots in the verification of the horizontal accuracy of the Lidar. And we were careful to look at different roadway orientations to make sure that a horizontal shift in the Lidar data parallel to the roadway is not providing false reassurance of the data. The most horizontal shift we were able to find between the intensity and the orthophotos is about 1.5 feet, occurring near the edge of the field of view.
