LiDAR Quality Assessment Report

OR_OLCRogue_2012

WSI has collected Light Detection and Ranging (LiDAR) data of the Rogue River Study Area for the Oregon Department of Geology and Mineral Industries (DOGAMI). The Oregon LiDAR Consortium's Rogue River project area encompasses approximately 1.4 million acres in the southwestern region of the state. The area includes portions of the Siskiyou National Forest, the City of Grants Pass and the Rogue River.

Rogue River

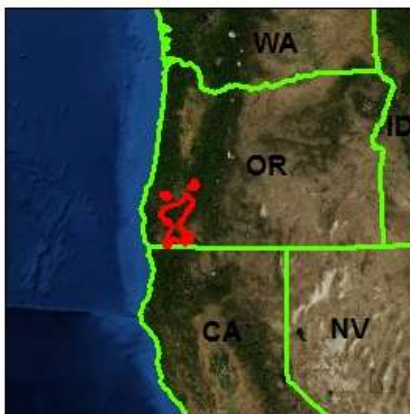
Checkpoint Distribution Image?

There are a minimum of 20 checkpoints for each land cover class represented. Points within each class are uniformly distributed throughout the dataset. USGS was able to locate independent checkpoints for this analysis. USGS accepts the quality of the checkpoint data for these LiDAR datasets.

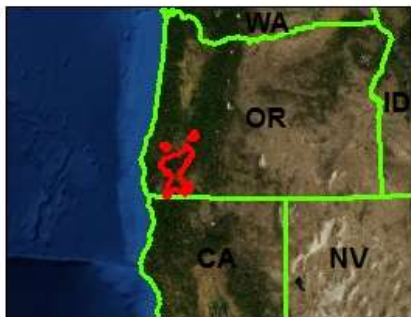
Lidar Landcover Categories from aggregated 2006 NLCD. Categories occupying more than 10% of the total area include:
Brushlands & Low Trees (16.84%)
Forested Areas Fully Covered by Trees (68.01%)

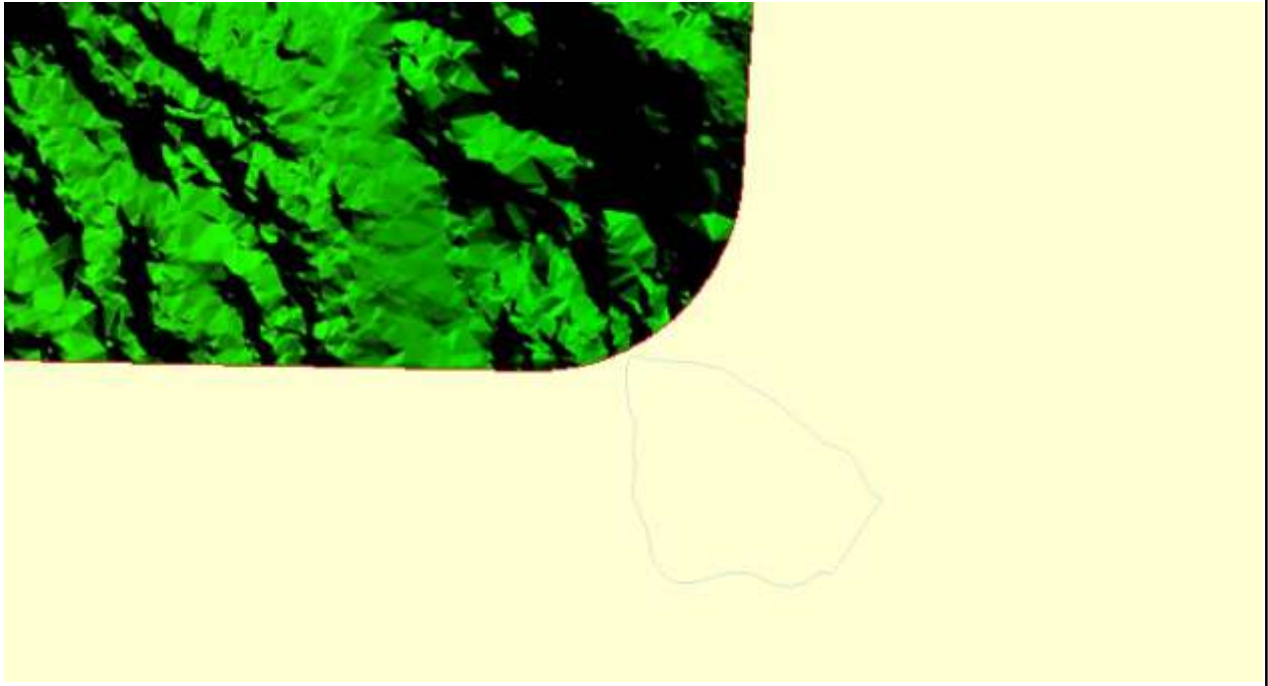
There was an instance of a Breakline falling outside the delivered DEM data, issue is of little consequence to DEMs.

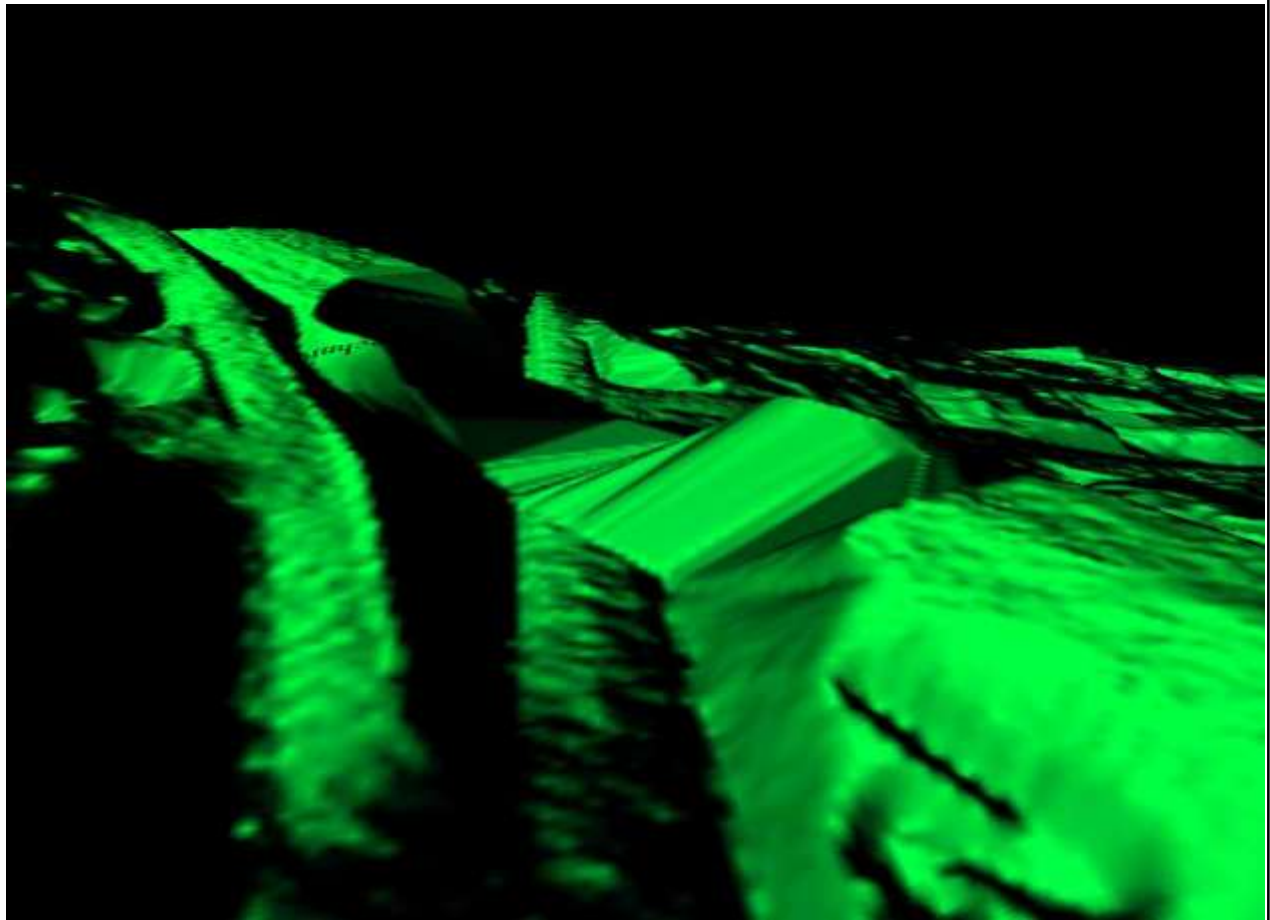
There were several instances of Bridges that could have been removed more cleanly (via Breaklines, etc...); however the bridges have been adequately removed for the project.

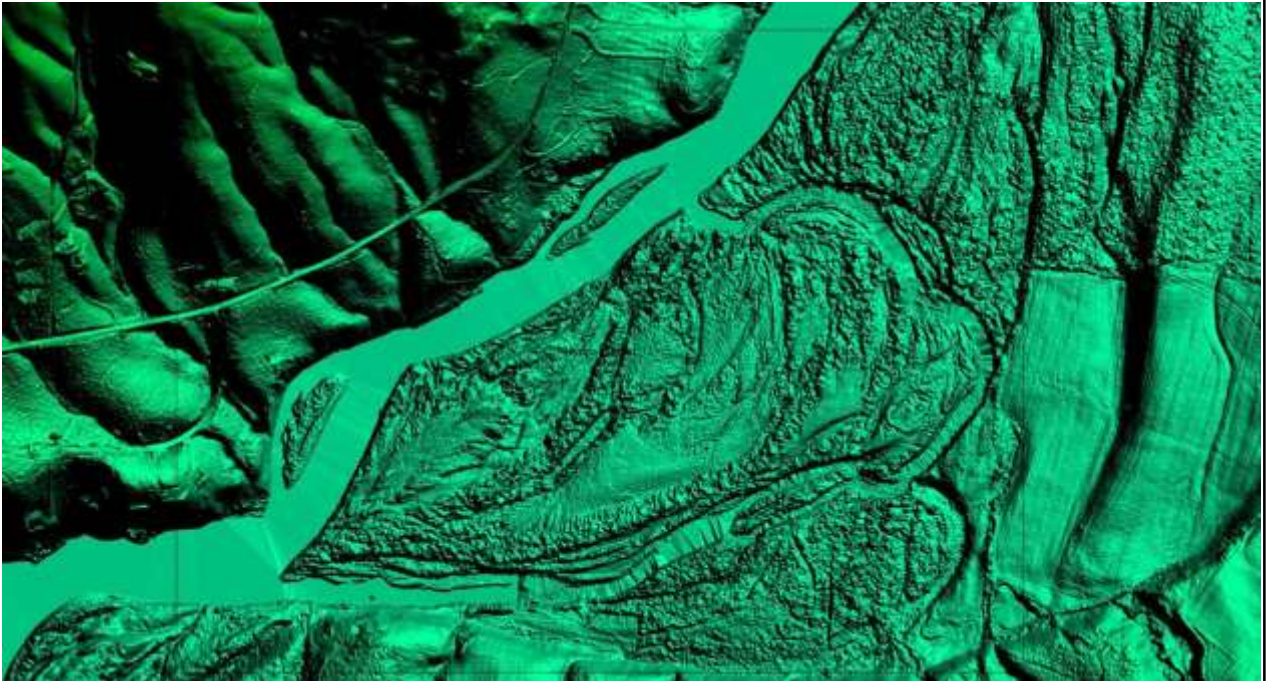
All Water bodies greater than 2 Acres were hydroflattened. Likewise, the vast majority of sloping streams greater than 100ft width were flattened in a downstream monotonic manner as well; however, there were several instances where the water could have been flattened or flattening is called into question, see the image above and those below. Pictured above is a channel breaking off from the main hydro flattened stream that was not flattened. The most recent NAIP Imagery shows this area as being connected. These instances are few in number throughout the project.

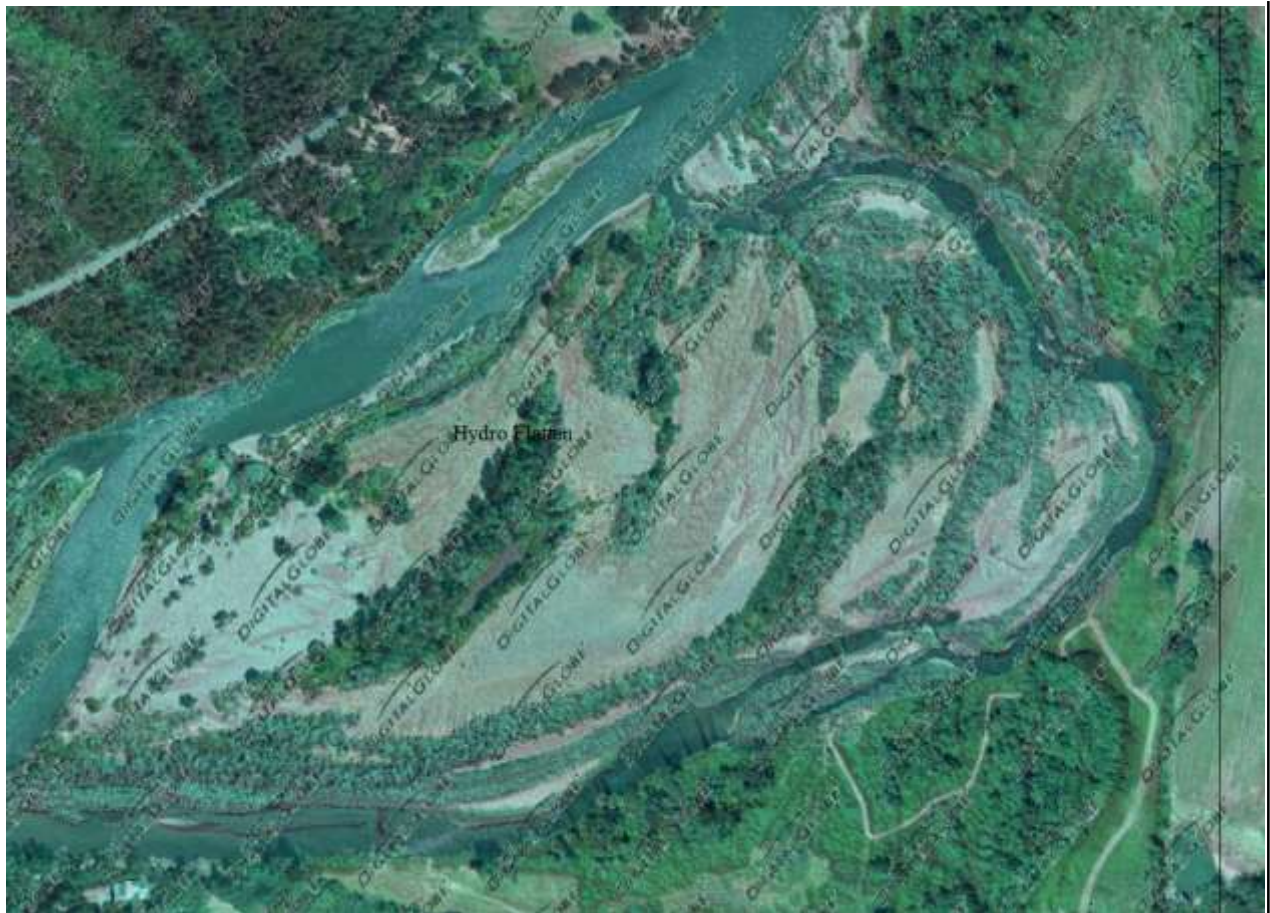
Area Above with Digital Globe Imagery Overlay.

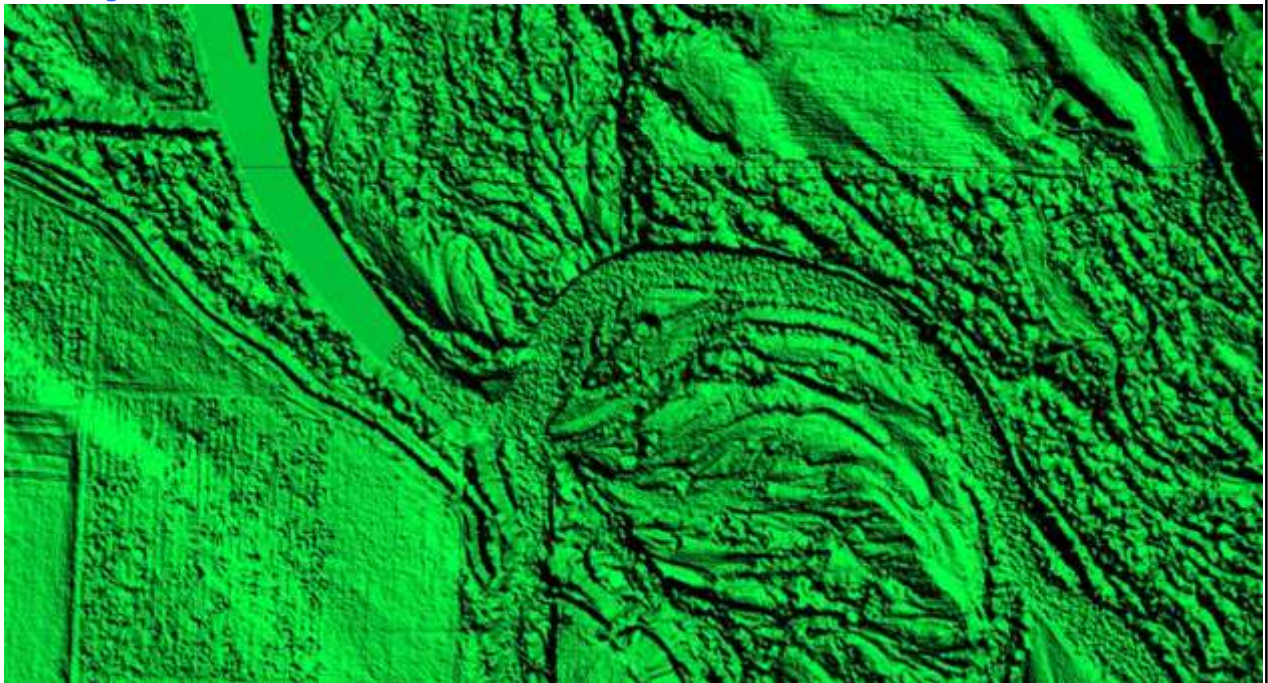
This is the location where hydroflattening stops for the "Applegate River" and everything south of this river is not flattened. The density of the stream bed suggests that the water level may have been very shallow or dry at the time of capture and would not require flattening if that were the case. NAIP Imagery shows both dry conditions and wet conditions for this river south of this location, images below will show the character of river in the DEMs.

See DEM review section regarding possible missing breaklines for a river in the southern portion of the dataset.

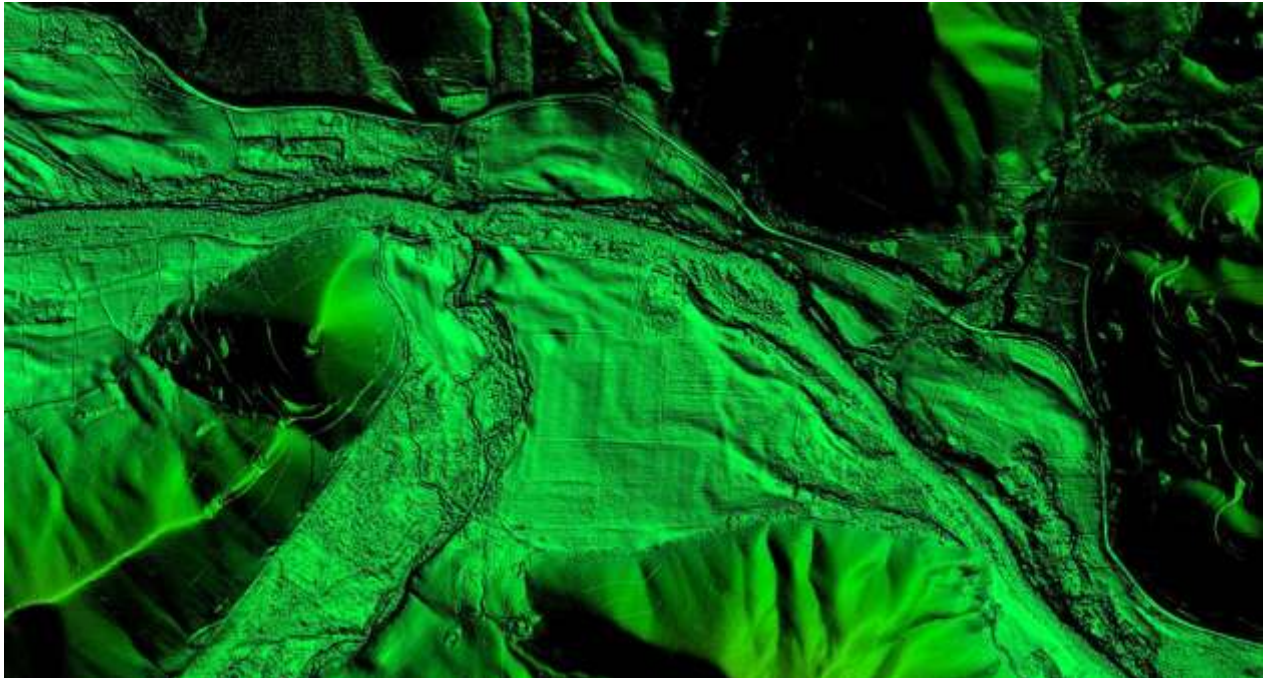
A section of the river with greater than 100ft banks that is not hydro flattened. The river lacks heavy tinning suggesting dry or shallow conditions, however this must be balanced with the fact that the density of the dataset is also very high. As the majority of the rivers are well flattened for the project, it is highly probably that this river was not missed, but consciously not flattened due to shallow or dry conditions. The data is acceptable.

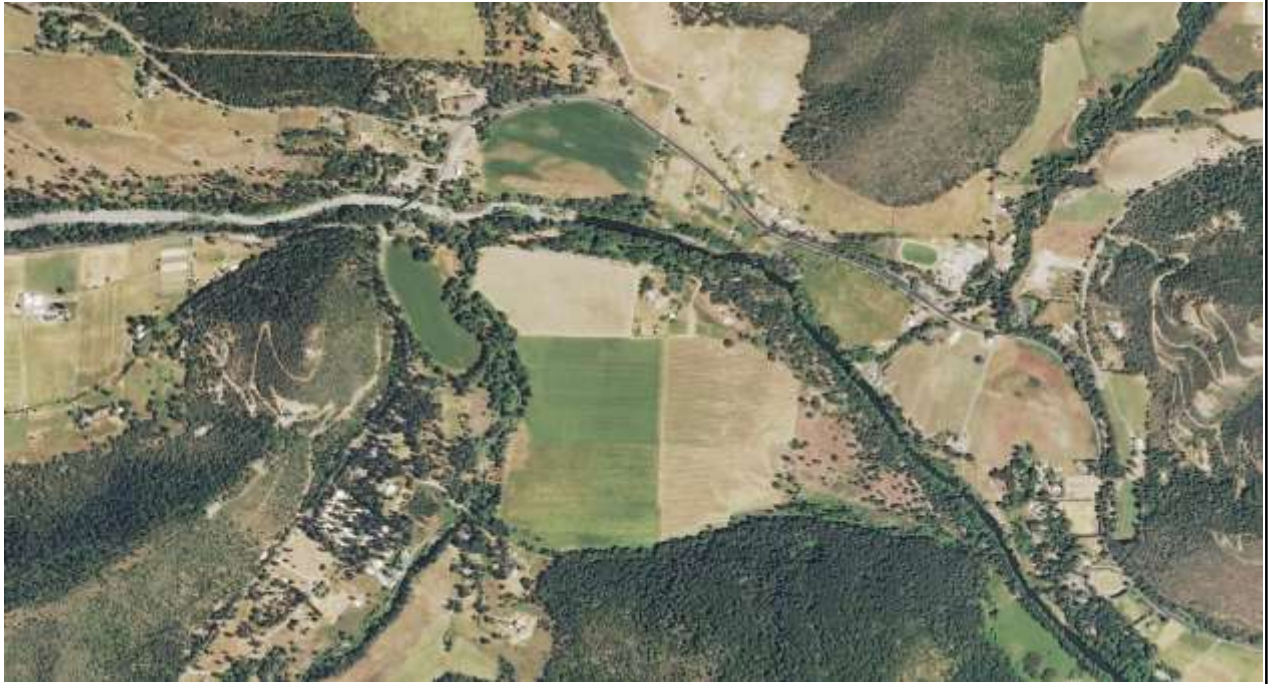
This image of the previous DEM area appears to be a blend from two separate dates and shows the river in both wet and dry conditions.
