**LIDAR REMOTE SENSING DATA COLLECTION
DEPARTMENT OF GEOLOGY AND MINERAL INDUSTRIES
MEDFORD**

SEPTEMBER 4, 2009

LIDAR REMOTE SENSING DATA COLLECTION: DOGAMI, MEDFORD STUDY AREA

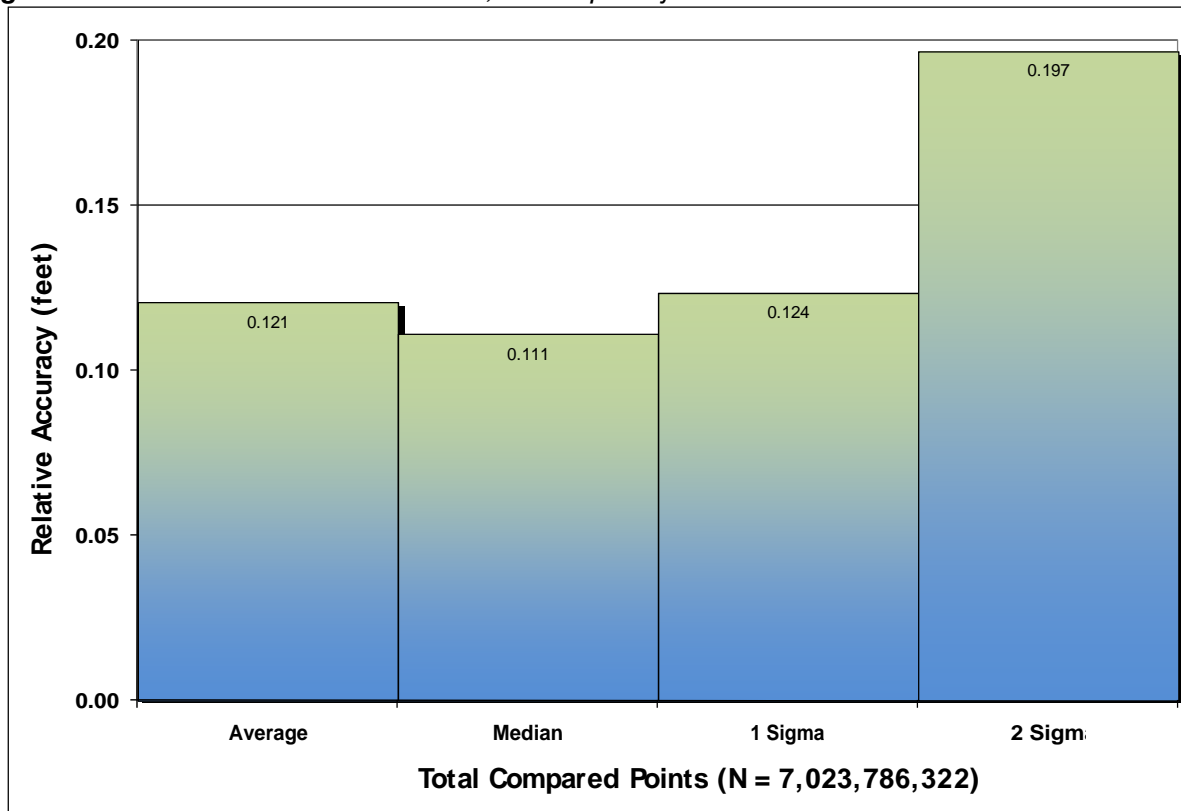
Figure 2.1. Statistical relative accuracies, non slope-adjusted.

Relative accuracy statistics are based on the comparison of 384 flightlines and over 7 billion points.

- Project Average = 0.121 ft (0.037 m)
- Median Relative Accuracy = 0.111 ft (0.034 m)
- 1 σ Relative Accuracy = 0.124 ft (0.038m)
- 2 σ Relative Accuracy = 0.197 ft (0.060 m)

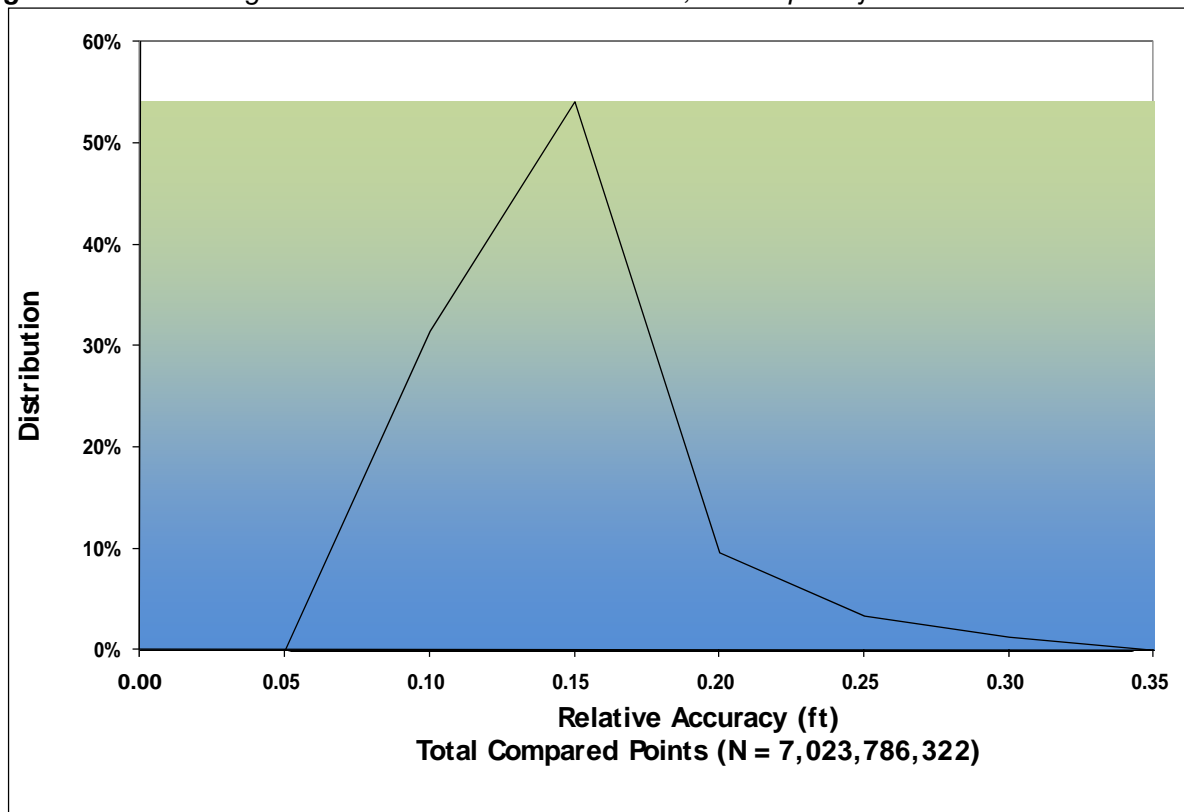
Figure 2.2. Percentage distribution of relative accuracies, non slope-adjusted.

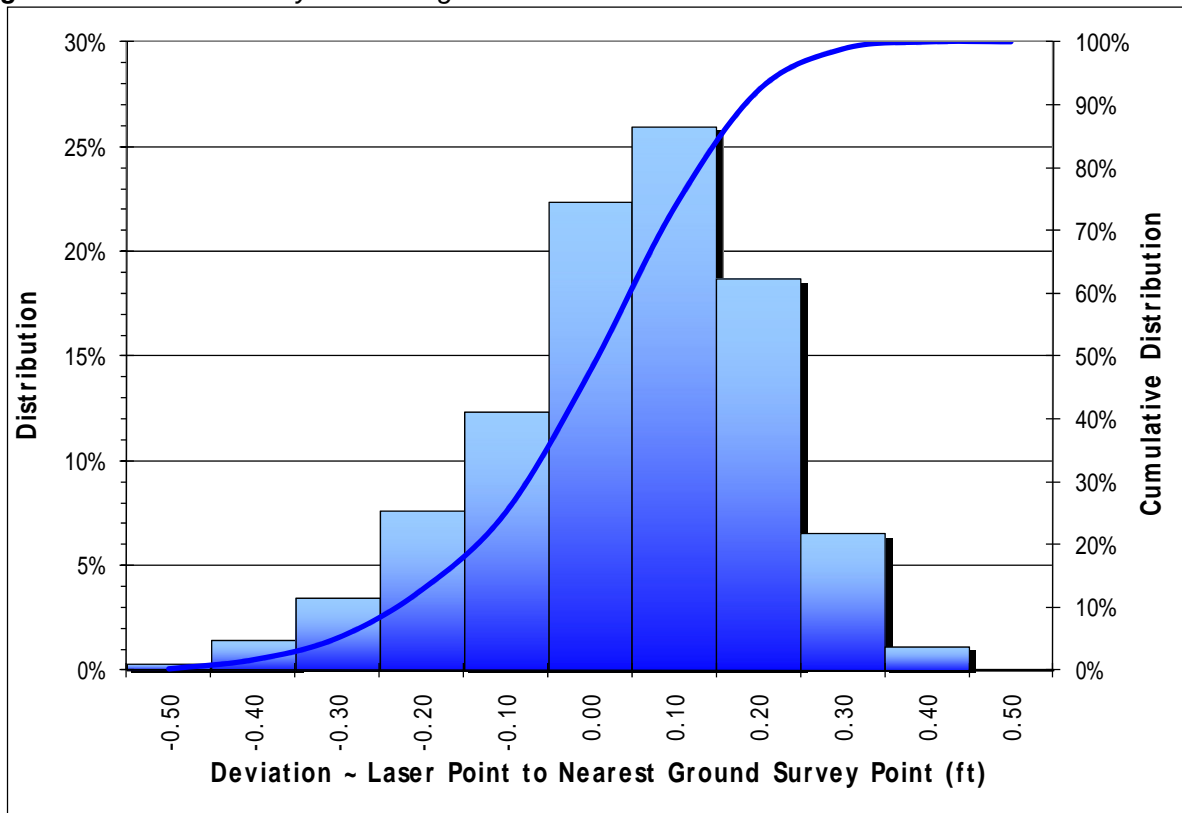
Figure 2.3. Medford Study Area histogram statistics

Absolute accuracy compares known Real Time Kinematic (RTK) ground survey points to the closest laser point. For the Medford Study Area, 2,661 RTK points were collected. Absolute accuracy is reported in **Table 2.1** below. Histogram and absolute deviation statistics are reported in **Figures 2.3 and 2.4**.

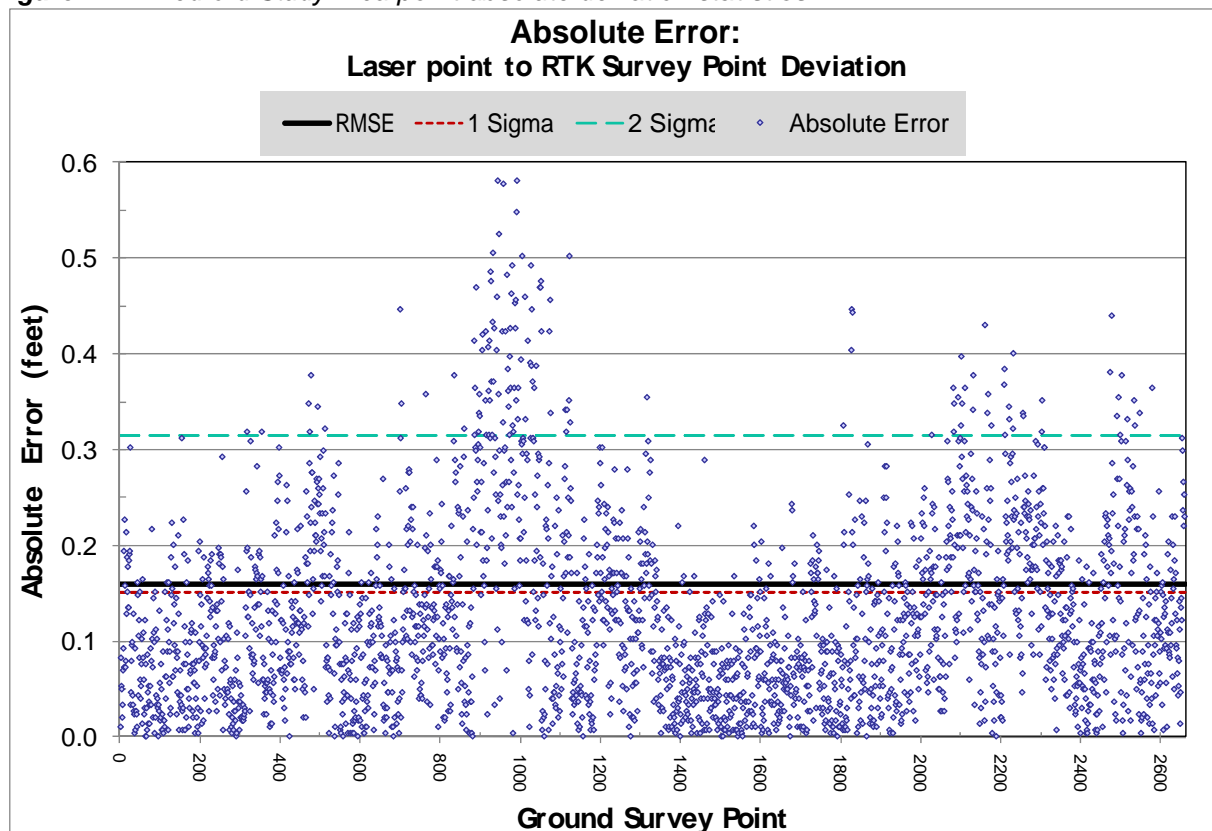
Figure 2.4. Medford Study Area point absolute deviation statistics.

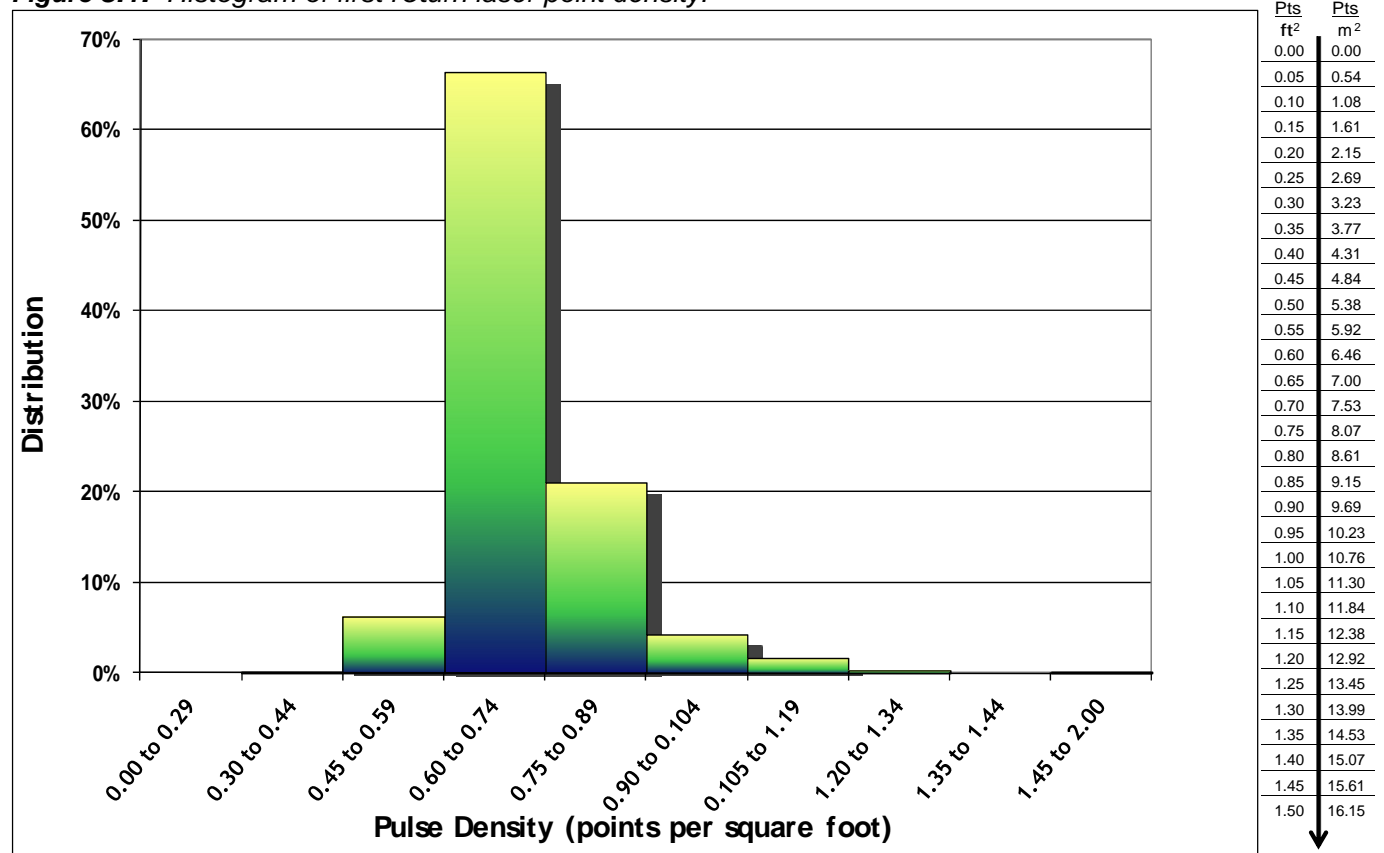
Figure 3.1. Histogram of first return laser point density.

Some types of surfaces (i.e., dense vegetation or water) may return fewer pulses than the laser originally emitted. Therefore, the delivered density can be less than the native density and vary according to distributions of terrain, land cover and water bodies. Density histograms and maps (Figures 3.1 –3.4) have been calculated based on first return laser point density and ground-classified laser point density.

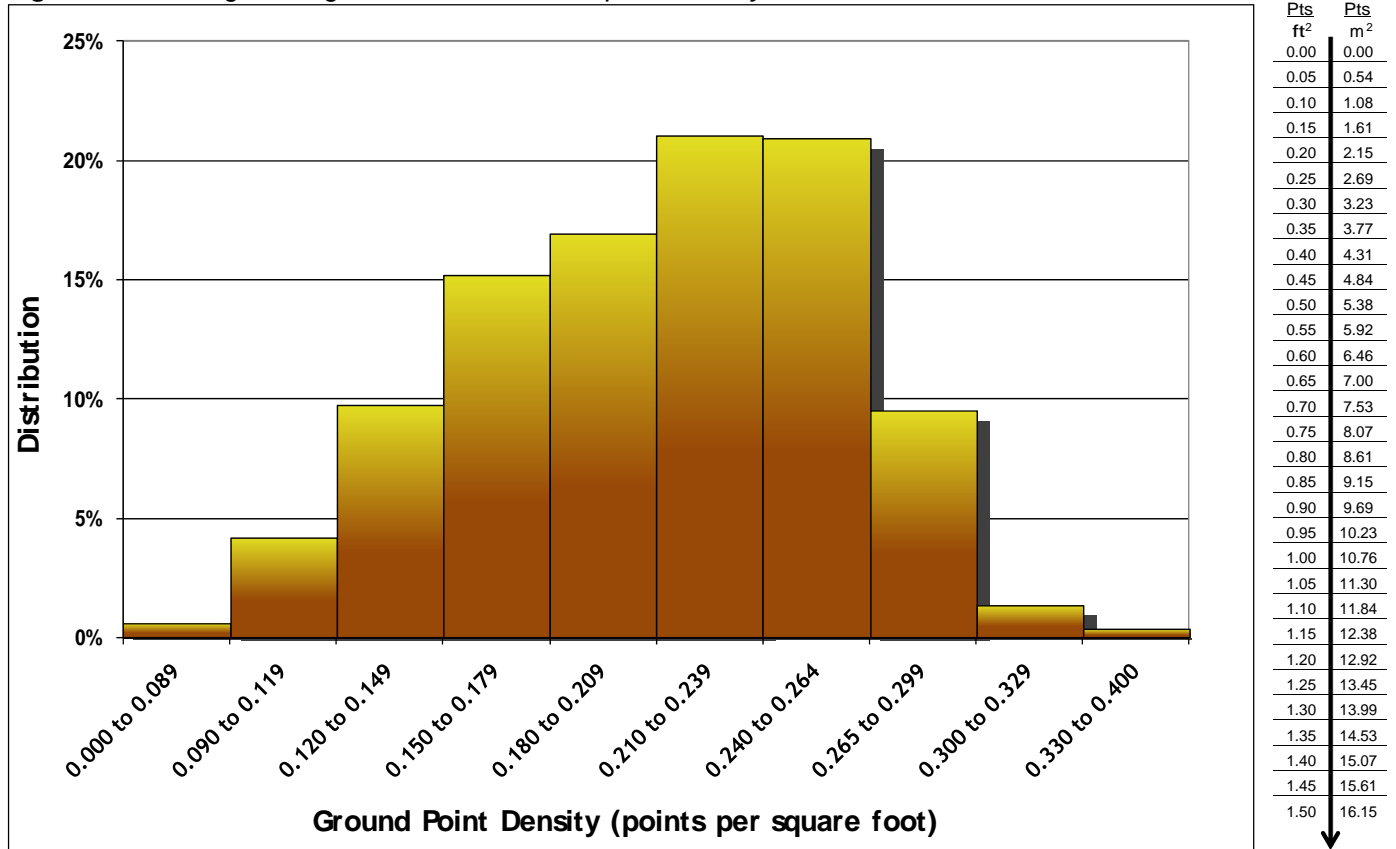
Figure 3.3. Histogram of ground-classified laser point density.

Ground classifications were derived from ground surface modeling. Supervised classifications were performed by reseeded of the ground model where it was determined that the ground model failed, usually under dense vegetation and/or at breaks in terrain, steep slopes and at bin boundaries.

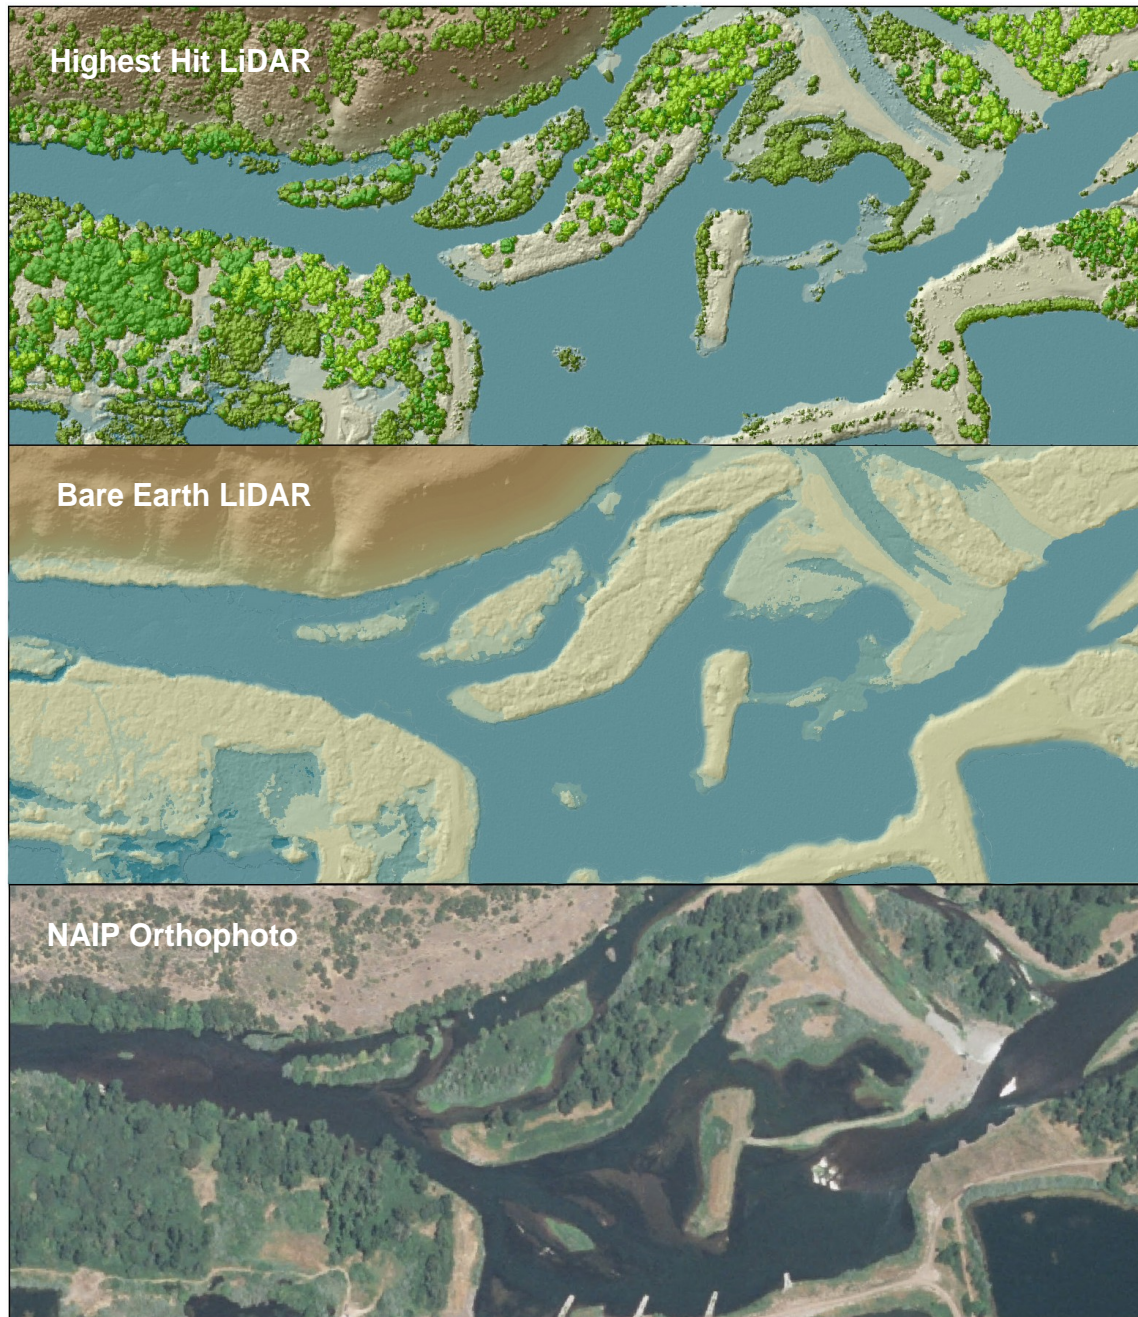
Figure 4.1. Section of the Rogue River located just south of Lower Table Rock. Topmost image derived from highest hit LiDAR, center image from bare earth LiDAR, bottom image derived from NAIP orthophoto.

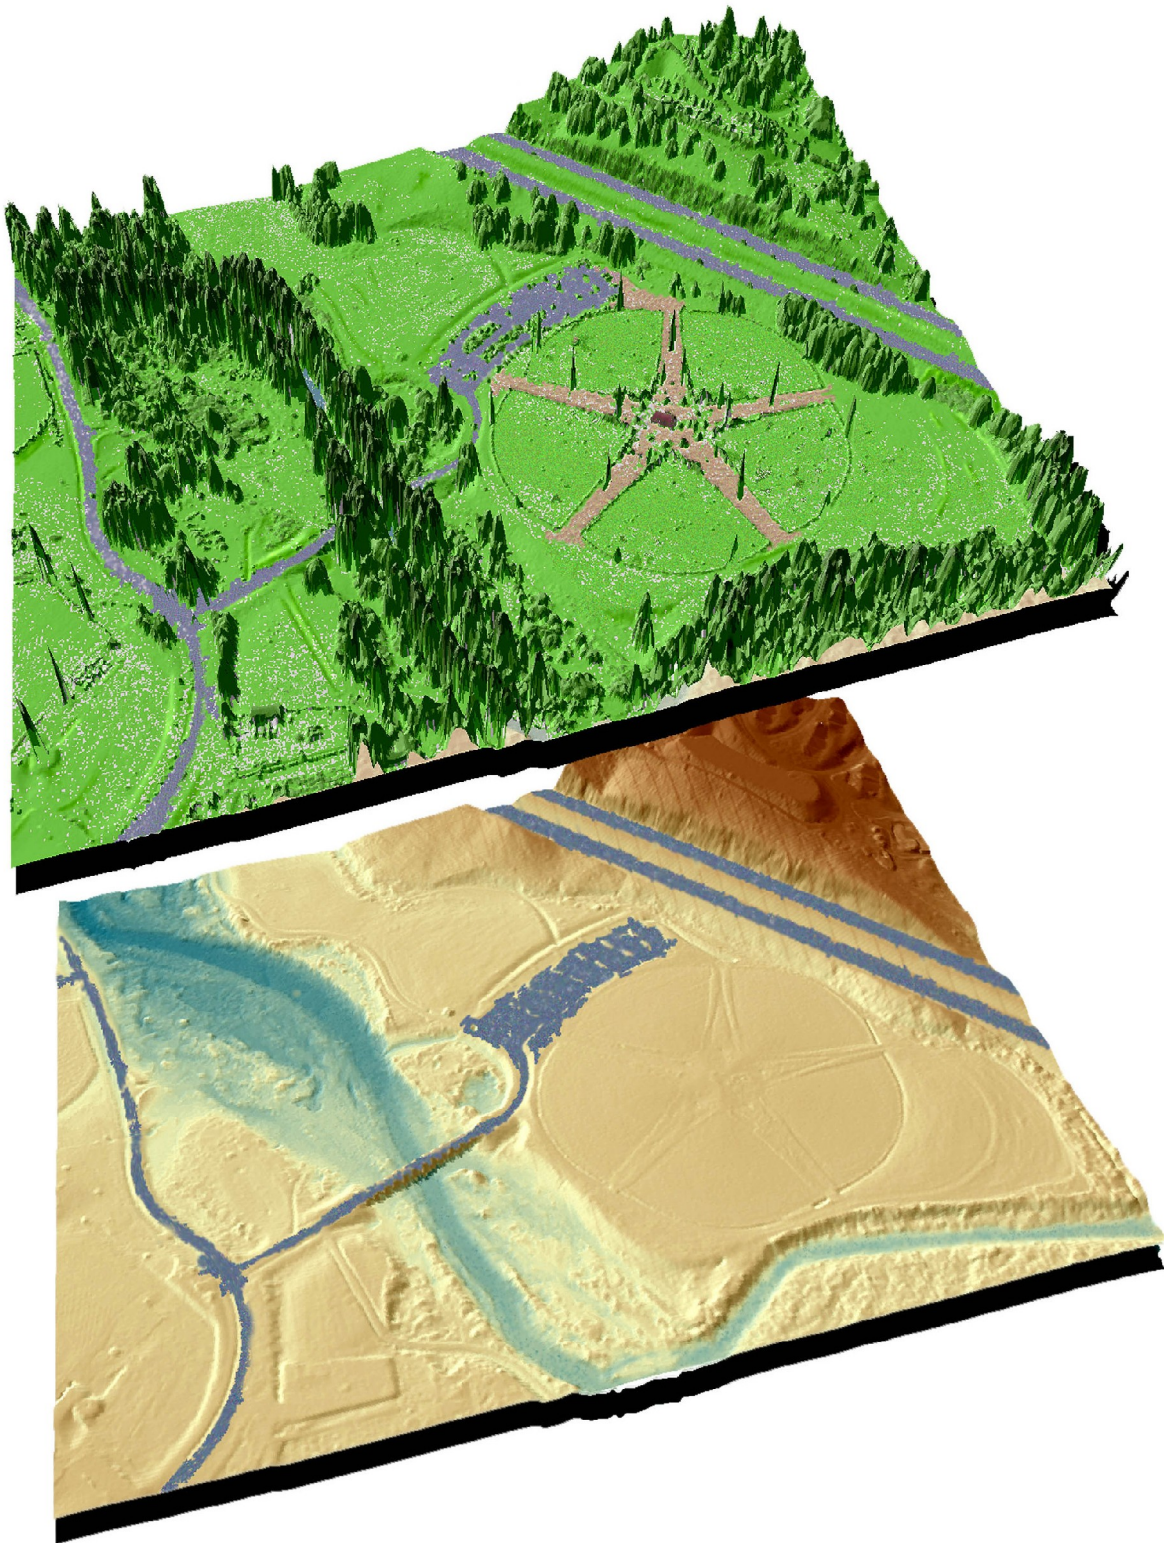
Figure 4.2. Baseball field complex located off of Interstate-5, south of Medford . Top image derived from highest hit LiDAR and bottom image derived from bare earth LiDAR.

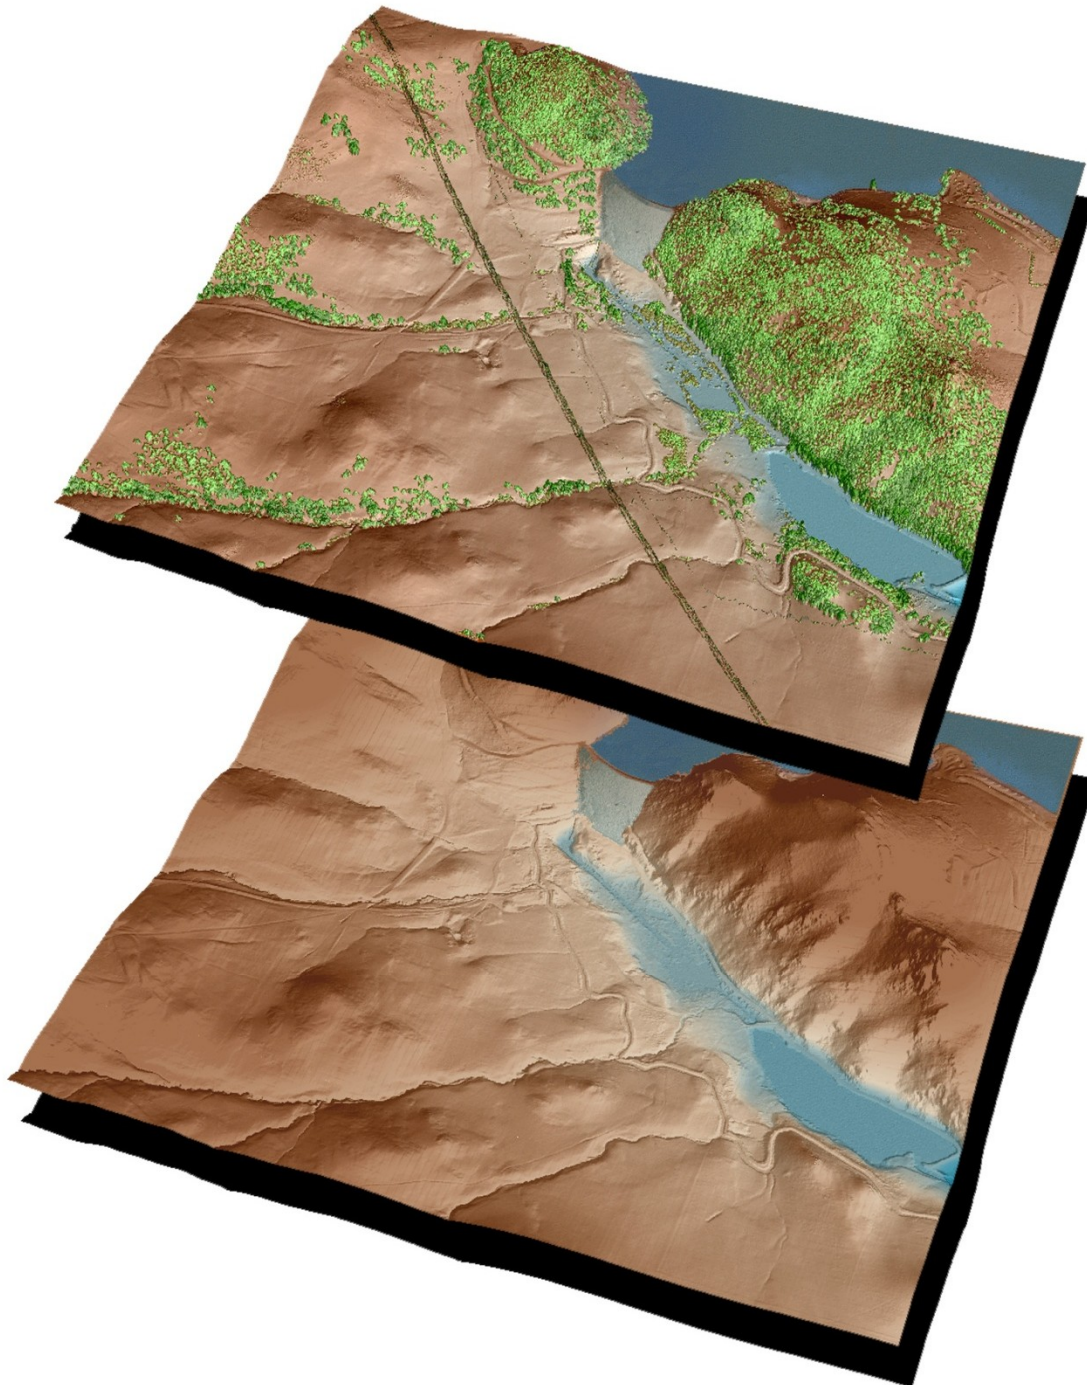
Figure 4.3. Dam at Emigrant Lake, southwest of Ashland. In Delivery Quad 42122B5. Top image derived from highest hit LiDAR and bottom image derived from bare earth LiDAR.
