LiDAR Quality Assessment Report

SC_Saluda_2010

Sanborn

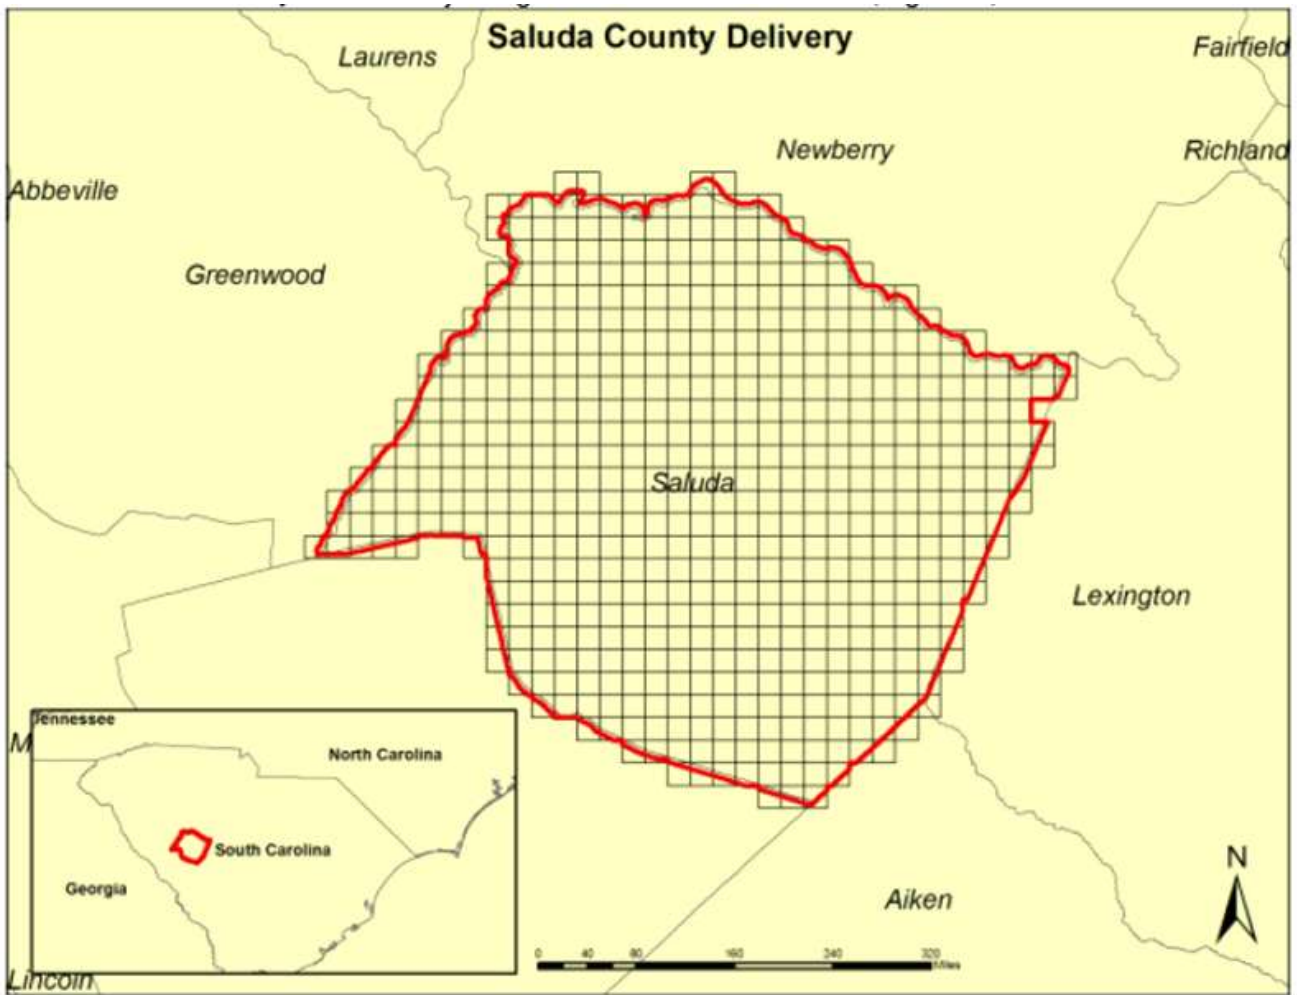
Figure 1: Location of Saluda County overlaid by delivered LAS grid.

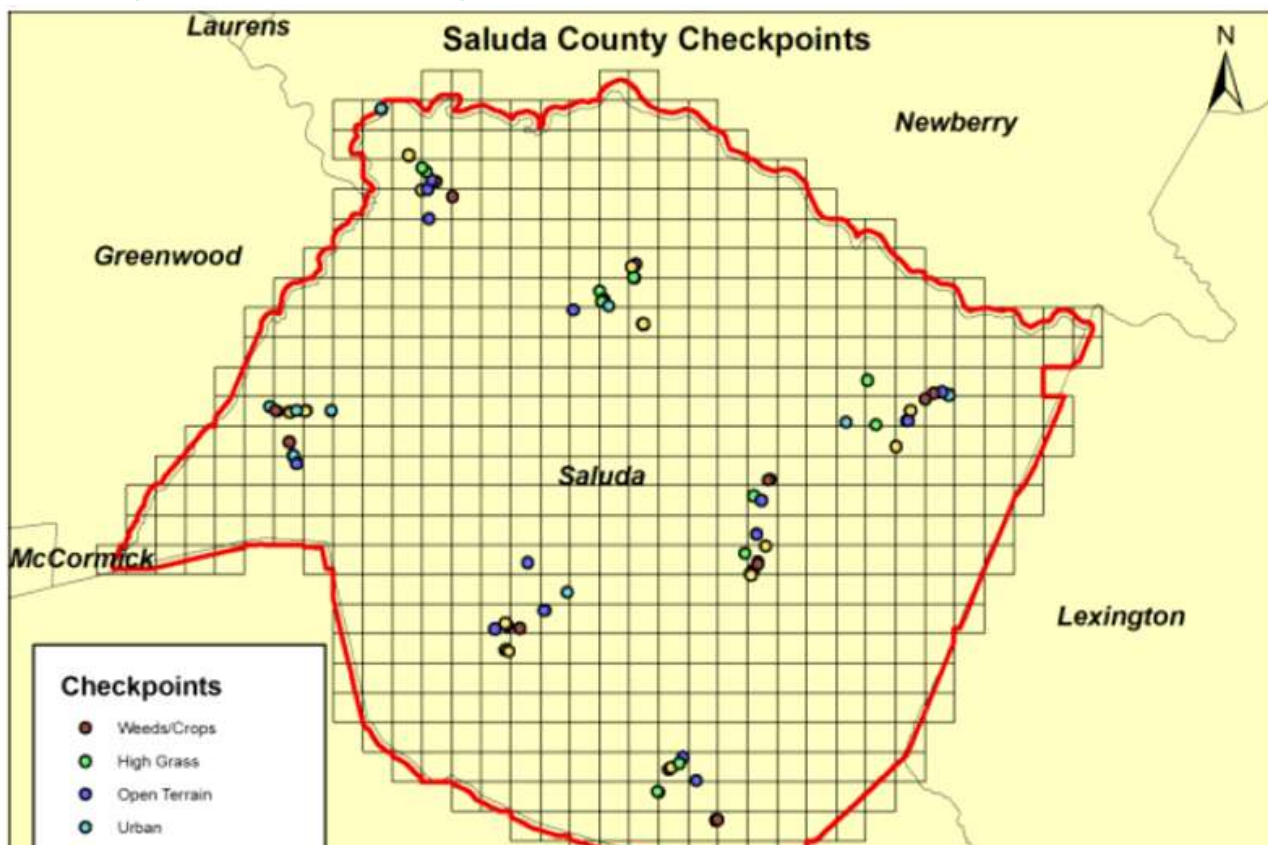
Figure 2: Checkpoints distribution for the current delivery for Saluda County, SC.

There are a minimum of 20 checkpoints for each land cover class represented. Points within each class are uniformly distributed throughout the dataset. USGS was not able to locate independent checkpoints for this analysis. USGS does not accept at this time the quality of the checkpoint data for these LiDAR datasets.

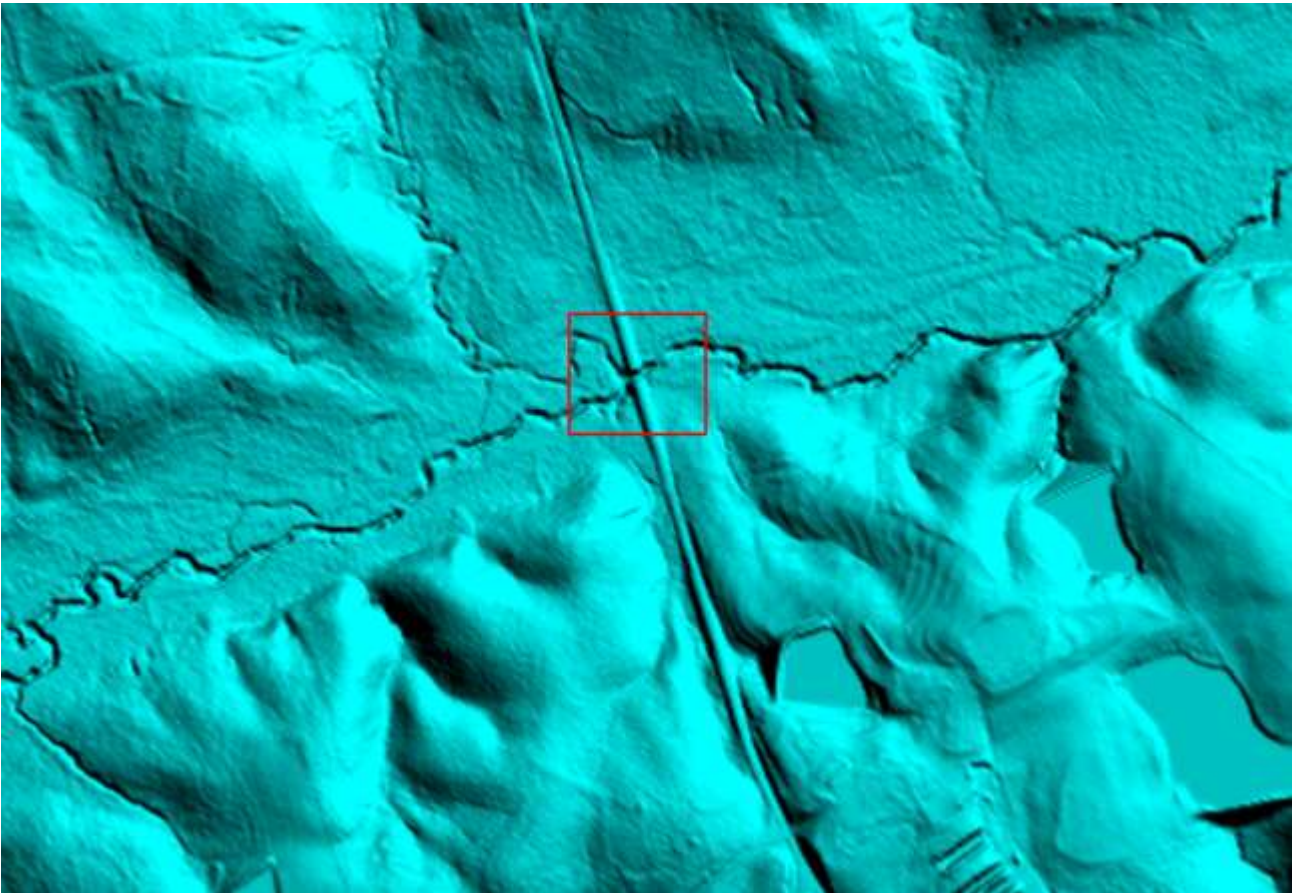
Removal of what appears to be a culvert, though whether it is a small bridge or culvert remains somewhat ambiguous, and it cannot be fully determined by NGTOC using ancillary data.
