LiDAR Quality Assurance (QA) Report
Eastern Shore Virginia (ESVA) LiDAR Project
USGS
November 18, 2011

Submitted to:
USGS

Contract:
G10PC00013

Task Order:
G10PD01537

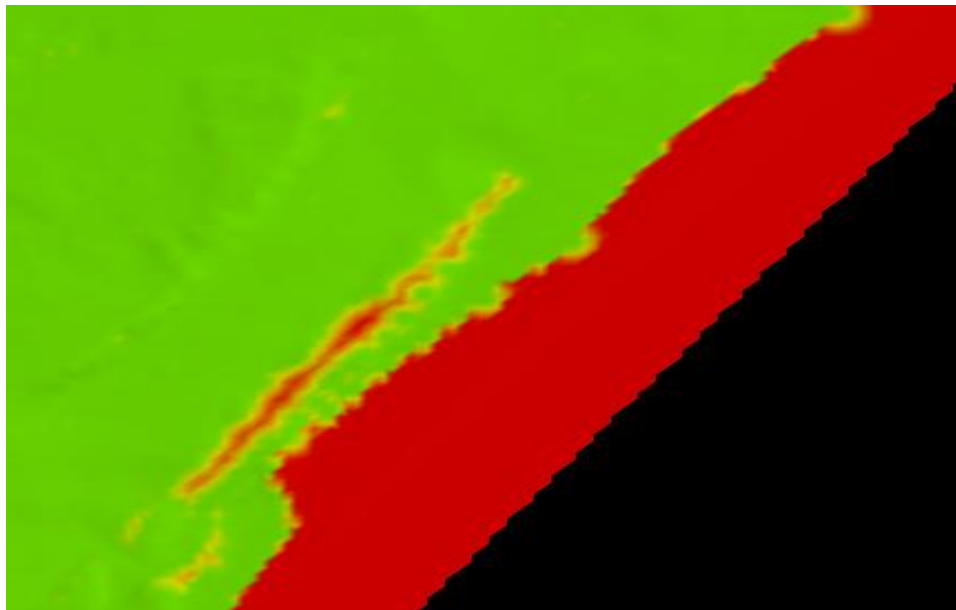
The first review of the Eastern Shore of Virginia LiDAR dataset identified multiple areas of aggressive classification. Most of the areas of aggressive classification occurred where legitimate ground points on a slope, such as along the bank of a hydrographic feature or a road embankment, were removed from ground and resulted in the loss of ground definition. Sanborn addressed all edit calls that impacted the final bare earth surface. Edit calls for aggressive classification that were minor and did not impact the final bare earth surface may not have been corrected or modified. Examples from the first and last deliveries are shown below.

Figure 5-Tile LAS_S23_3853_20, Delivery 1. Ground density model showing an area of aggressive classification along the coast.

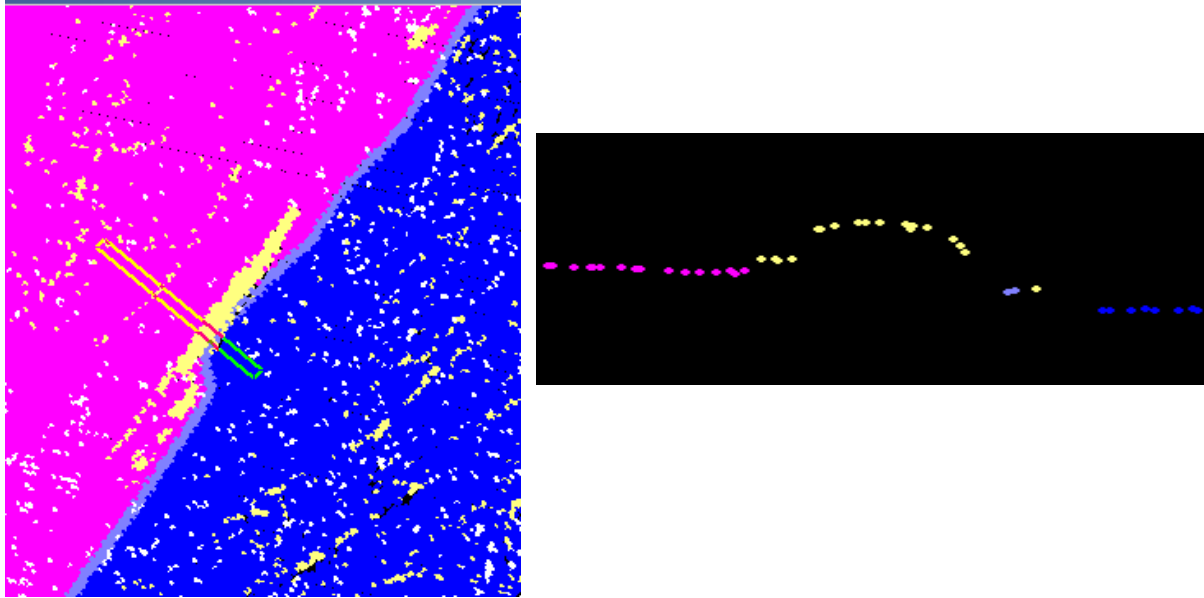
Figure 6-Tile LAS_S23_3853_20, Delivery 1. Profile view of an area along the coast that was aggressively classified. An embankment was missing from the ground surface because these points had been incorrectly classified as class 1 (unclassified, yellow) but should have been classified as class 2 (ground, pink).

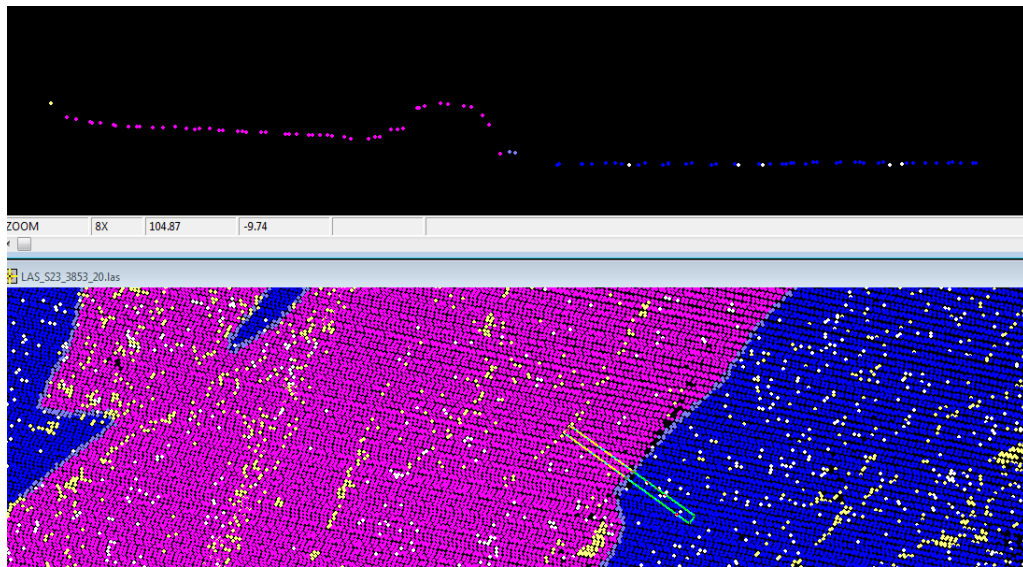
Figure 7-Tile LAS_S23_3853_20, Delivery 4. Profile view of an area along the coast that was aggressively classified, but has been corrected. Points representing an embankment had previously been classified as class 1 (yellow) but are now classified as class 2, ground (pink). This correction has added detail to the ground model.

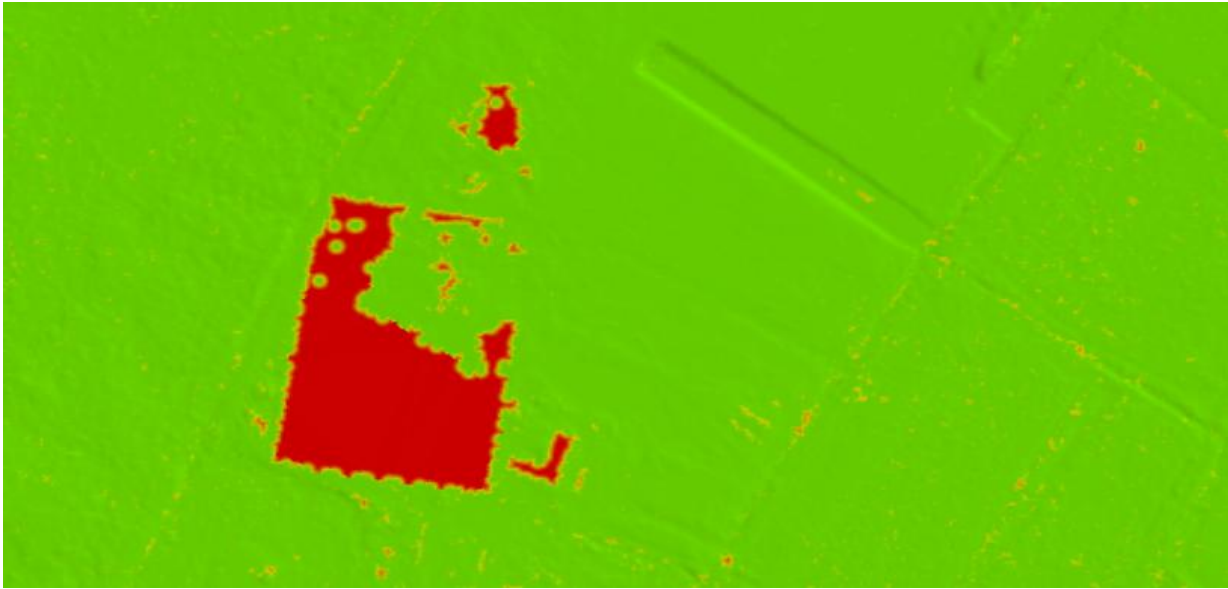
The first review highlighted multiple areas where ground points (class 2, pink) were misclassified to unclassified (class 1, yellow) or ground points were misclassified to water (class 9, blue). Sanborn addressed all edit calls that impacted the final bare earth surface. Edit calls for misclassification that were minor and did not impact the final bare earth surface may not have been corrected or modified. Examples from the first and last deliveries are shown below.

Figure 8-Tile LAS_S23_2786_40, Delivery 1. Ground density model showing a void was present in the bare earth surface model. As the profile below shows, this void was a result of ground points being misclassified as class 1, unclassified.

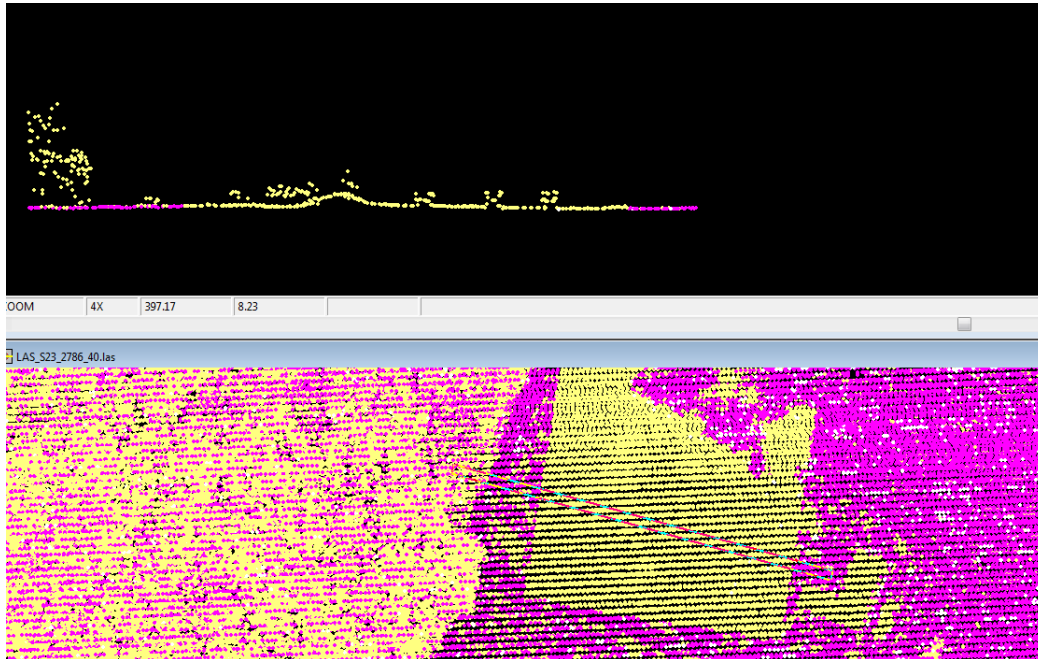
Figure 9-Tile LAS_S23_2786_40, Delivery 1. Profile view of points displayed by classification, showing points that were classified as unclassified (class 1, yellow) should have been classified as Bare Earth (class 2, Pink).

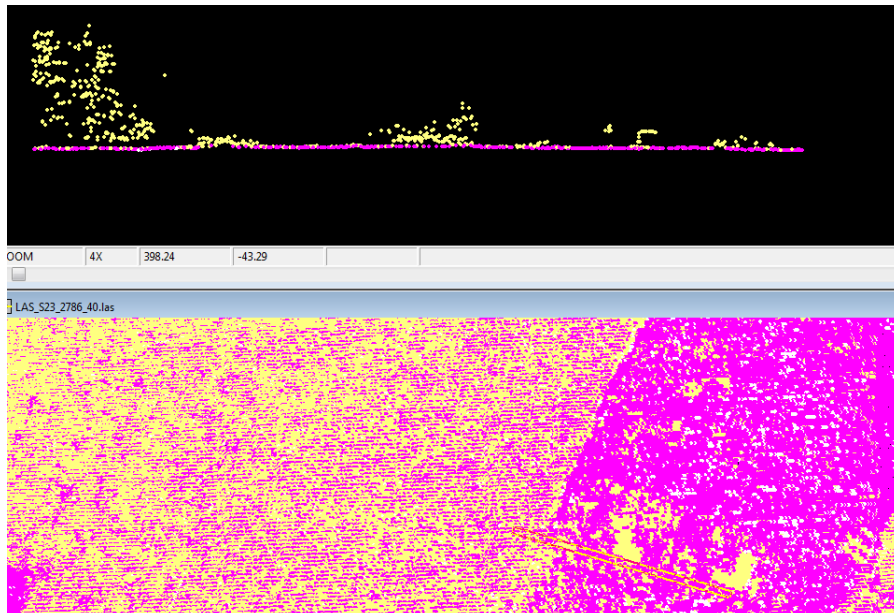
Figure 10-Tile LAS_S23_2786_40, Delivery 4. Profile view of points displayed by classification, showing legitimate points that were classified as unclassified (class 1, yellow) have been corrected by Sanborn and are now classified as Bare Earth (class 2, Pink).

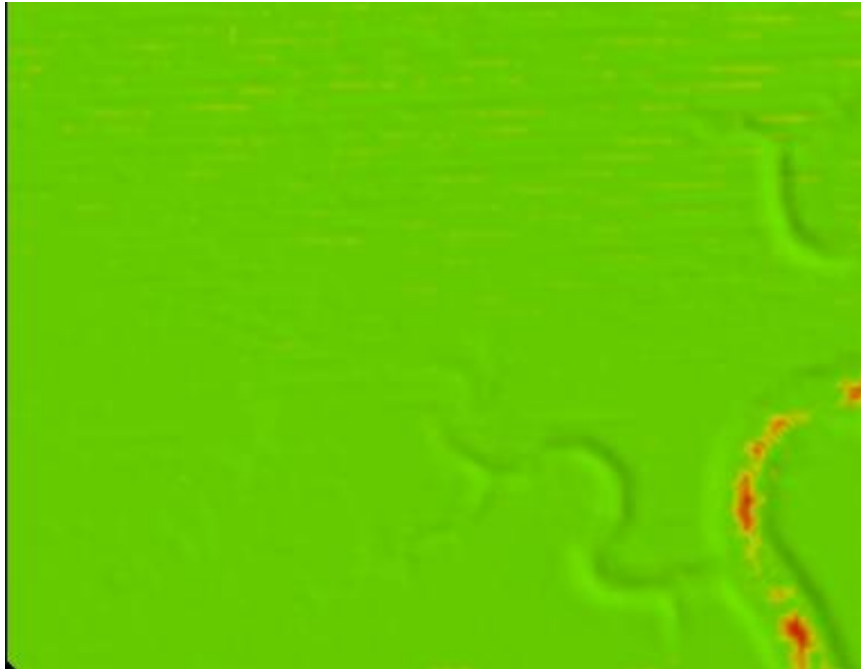
Dewberry identified several areas in the dataset with slightly uneven point spacing. The adjacent flight lines appear to diverge and converge, usually due to sudden changes in atmospheric conditions such as wind. This point spreading is somewhat visible in the density models. This issue does not affect the usability of the data but should be noted by the end user.

Figure 11-Tile LAS_S23_2653_30, all deliveries. The ground density model is predominantly green meaning there is sufficient coverage of ground points and does not affect the quality of the ground model.

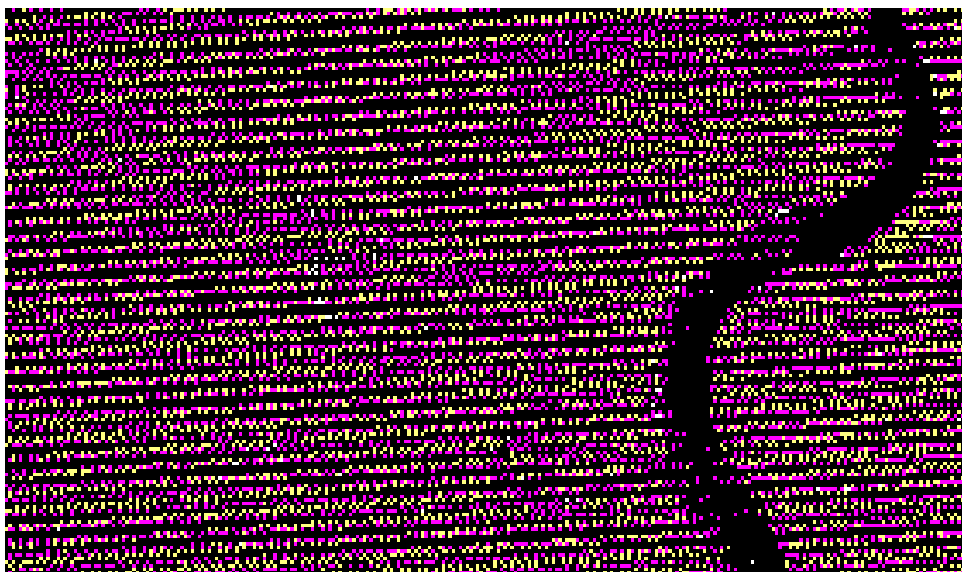
Figure 12-Tile LAS_S23_2653_30, all deliveries. The image shows the distribution of the points is not even, which causes the low density stripes in the density model.

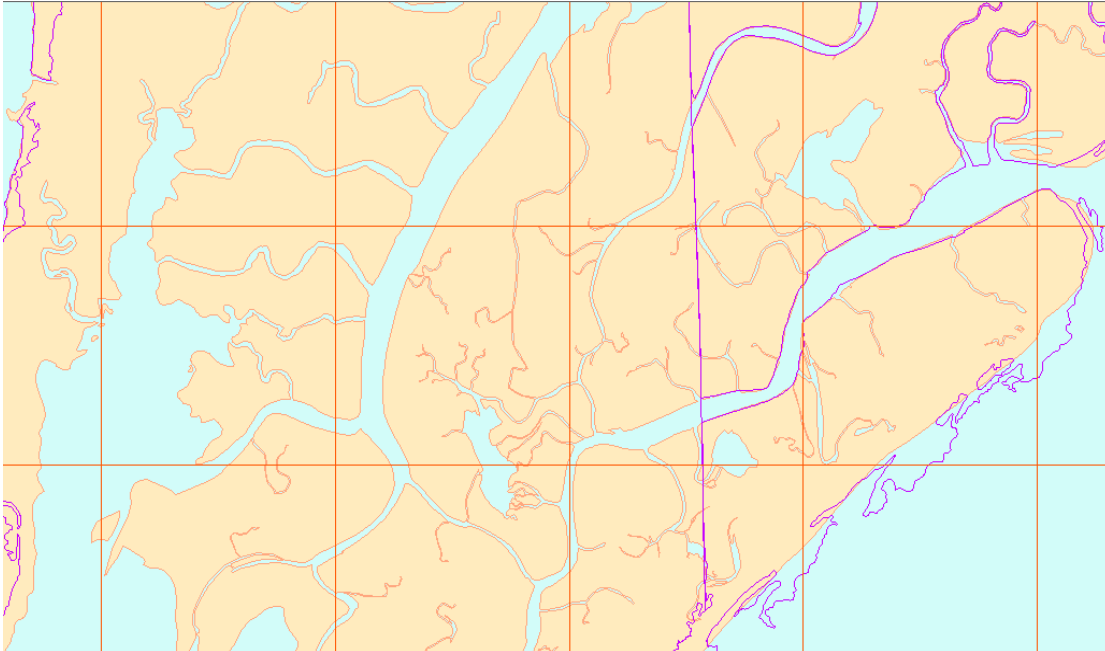
The entire coastline of this project area, which consisted of Accomack and Northhampton Counties, is tidally influenced. Differing tide levels can cause elevation changes within one flight line and can cause substantial elevation changes between flight lines. There are many low-lying islands off the coast of Accomack and Northhampton Counties. Many of these islands are only exposed at low tide. This caused some discontinuity in the data from one flight line to the next when an island is exposed in one flight line but inundated in the neighboring flight line.

This resulted in tidal breaklines that show abrupt changes between land and water interfaces. These breaklines often do not appear natural. However, this phenomenon is related to tidal fluctuations as Sanborn was not required to collect data at low tide.

Figure 13, all deliveries-Tidal breaklines are shown in purple, overlaid on the vcr_land_area" shapefile that identifies the extent of land that is used as a boundary for the USGS ESVA project. As the screenshot shows, tidal breaklines run through the middle of islands and appear unnatural.

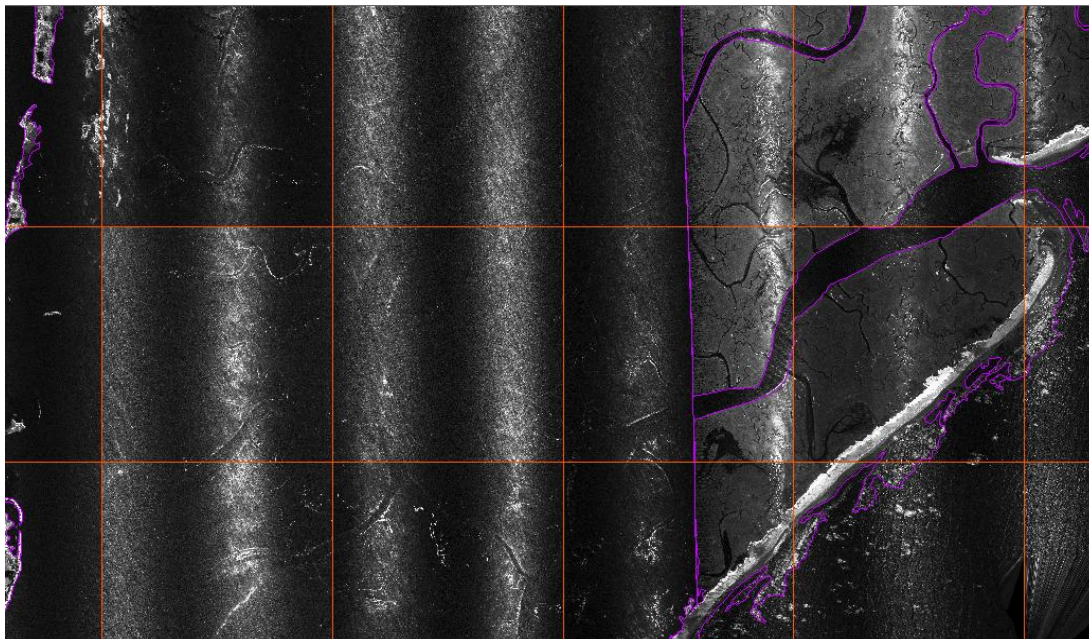
Figure 14, all deliveries-Tidal breaklines are shown in purple overlaid on intensity imagery. As the screenshot shows, the tidal breaklines follow the land water interface as seen in the intensity imagery.

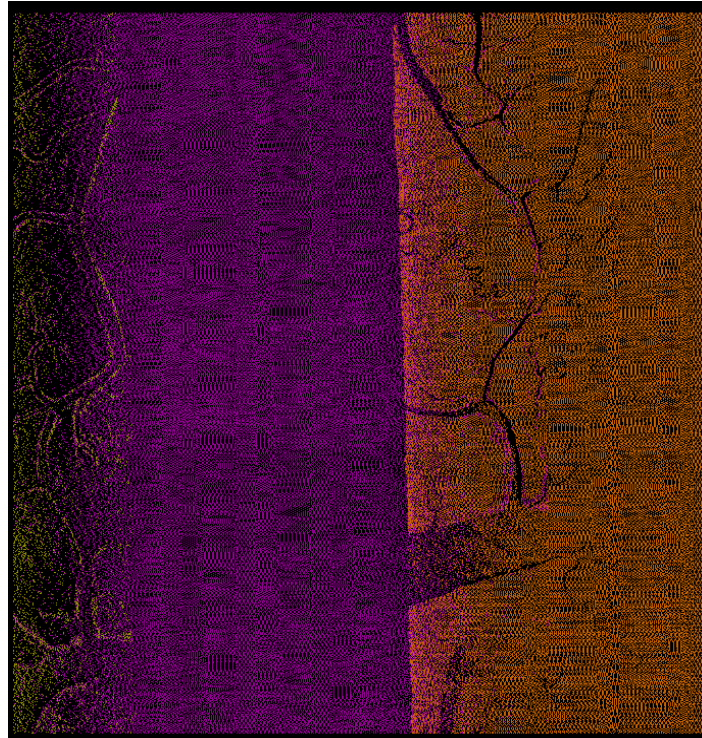
Figure 15, all deliveries-Tile LAS_S23_2559_20. Point cloud displayed by flight line source id. Flight line edges correspond to the land water interface seen in the intensity imagery and reflected in the breakline collection.

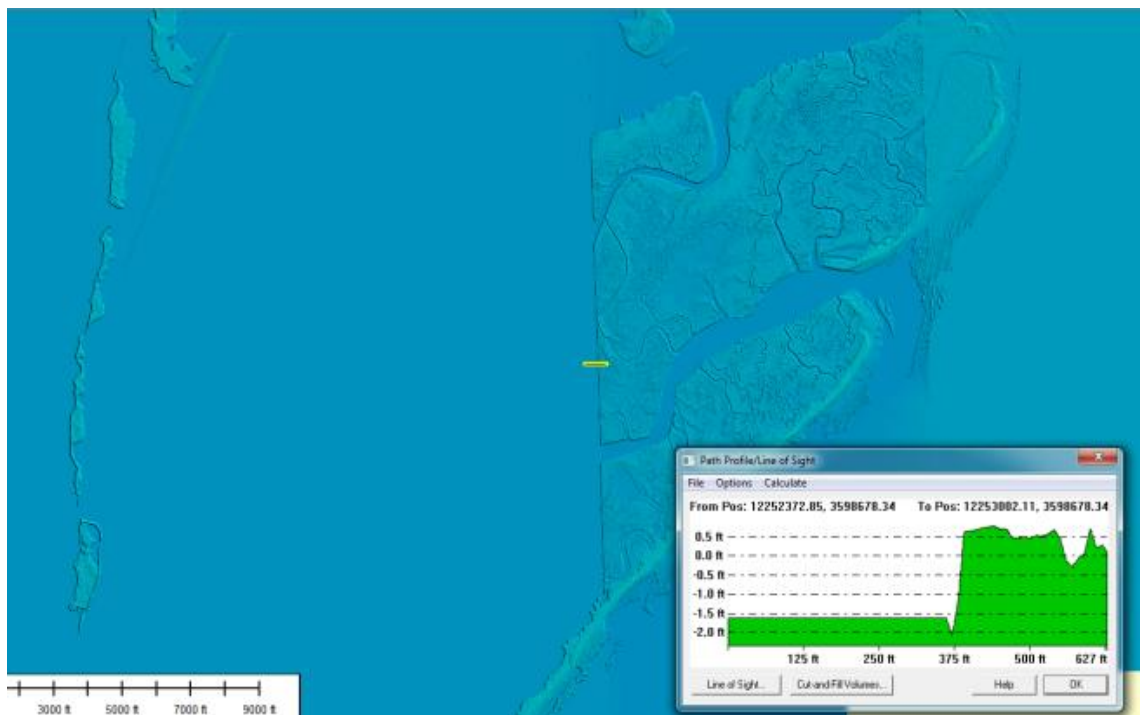
Figure 16, all deliveries-DEMs of the same area shown in the screenshots above. DEMs also seem to show an “unnatural” break between land and water interfaces due to large tidal variations between flight lines. While the water on the left side of this image is actually higher than the exposed island on the right side of this image, the water must be flattened and given a lower elevation. Otherwise, the water will appear as floating above surrounding land.

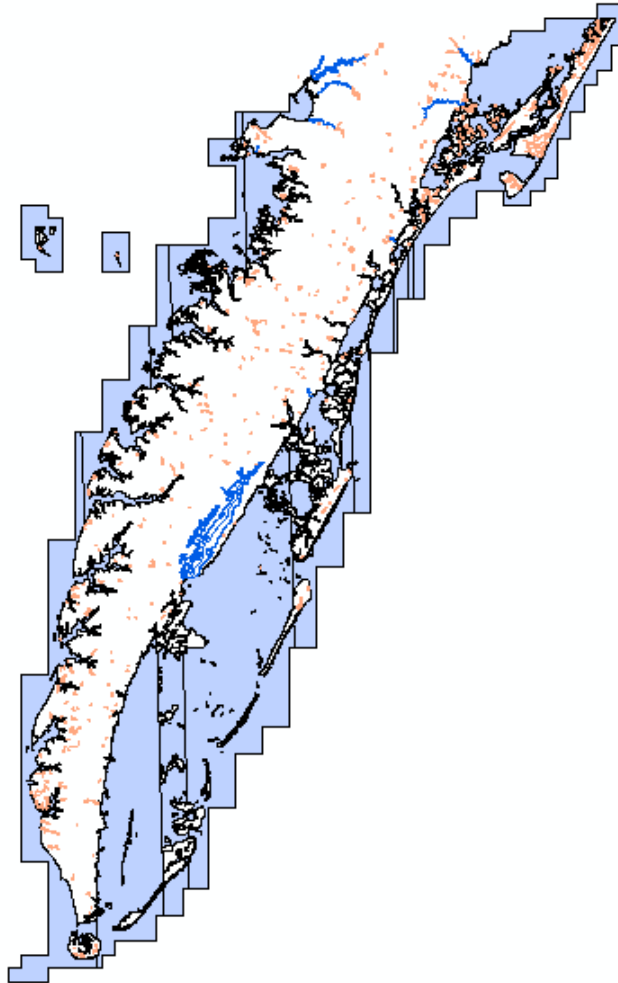
Normally, Dewberry asks that adjacent polygons be merged together into one feature. This is normally more organized and creates a cleaner line for the breakline data. However, due to tidal variations between adjoining flight lines, Sanborn has kept each tidal water area within a flight line as a separate polygon. Having Tidal Waters as separate polygons for each flight line helped immensely during the QA review as this area can be complicated, especially with tidal variations that can be drastic from one flight line to the next. Due to the usefulness of the separate polygons, Dewberry did not mark edit calls for “unnecessary polygon boundaries” in the Tidal Waters as is listed in the Breakline QA/QC Checklist. Below is a screenshot of the Tidal Water breaklines that are split at flight line boundaries.

Figure 17, all deliveries-Tidal Water polygon breaklines are shown in light blue with a black outline. Normally Dewberry uses the PLTS “unnecessary polygon boundaries” check to identify adjacent polygons that should be merged into one. Due to the drastic tidal variations between flight lines, having the Tidal Waters split at those boundaries was very useful during the QA review. Because it could be useful for end users to have the Tidal Water breaklines split at flight line boundaries, Dewberry did not run the unnecessary polygon boundaries check on Tidal Waters.

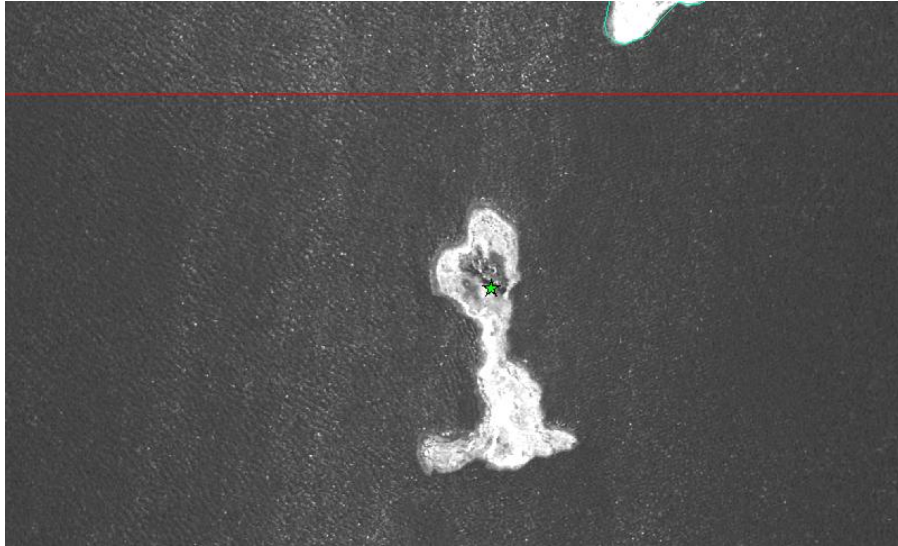
Islands that meet USGS capture specifications of .5 acres should be collected as “holes” and excluded from polygon layers, such as Inland Ponds and Lakes or Tidal Waters. Forty-eight (48) features were identified as missing in the first delivery. Sanborn has addressed these edit calls. An example is shown below.

Figure 18-Tile S23_4900_40, Delivery 1. Island was not collected that is large enough to meet USGS specifications.

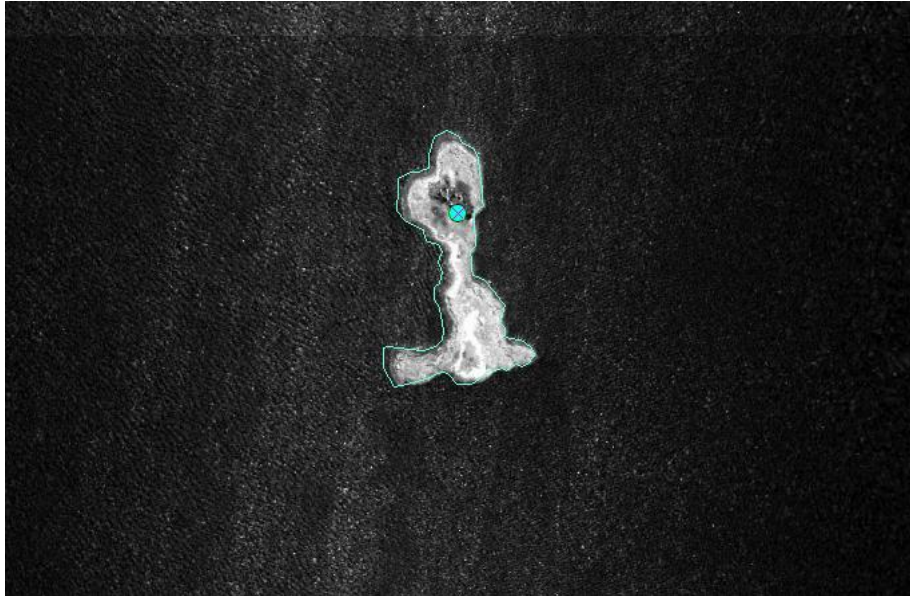
Figure 19-Tile S23_4900_40, Delivery 4. Island has been collected.

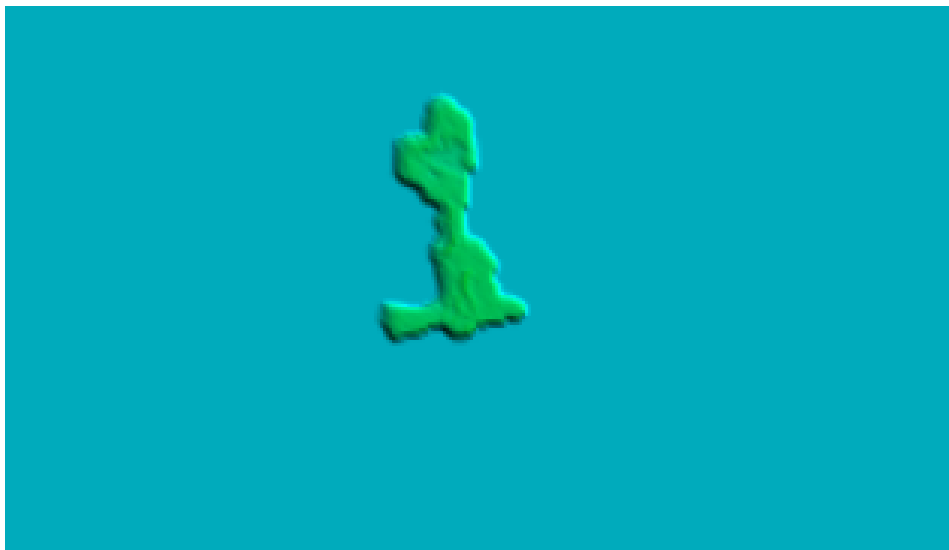
Figure 20-Tile S23_4900_40, Delivery 4. Island has been collected and is now visible in the DEM.

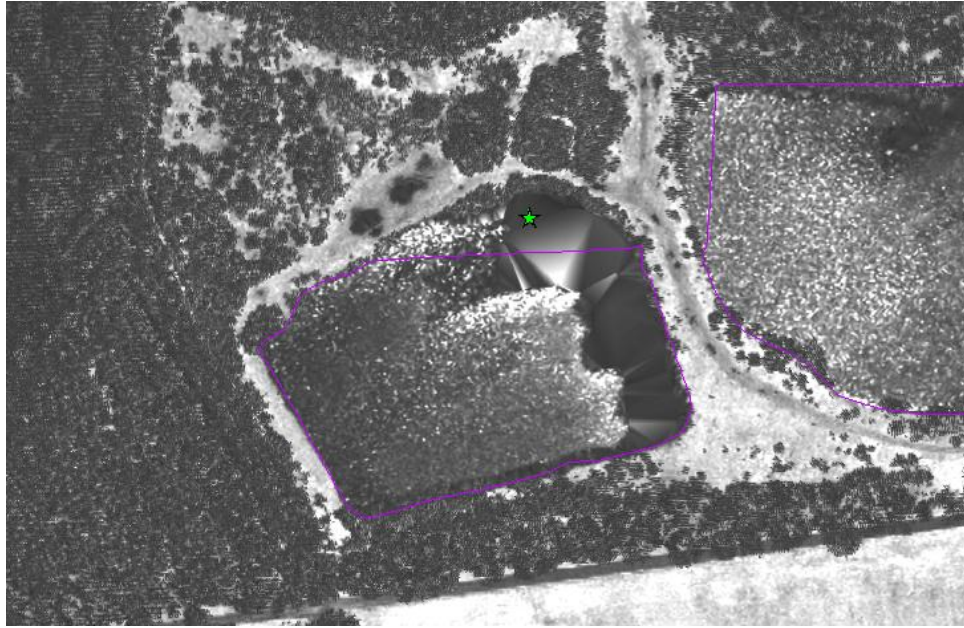
The delineation of features (104) in some areas was identified in the first delivery as not correctly following the shoreline. These features were updated in subsequent deliveries to better reflect the land/water interface at the time of LiDAR collection. An example is shown below.

Figure 21-Tile S23_3930_10, Delivery 1. Delineation of water body did not correctly follow shoreline, leaving a large area of the feature missing.

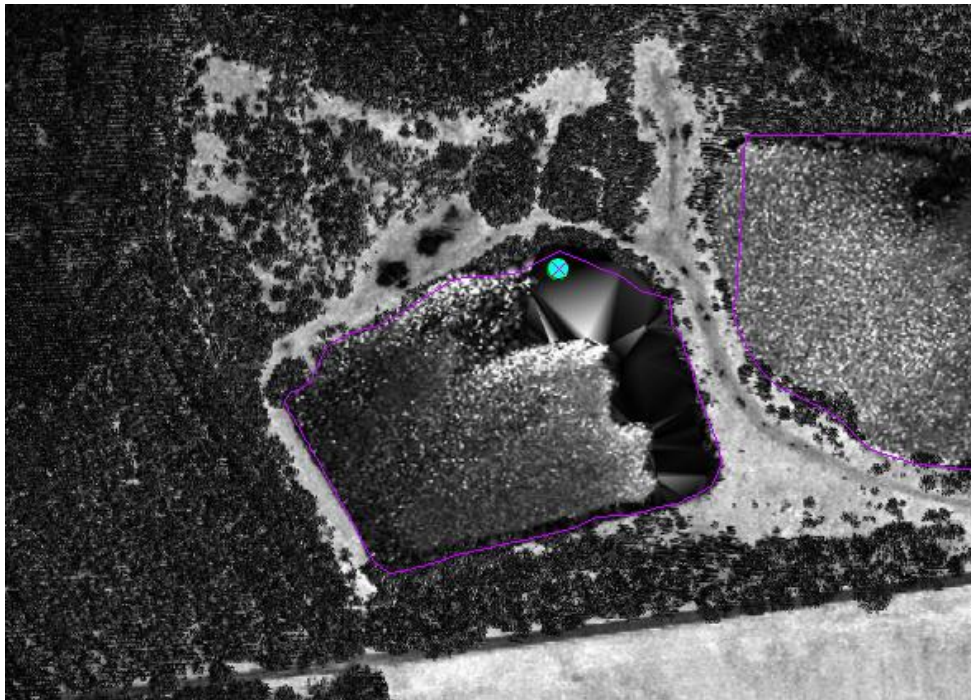
Figure 22-Tile S23_3930_10, Delivery 4. Delineation of water body has been corrected to fully capture feature.

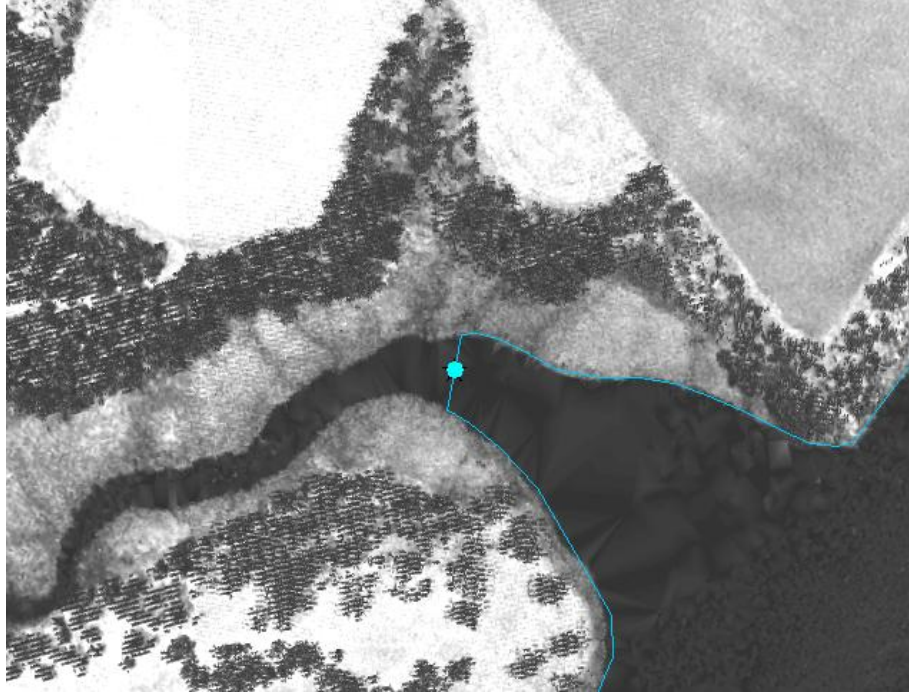
During the first review it was noted that when some features became too small to meet minimum collection requirements, the breaklines (7) were abruptly stopped or appeared “cut off” as if a man-made structure was at that location. These breaklines were corrected to appear more natural and not mistaken for man-made features, such as dams. An example is shown below.

Figure 23-Tile S23_3858_10, Delivery 1. Unnatural appearance of Inland Stream, shown with blue line. Feature should have been rounded off where it becomes too narrow to meet specifications, so as not to appear to be “cut-off”, or stopped by a man-made structure.

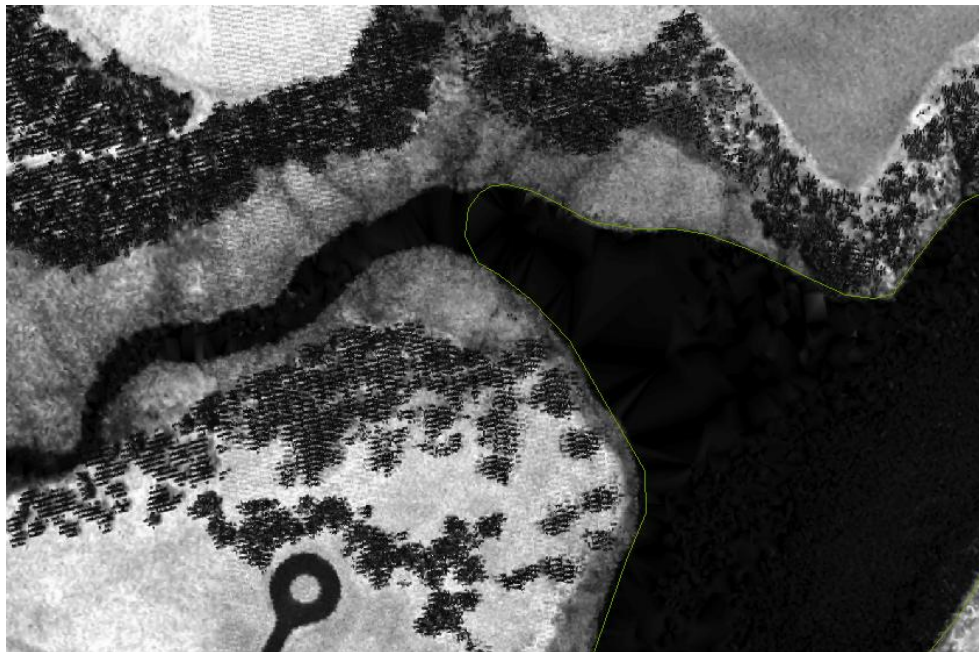
Figure 24-Tile S23_3858_10, Delivery 4. Unnatural appearance of Inland Stream, shown with green line, has been corrected by rounding it off. This feature no longer appears to be “cut-off”, or stopped by a man-made structure.

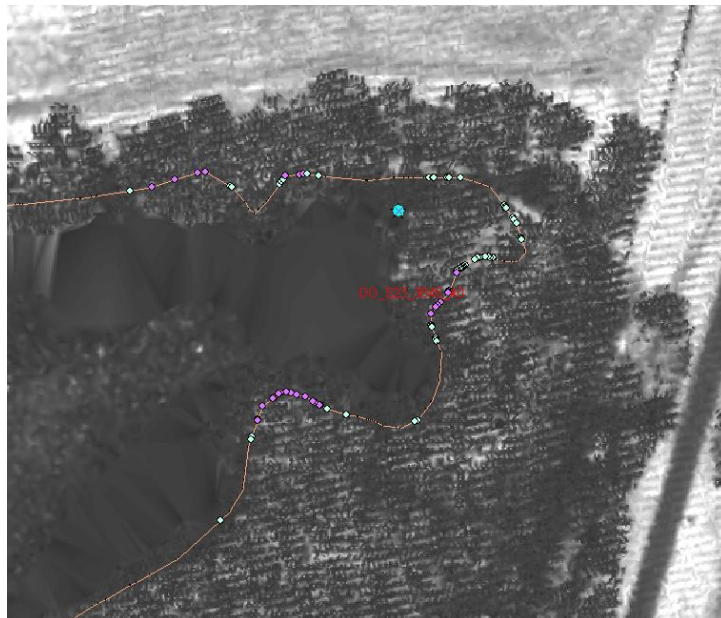
Per USGS specification, all breaklines must be at or just below the surface of the surrounding terrain. To ensure this requirement is met, the ΔZ is reviewed for every vertex. Vertices floating above the surrounding terrain by more than 0.1ft are considered an error as 0.1ft is noticeable in the DEMs. Vertices digging by more than 1ft were also reviewed. Vertices digging due to LiDAR noise, holding pond and lake elevations constant, etc. are not considered to be errors. A few edit calls (23) were placed during the first review for water body features that were digging by several feet due to incorrect horizontal placement. Sanborn corrected these issues in subsequent deliveries by modifying the breaklines to show the actual land/water interface. Elevations for features that were identified as floating (2) or excessively digging (3) in the first review was corrected in subsequent deliveries.

Figure 25-Tile S23_3845_40, Delivery 1. The incorrect horizontal placement of this feature along the bank was causing sections of it to be digging by several feet. Breaklines need to be adjusted to define the actual land/water interface.

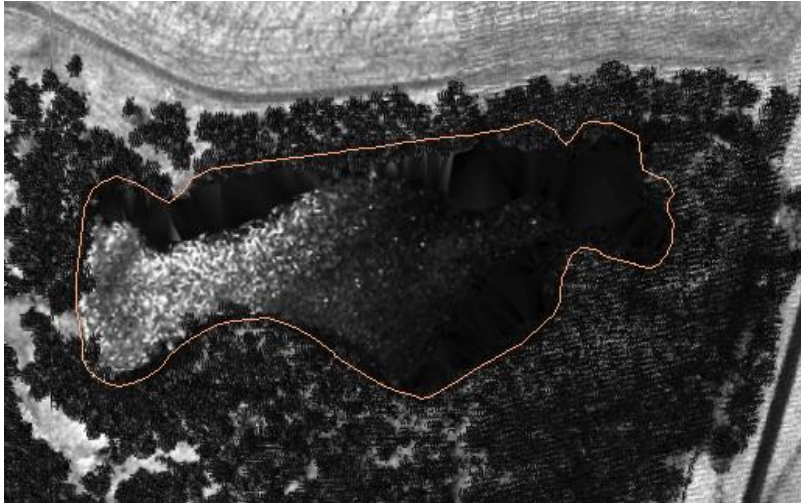
Figure 26-Tile S23_3845_40, Delivery 4. The horizontal placement of this feature was corrected to show the actual land/water interface.

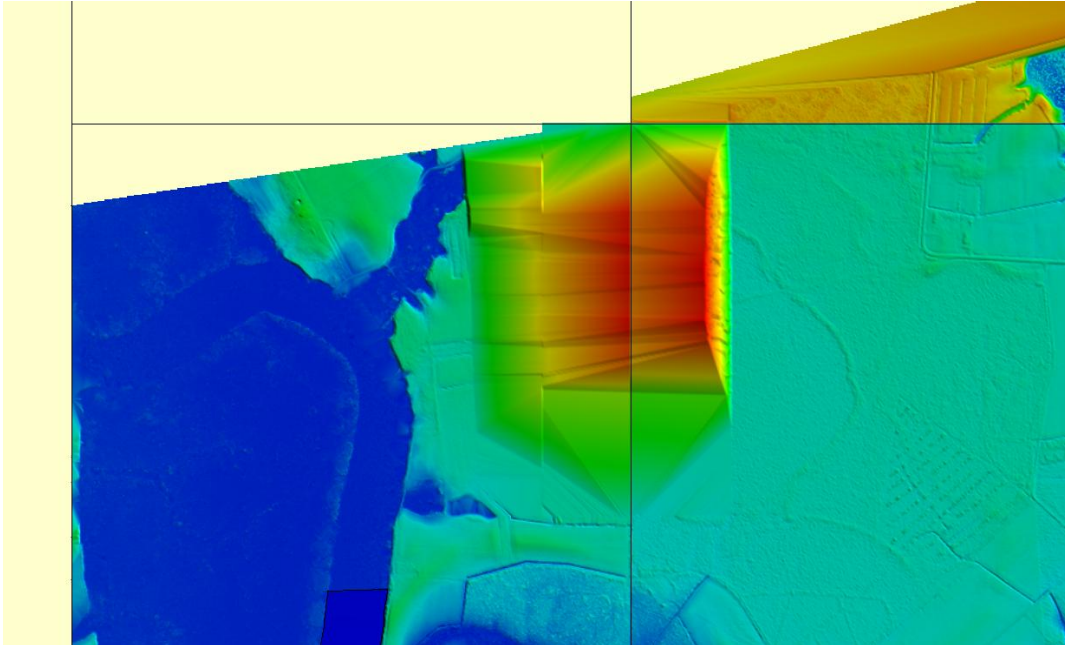
The DEMs have coverage to the full extent of the project boundary. Data was not clipped to this boundary, but extends well beyond the boundary. Data extending beyond the boundary may not always have full coverage and DEMs may not be flattened in these areas outside of the boundary. Some of this data outside of the boundary may have coverage gaps and be unusable. Sanborn is not required to clip the data. EROS has elected to receive all data and to perform the final clipping so that they control the final clipping boundary and selection of data that will ultimately be used in the NED program. An example of unusable data located outside of the project boundary is shown below.

Figure 27-DEM_S23_3910_10, all deliveries. Some areas outside of the project boundary may be unusable. The identified area is a coverage gap well outside of the required project boundary, with an anomalous high ridge along the eastern side of the gap. This particular area is unusable even though it was delivered with the final DEMs. EROS will perform the final clipping of the data.

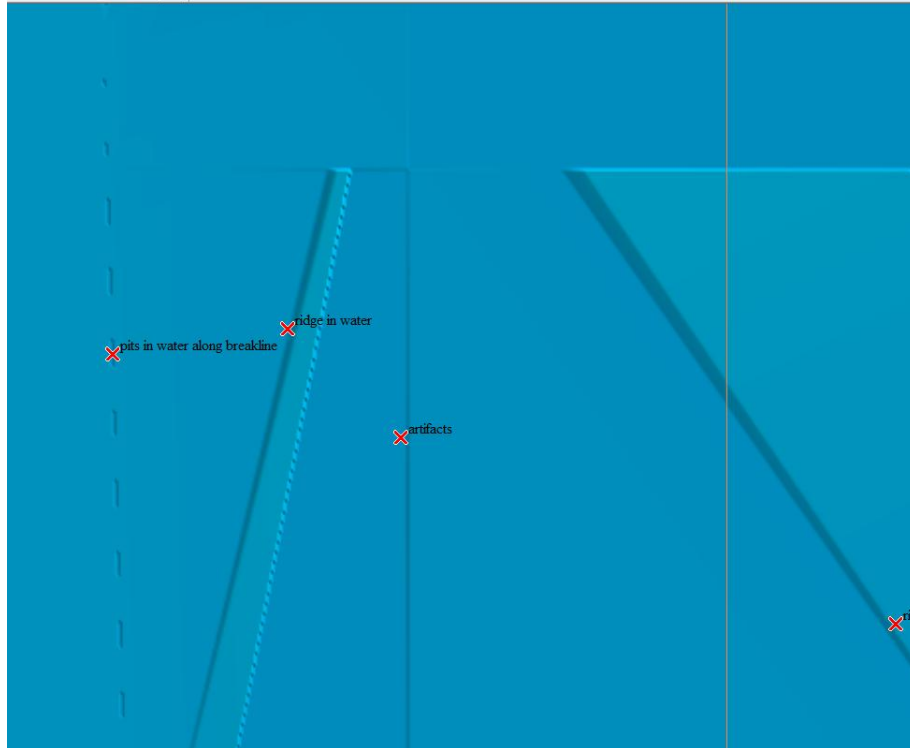
Numerous artifacts (315) were identified within water features in the first delivery. Sanborn modified their production process and the DEMs are now flat from bank to bank. Examples are shown below.

Figure 28-DEM_S23_2652_20, Delivery 1. Multiple artifacts with varying elevations were located within Tidal Waters.

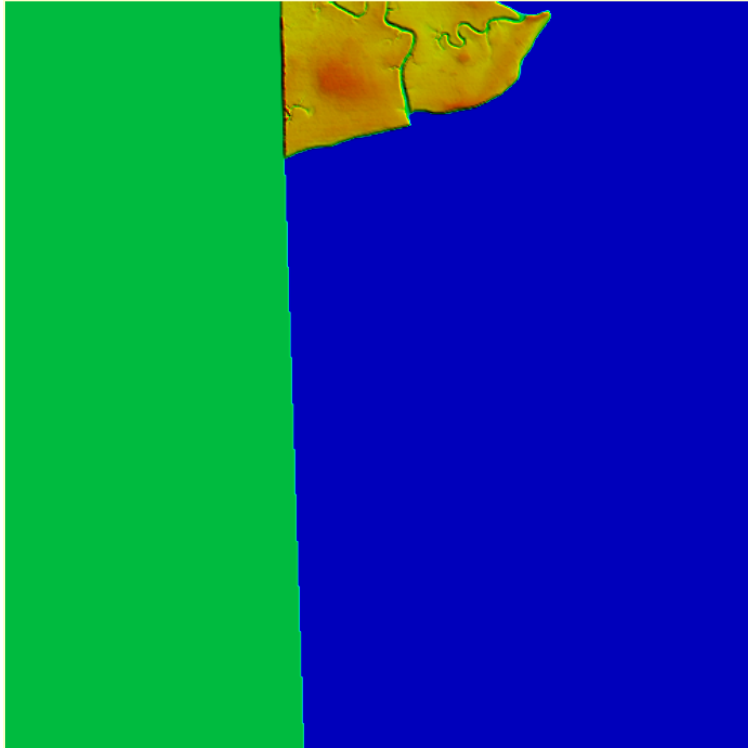
Figure 29-DEM_S23_2652_20, Delivery 4. The only elevation change in the water of this tile occurs along the flight line from tidal variations. This step is an acceptable way to show elevation change in water. The water is flat from bank to bank.

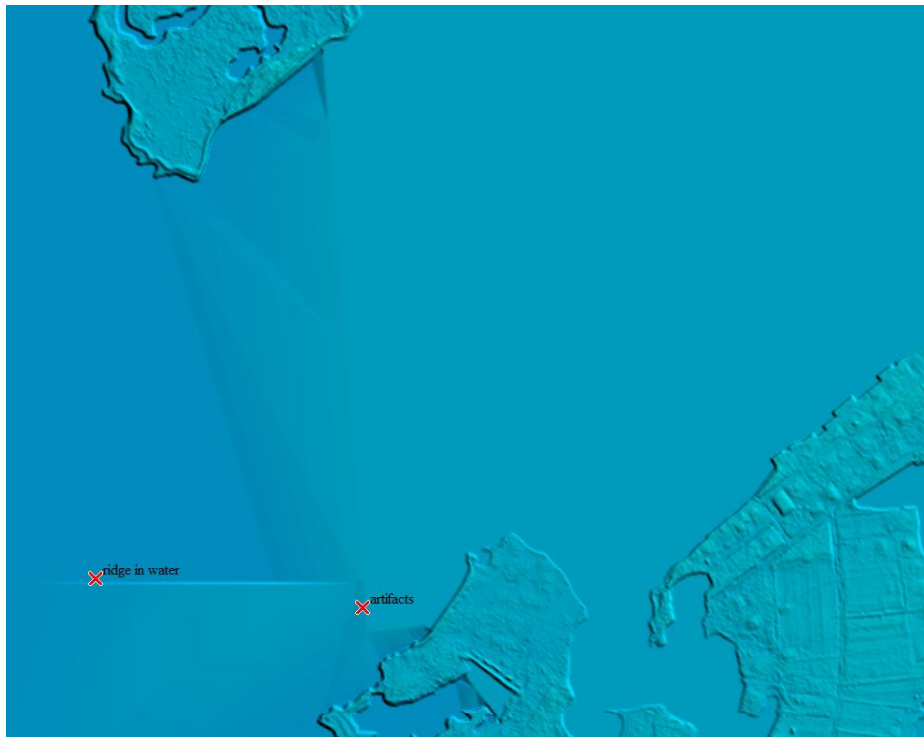
Figure 30-DEM_S23_2759_20 and DEM_S23_2759_30, Delivery 1. Multiple artifacts with varying elevations were located within Tidal Waters.

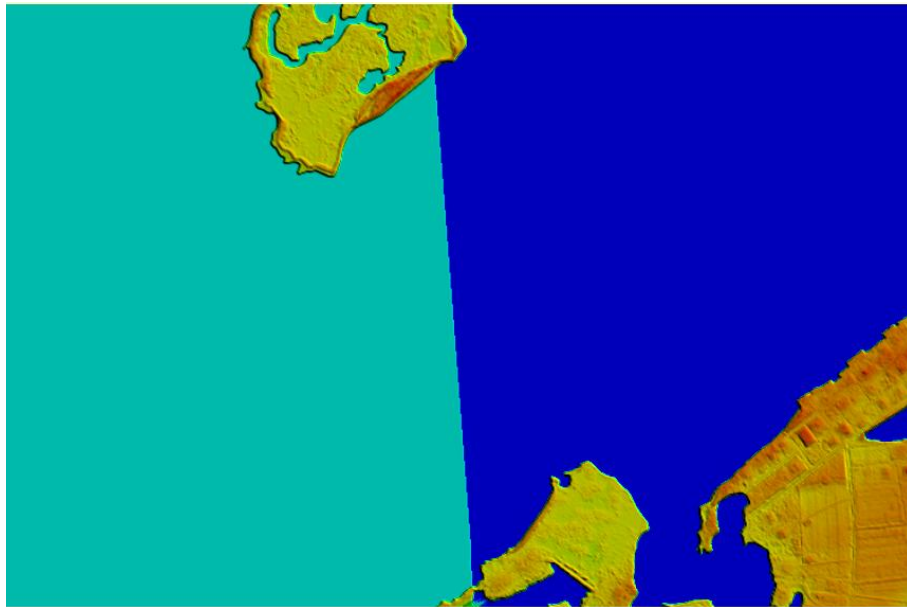
Figure 31-DEM_S23_2759_20 and DEM_S23_2759_30, Delivery 4. Now, the only elevation change in the water of these tiles occur along the flight line from tidal variations. This step is an acceptable way to show elevation change in water. The water is flat from bank to bank.

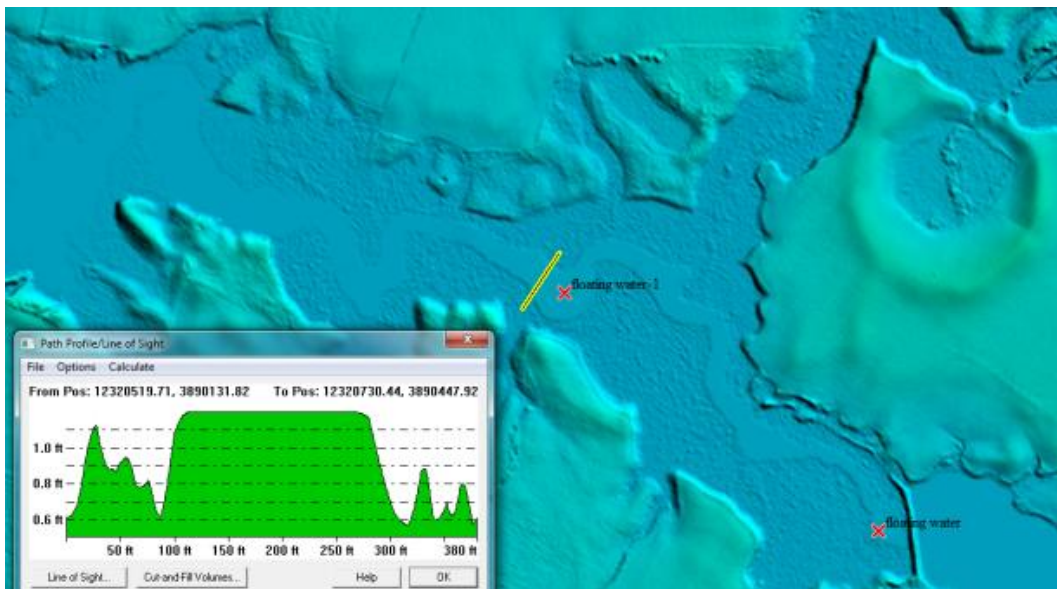
A few features (9) were identified in the first delivery as floating in the DEMs. These features were adjusted to be at or below the surrounding terrain. An example of the corrections is shown below.

Figure 32-DEM_S23_3829_10, delivery 1. Tidal waters were floating above the surrounding terrain.

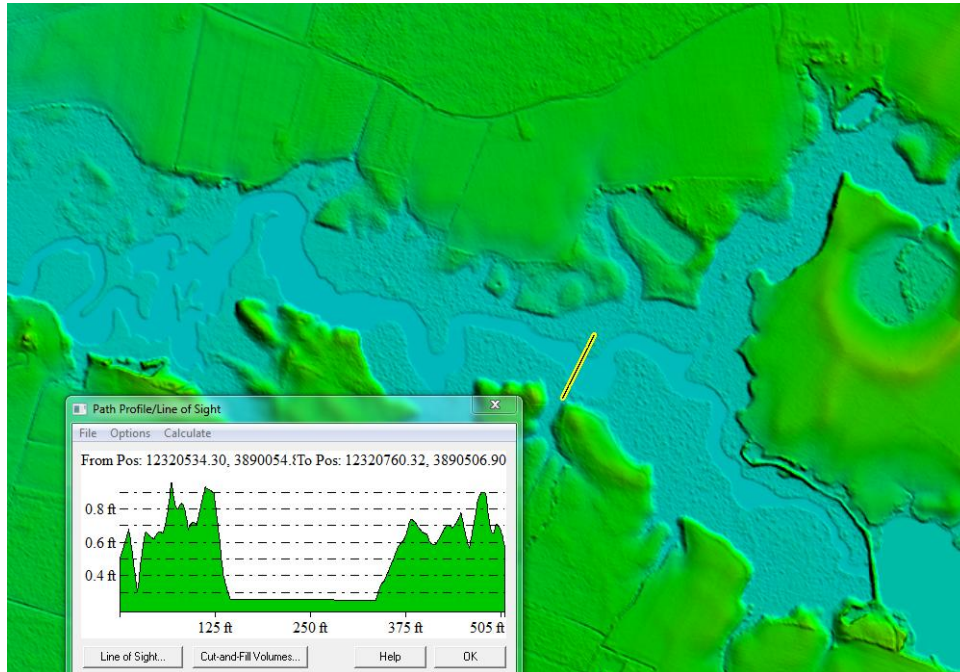
Figure 33-DEM_S23_3829_10, delivery 4. Tidal waters that were floating above the surrounding terrain have been corrected and are now at or below the surrounding terrain.

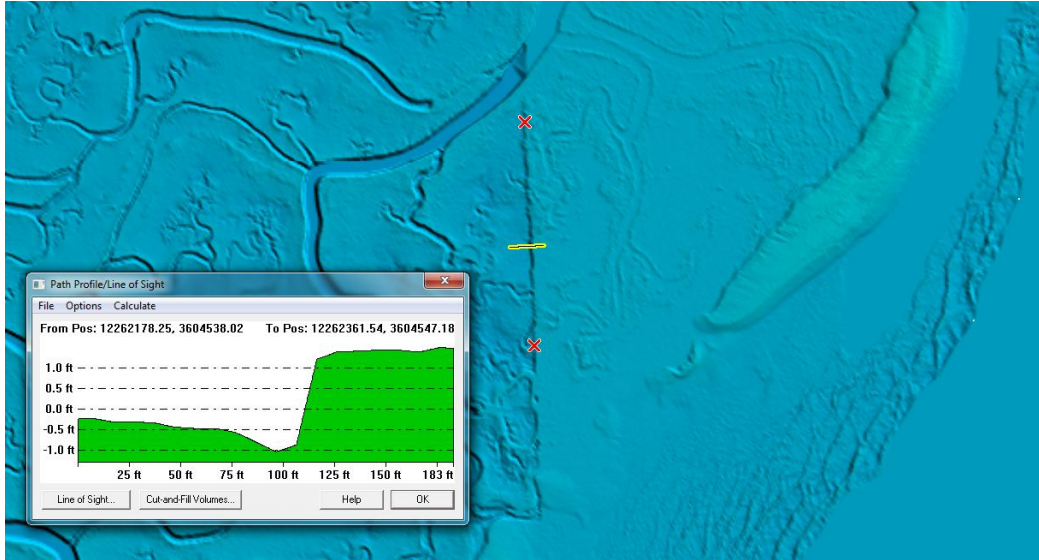
Numerous edit calls (23) were placed in the first delivery where flight line ridges between two adjoining swaths exceeded 12 cm or 0.4 ft as outlined in the Quality Plan. These issues were corrected when Sanborn re-calibrated the LiDAR data. A few flight line ridges were identified in previous deliveries. Most of these were corrected when Sanborn re-calibrated the LiDAR data. However, varying water levels in marsh or vegetated areas can affect the return of LiDAR signals to the sensor. Some LiDAR signals may show a greater absorption in wetter marsh areas compared to drier marsh areas. This greater absorption before the LiDAR signal is transmitted back to the sensor can translate into lower elevations. Or, some LiDAR signals may reflect off of the thin water layer covering or partially covering an island rather than reflecting off of the “ground” surface. The LiDAR could potentially show different responses between adjoining flight lines in marsh or wet areas such as tidally exposed islands, depending on the tide levels. Some of this variance in the LiDAR return signals may result in an elevation step between adjacent flight lines. These flight line ridges that occur in marsh like land cover types were not held to the USGS 10 cm relative accuracy specification for adjoining swaths as the flight line ridges do not occur over “true” ground. An example of flight line ridges that may still appear in the dataset is shown below.

Figure 34-DEM_S23_2660_20 and DEM_S23_2660_10, All deliveries. Flight line ridges are more prominent on tidally exposed ground. These tidal flats can be very marshy with varying levels of water present. As these areas are not “true” ground, they were not held to the same relative accuracy specifications outlined for actual ground.

It is Dewberry’s recommendation that the DEMs delivered by Sanborn be accepted. Flight line ridges, with the exception of those located in tidally influenced areas, were corrected when Sanborn recalibrated the LiDAR data. Sanborn modified their production process. This corrected all other DEM issues, including artifacts in water that needed to be flattened.
