PROJECT REPORT

King William Acquisition and Classification for FEMA VA LiDAR

Dewberry

Report Date: October 27, 2011

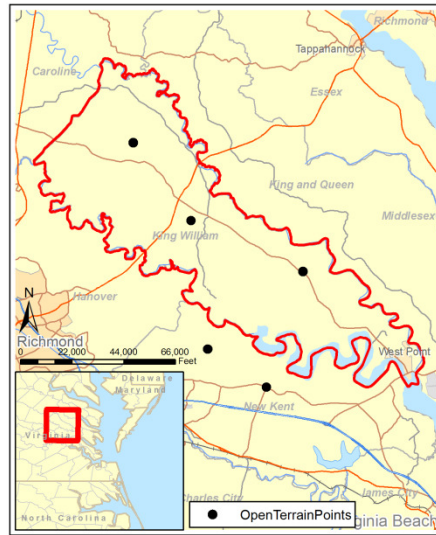
Because the raw swaths extend past the project boundary, Dewberry was able to test two additional open terrain points. The forested and weed/crops points could not be tested because the data was not classified, but in future deliveries of New Kent County, these points will be included.

Figure 3 - Checkpoints used to check open terrain points in raw swath LAS
