LiDAR Quality Assessment Report

Materials Received:	Project Type: GPSC
3/29/2013	
	Project Description:
Project ID:	
WA_ElwhaRiverLidar_2012	
Project Alias(es):	Year of Collection: 2012

Lot 5 of 6 lots.

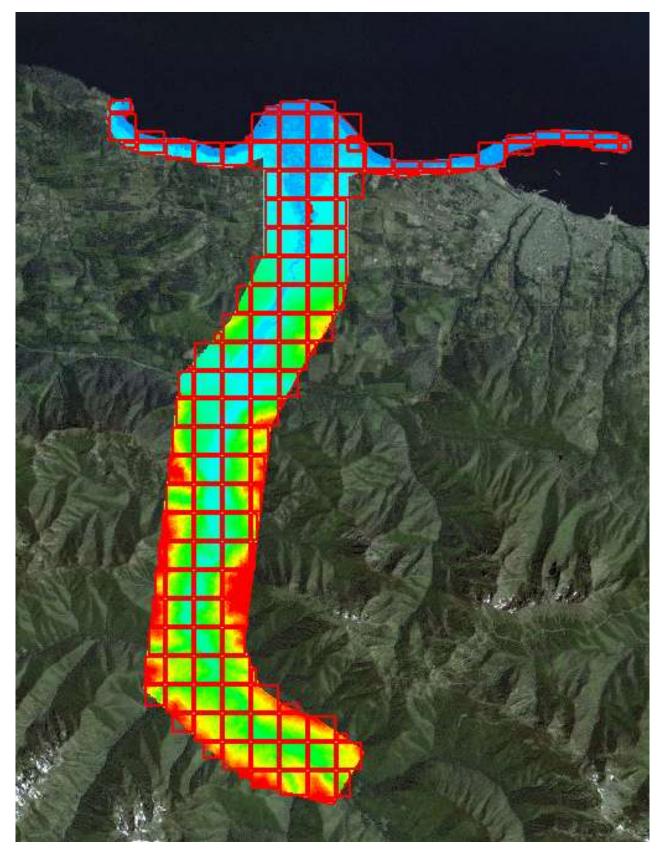
Project Tiling Scheme: ☑ Project Tiling Scheme image?

The tiling system specified in the Task Order was for 1500m X 1500m however the tiling system is 1000m X 1000m. I do not see this as a reason to reject the LAS files.

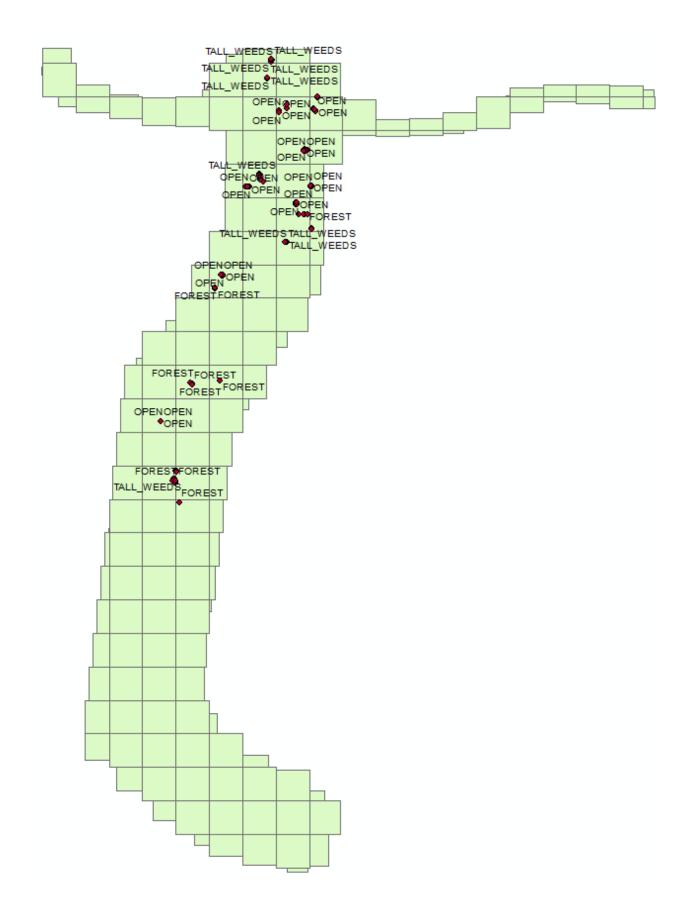
Checkpoint Shapefile or Geodatabase: ☑ Checkpoint Distribution Image?

For this dataset, USGS checked the spatial distribution of checkpoints with an emphasis on the bare-earth (open terrain) points; the number of points per class; the methodology used to collect these points; and the relationship between the data supplier and checkpoint collector. When independent control data are available, USGS has incorporated this into the analysis.

There are a minimum of 20 checkpoints for each land cover class represented. Points within each class are uniformly distributed throughout the dataset. USGS <u>wasable to</u> locate independent checkpoints for this analysis. USGS <u>accepts</u> the quality of the checkpoint data for these LiDAR datasets.
