New York State Airborne LIDAR

Final Review Report

Madison-Otsego Quality Level 2 LIDAR Project

3DEP Project G15AC00113

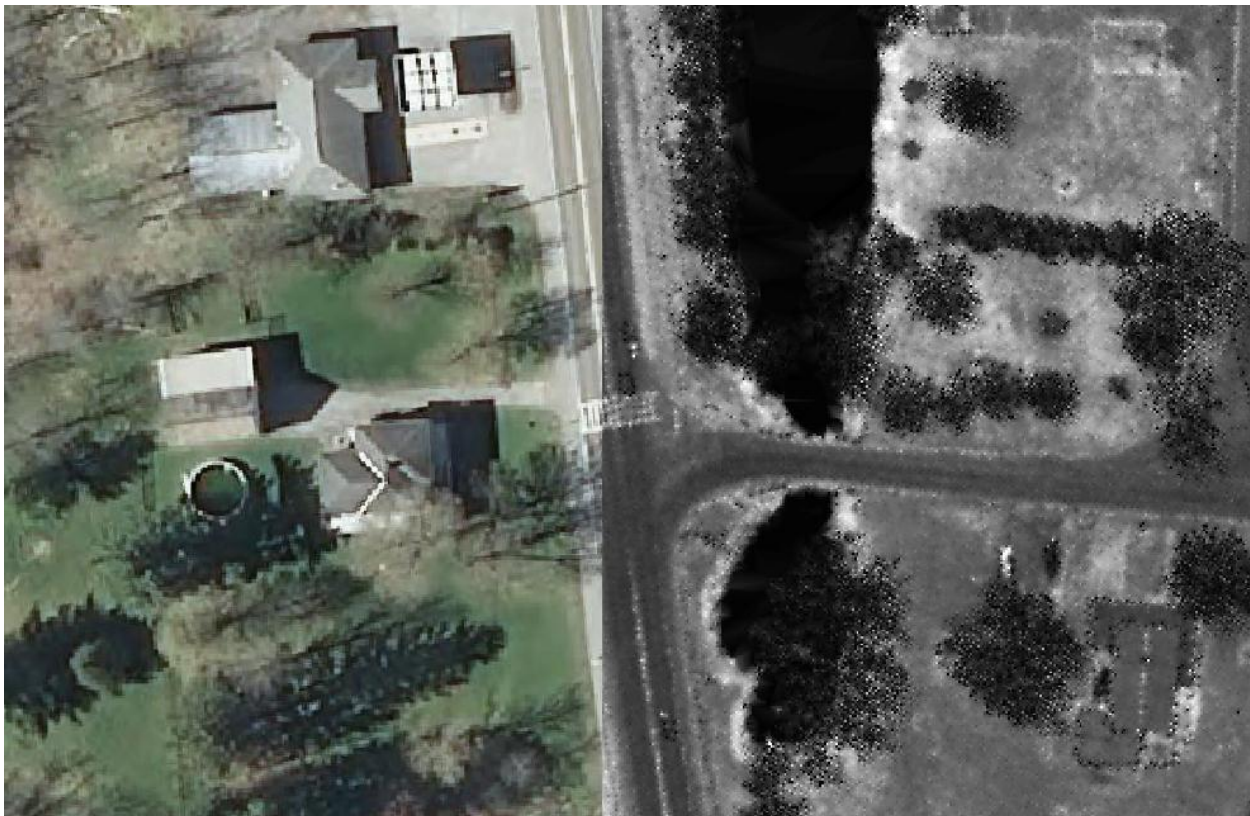
Below is an example where overlapping 1-ft resolution orthoimagery (horizontal accuracy better than +/- 4-ft at 95%) is shown with a 1-ft resolution intensity image created from the LAS point cloud.

Early in the review process, an intensity image was made from all tiles. In select areas, the horizontal position of features such as sidewalk corners, painted lines, and pavement intersections on this intensity image were compared to the locations of the same features on reference data. In most cases, the reference data were orthoimages or vector data digitized from the orthoimagery. In some cases, NYSDOT design scale mapping accurate to +/- 6 cm was also used. Occasionally, the project's surveyed checkpoints also could be used. This check on the horizontal position of the LIDAR data was done to confirm a reasonable horizontal alignment before starting detailed vertical accuracy checks.

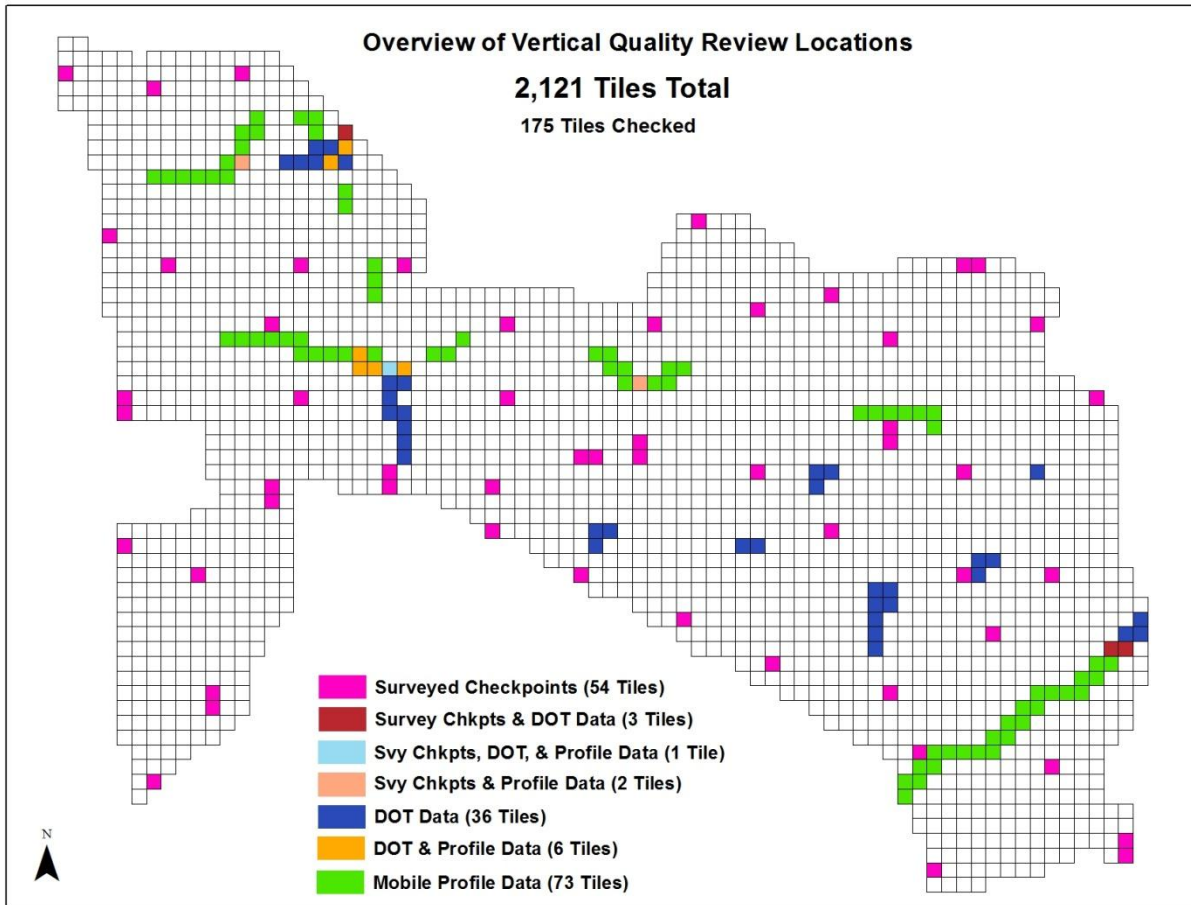
This project succeeded in producing high quality LIDAR point cloud data and bare earth DEMs. Final products were judged to meet 3DEP specifications. As stated earlier in this report, many of the review steps included all tiles. Given the specific locations of the check data for quantitative vertical review, the following graphic provides an overview showing good distribution of these checks.
