Tallahassee-Leon County GIS Landbase Update Project

Report Produced for Tallahassee-Leon
County

Report Date: 3/15/2019

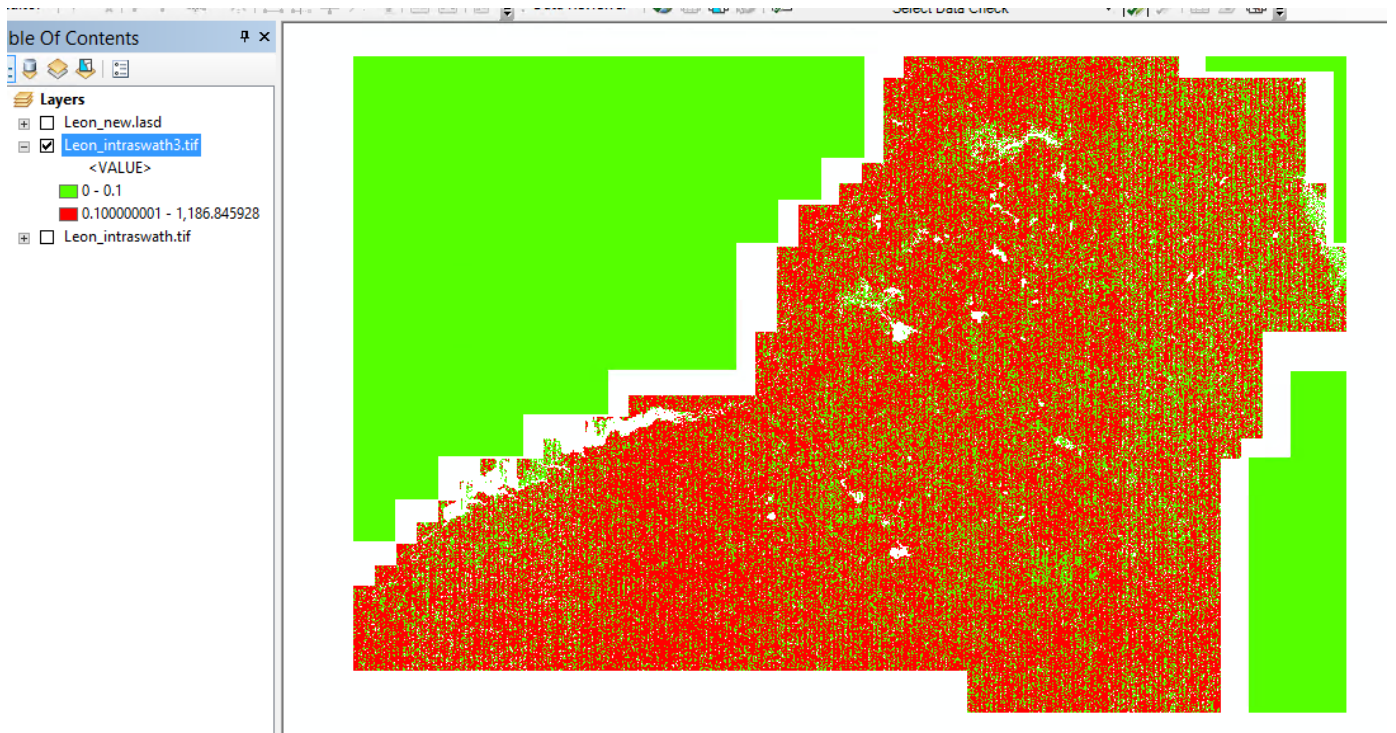
Figure 8–Intra-swath relative accuracy. The top image shows the full project area; areas where the maximum difference is ≤ 3 cm (0.1 ft) per pixel within each swath are colored green and areas exceeding 3 cm (0.1 ft) are colored red. The bottom image is a close-up of a road interchange, showing flat road surfaces pass specifications.

Dewberry verifies the intra-swath or within swath relative accuracy by using Quick Terrain Modeler (QTM) scripting and visual reviews. QTM scripting is used to calculate the maximum difference of all points within each 1-meter pixel/cell size of each swath. Dewberry analysts then identify planar surfaces acceptable for repeatability testing and analysts review the QTM results in those areas. According to the SOW, USGS Lidar Base Specifications v1.3, and ASPRS Positional Accuracy Standards for Digital Geospatial Data, 5 cm Vertical Accuracy Class or QLo data must meet intra-swath relative accuracy of 3 cm maximum difference or less. The image below shows two examples of the intra-swath relative accuracy of Tallahassee-Leon County GIS Landbase Update Project; this project meets intra-swath relative accuracy specifications.

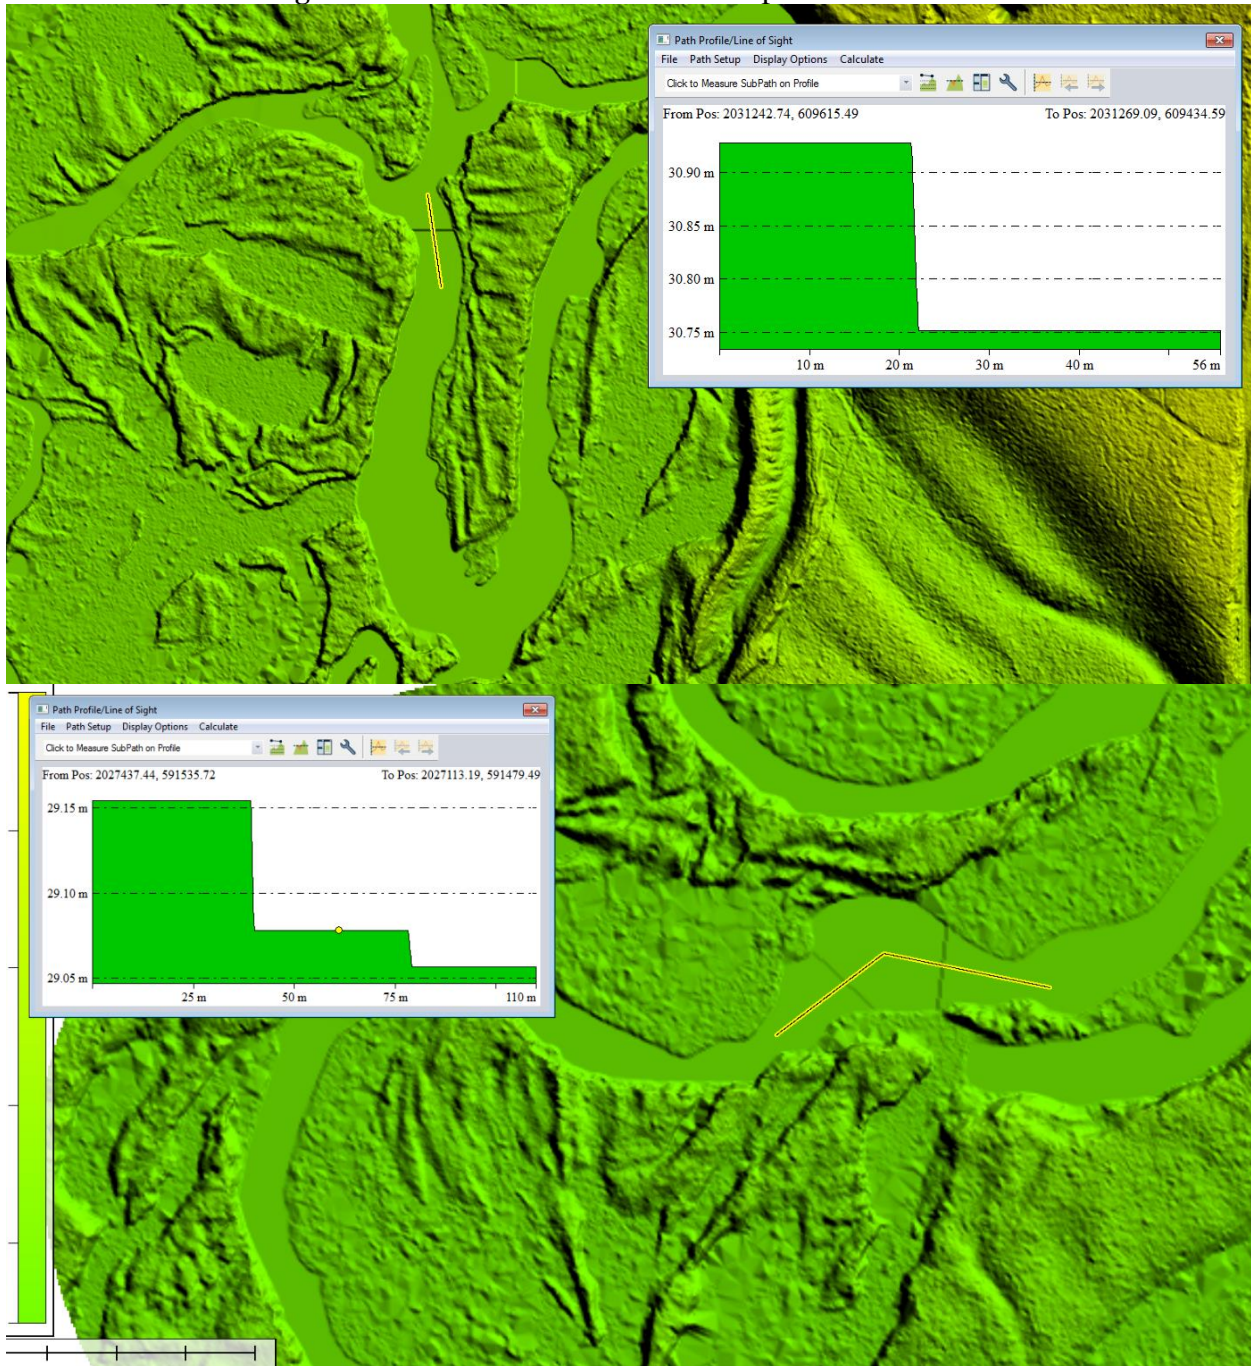
Figure 17 – Tiles number 039117_N and 040736_N. Elevation change has been stair stepped. The steps are flat from bank to bank and flow consistently downhill.

While water bodies are flattened in the final DEMs, other features such as linear hydrographic features can have significant changes in elevation within a small distance. In linear hydrographic features, this is often due to the presence of a structure that affects flow such as a dam or spillway. Dewberry has reviewed the DEMs to ensure that changes in elevation are shown from bank to bank. These changes are often shown as steps to reduce the presence of artifacts while ensuring consistent downhill flow. An example is shown below.

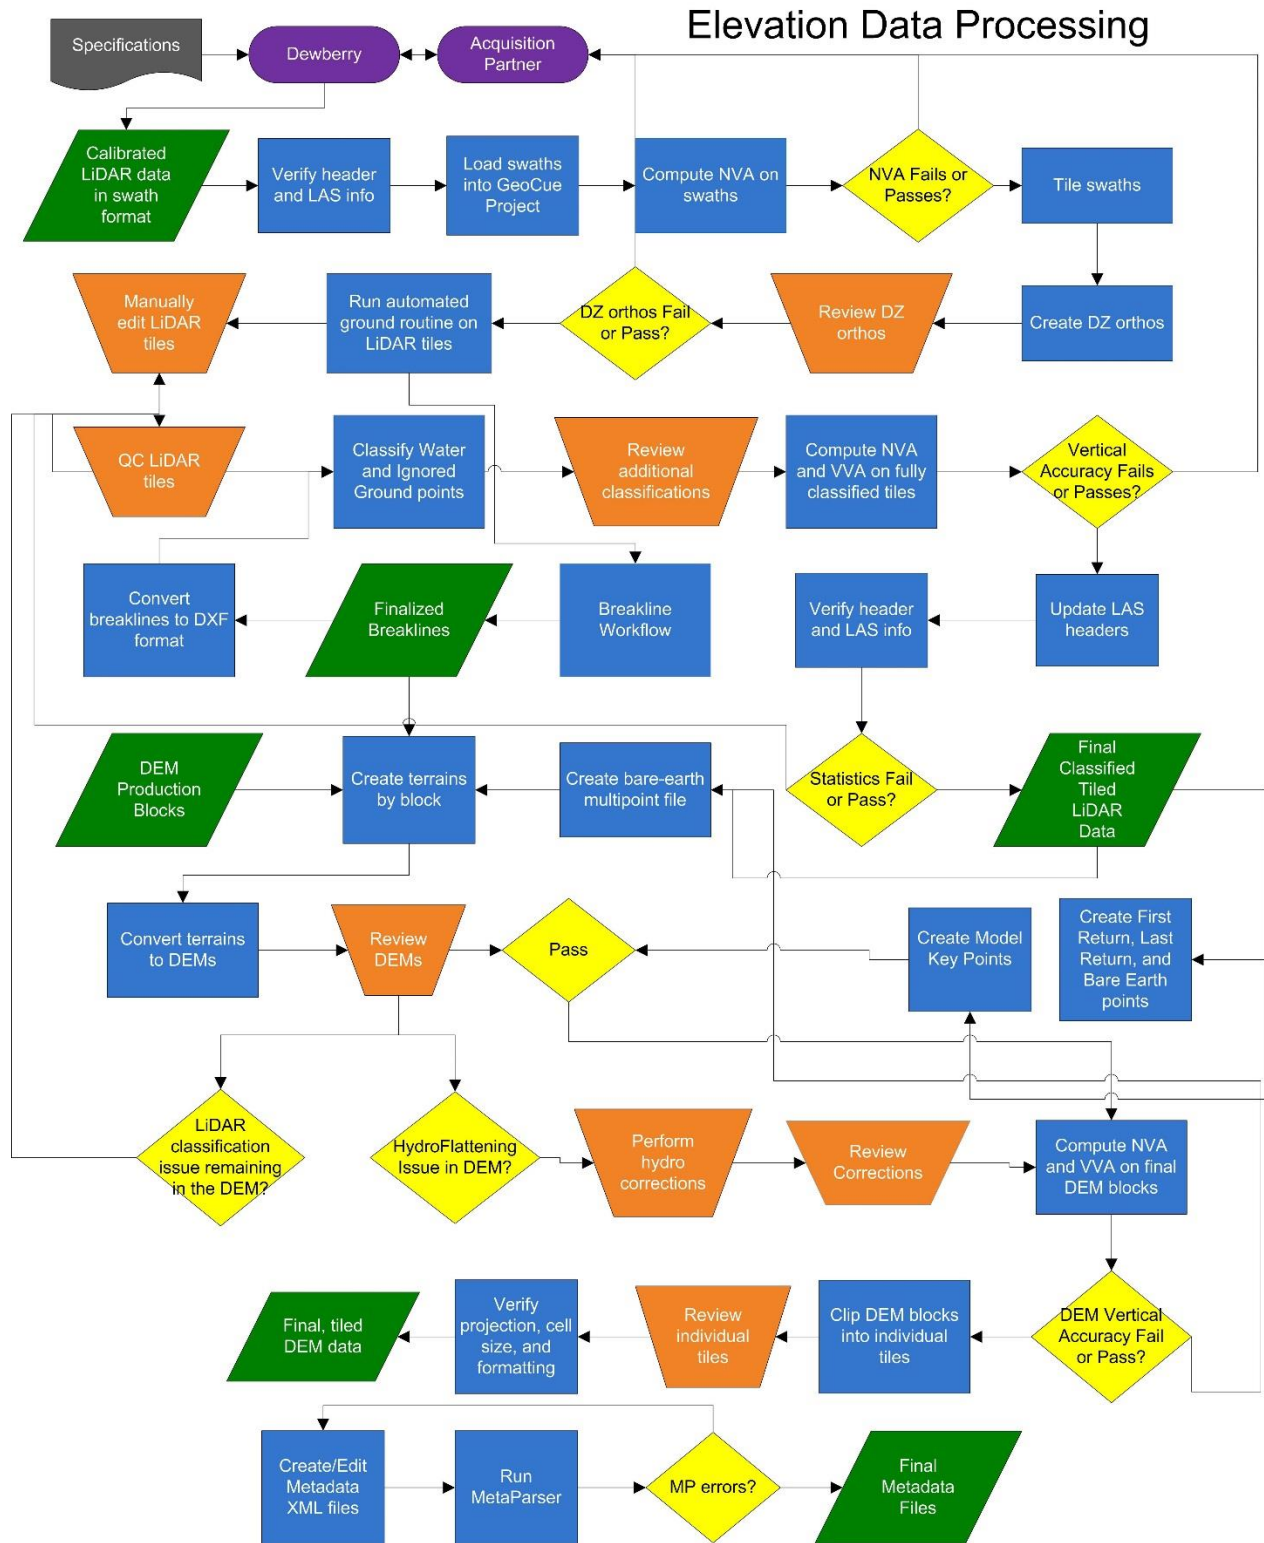
Figure 25-DEM Production Workflow

The final bare-earth lidar points are used to create a terrain. The final 3D breaklines collected for the project are also enforced in the terrain. The terrain is then converted to raster format using linear interpolation. For most projects, a single terrain/DEM can be created for the whole project. For very large projects, multiple terrains/DEMs may be created. The DEM(s) is reviewed for any issues requiring corrections, including remaining lidar mis-classifications, erroneous breakline elevations, poor hydro-flattening or hydro-enforcement, and processing artifacts. After corrections are applied, the DEM(s) is then split into individual tiles following the project tiling scheme. The tiles are verified for final formatting and then loaded into Global Mapper to ensure no missing or corrupt tiles and to ensure seamlessness across tile boundaries.
