NY FEMA R2 – WUID#214093 USGS FEEDBACK

Hydro Flattening Issue

USGS provided feedback for WUID#214093 on various issues related to hydroflattening, misclassification, withheld points and geometry errors using NY_FEMAR2_Central_3_2018_2021-08-04_Errors.gpkg and supplemental report files received 08/04/2021 for the deliverables submitted by Dewberry on 03/26/2021.

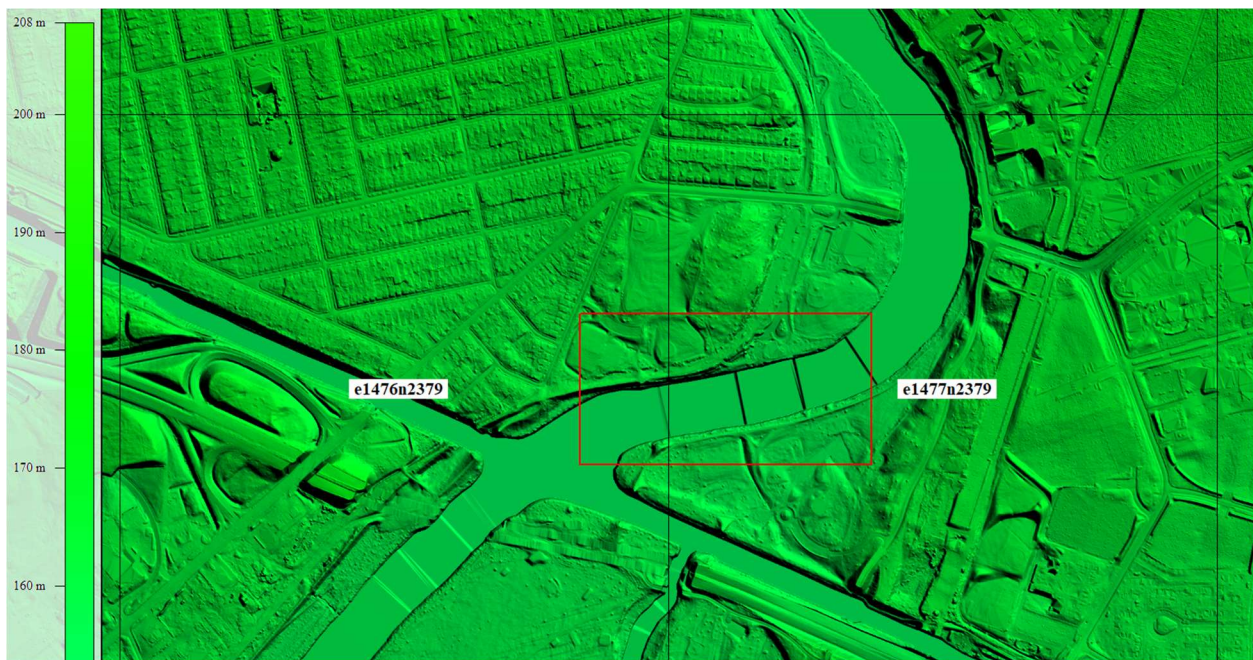
Error Call Feature id: 113

While reviewing the errors and performing corrections on the data, Dewberry observed an unusual monotonicity issue for error call id-113 for hydro breakline causing geometry / hydroflattening of DEM on tile ids : e1476n2379 and e1477n2379.

DELIV_TYPE	DELIV_ID	TYPE	SUBTYPE
Hydroflattened Polygon Breaklines	7556	Geometry Error	Downstream Constraint

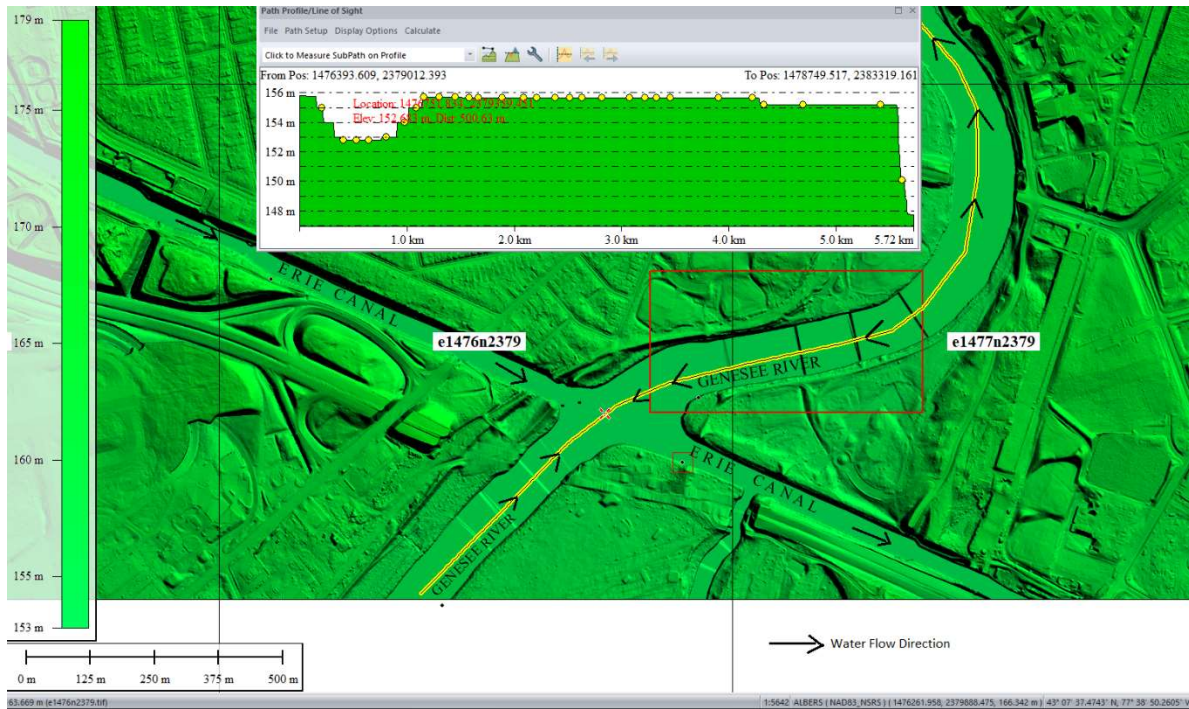
On further review of the error call and monotonicity issue at the location, Dewberry observed that the issue extends beyond the two tiles identified due to temporal variation of the water levels maintained in the Erie Canal during the lidar acquisition period. As the monotonicity was maintained in the Erie Canal for the deliverables submitted on 03/26/2021, Genesee River was shown as water flows in opposite direction from the northern section of the river at the Erie Canal intersection.

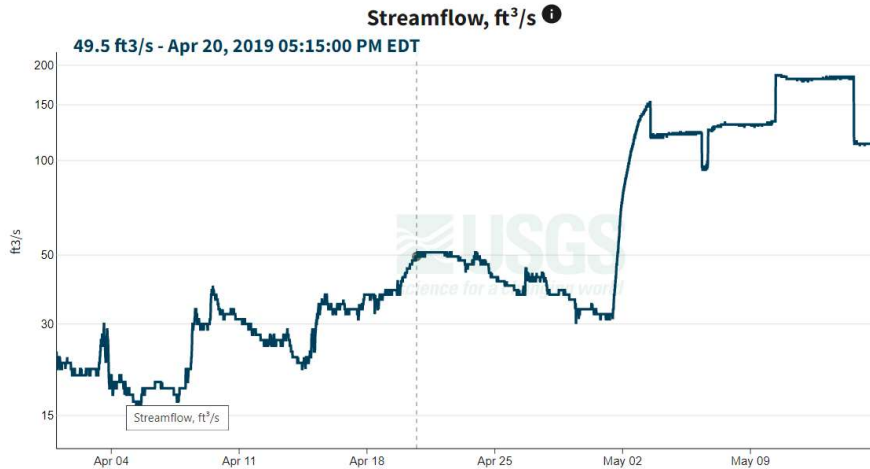
- 1) Water levels between the locks in the canal are normally maintained at a steady flow with discharge rate as low as 20 ft³/ second to 200 ft³/second. Water does not flow like a river system. Source: https://waterdata.usgs.gov/ny/nwis/uv/?site_no=04219000&agency_cd=USGS

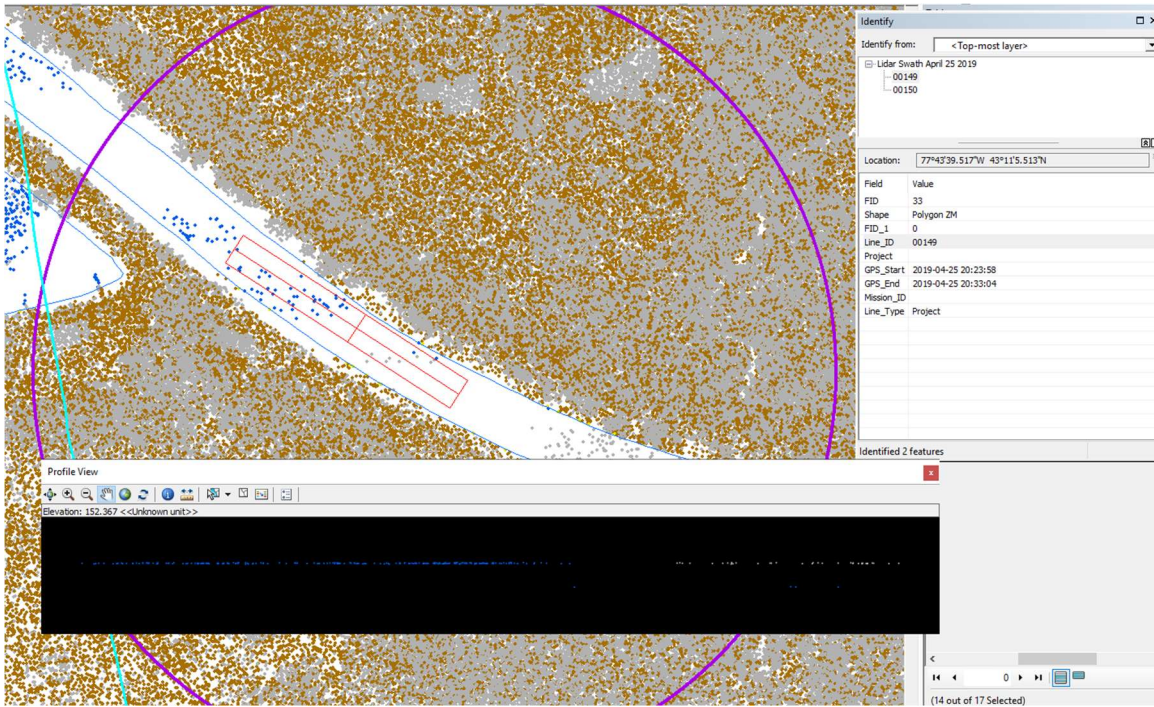
Profile view of Swaths flown on 04/25/2019 and 05/09/2019

Based on the lidar acquisition dates and point cloud data, the water elevation in the Western Erie Canal is at approximately 152 meters for the swaths (PSID 149 thru 155) acquired on 04/25/2019 up to the physical barrier feature West Guard Gate on Erie Canal. Water Level is approximately 155 meters for the swaths (PSID 136 thru 148, and reflight 10149) acquired on 05/09/2019. Temporal variation of 3 meters is occurring at 77°43'39.517"W 43°11'5.513"N (PSID 149).

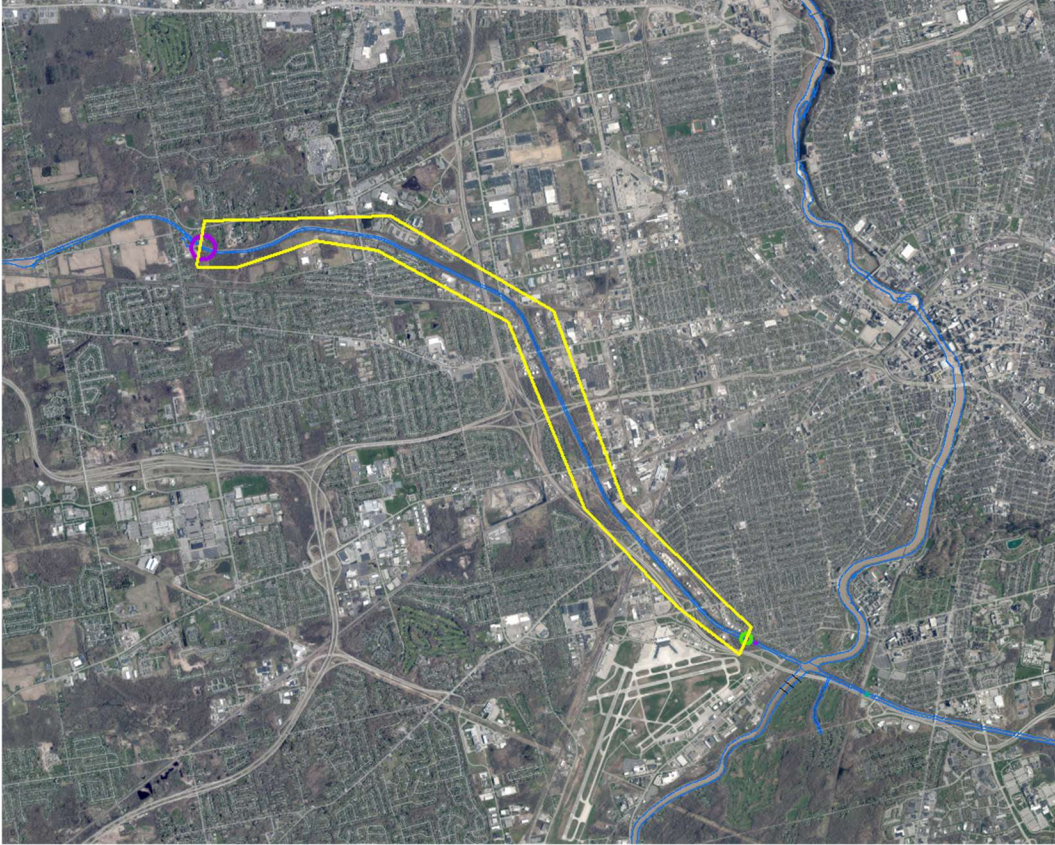
To mitigate the issue and maintain monotonicity for the Erie Canal and Genesee River, Dewberry collected Erie Canal hydro breakline with 155.350 m elevation based on the acquisition date 05/09/2019 and swaths east of West Guard Gate (04/25/2019) to align with rest of the canal elevation. This approach resolved the issue with downstream constraint occurring for Genesee river at the intersection of Erie Canal. The Erie Canal polygon width was expanded to match with canal walls / terrain. Water drained out / temporal change segment with 152m elevation (swaths collection date 04/25/2019) of the hydrographic polygon was created as a separate feature class and attributed with appropriate comments in the feature class attribute table. Dewberry classified the lidar points on the temporarily exposed canal walls of this impacted section between 152 m -155.350 m in elevation as Class-32.

The above approach resolved the downstream constraint issue for Genesee River as well as fixed the elevation for Western Erie Canal.
