DEWBERRY RESPONSE TO USGS FISH SPRINGS TOPOBATHYMETRIC LIDAR

Produced for U.S. Geological Survey

SEPTEMBER 7, 2023

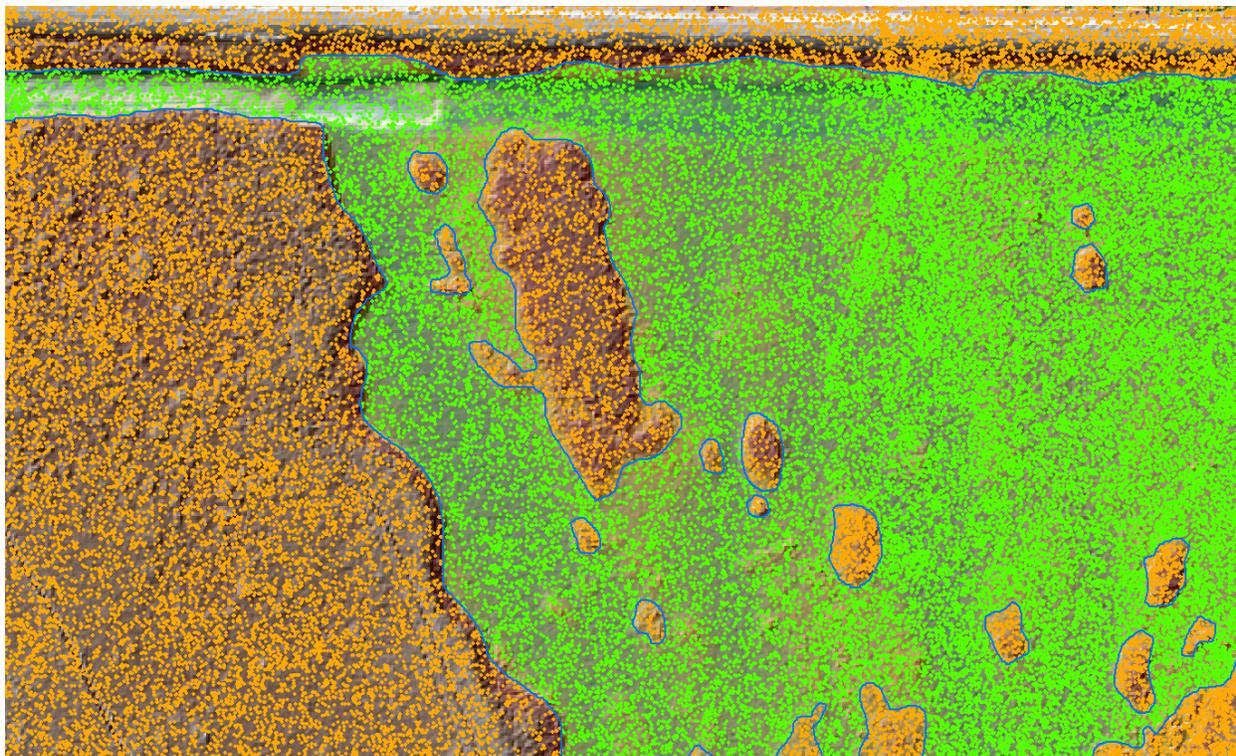
Dewberry has verified that the refraction correction was correctly applied to the Fish Springs lidar point cloud, but that the incorrect version of refraction extents was used for the final classification steps. Dewberry has updated the lidar point cloud classification to match the correct, final version of refraction extents (Figure 12 and Figure 13). The updated lidar point cloud and correct version of refraction extents will be redelivered. The redelivered refraction extents and updated point cloud resolves questions 2 and 3. This correction does not impact the delivered topobathymetric DEMs.

Figure 12. Overview showing the final/correct refraction extents and associated ground classification. Ground- class 2 is shown in orange, bathy bottom- class 40 is shown in green, refraction extents are represented as blue polygons.

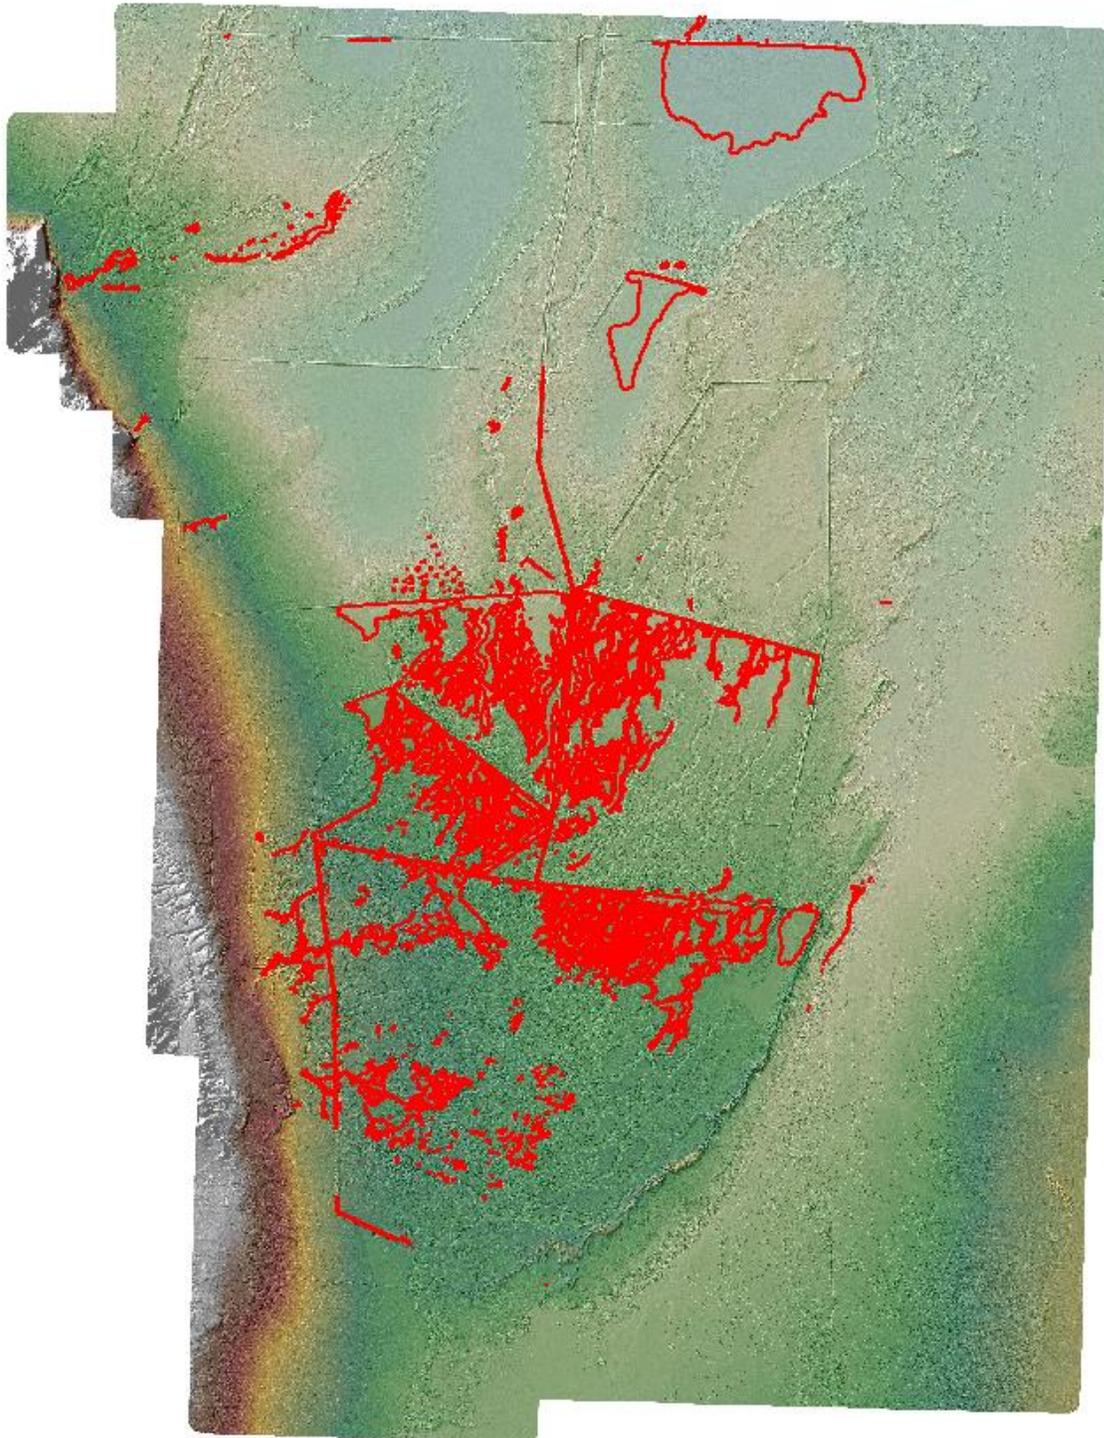
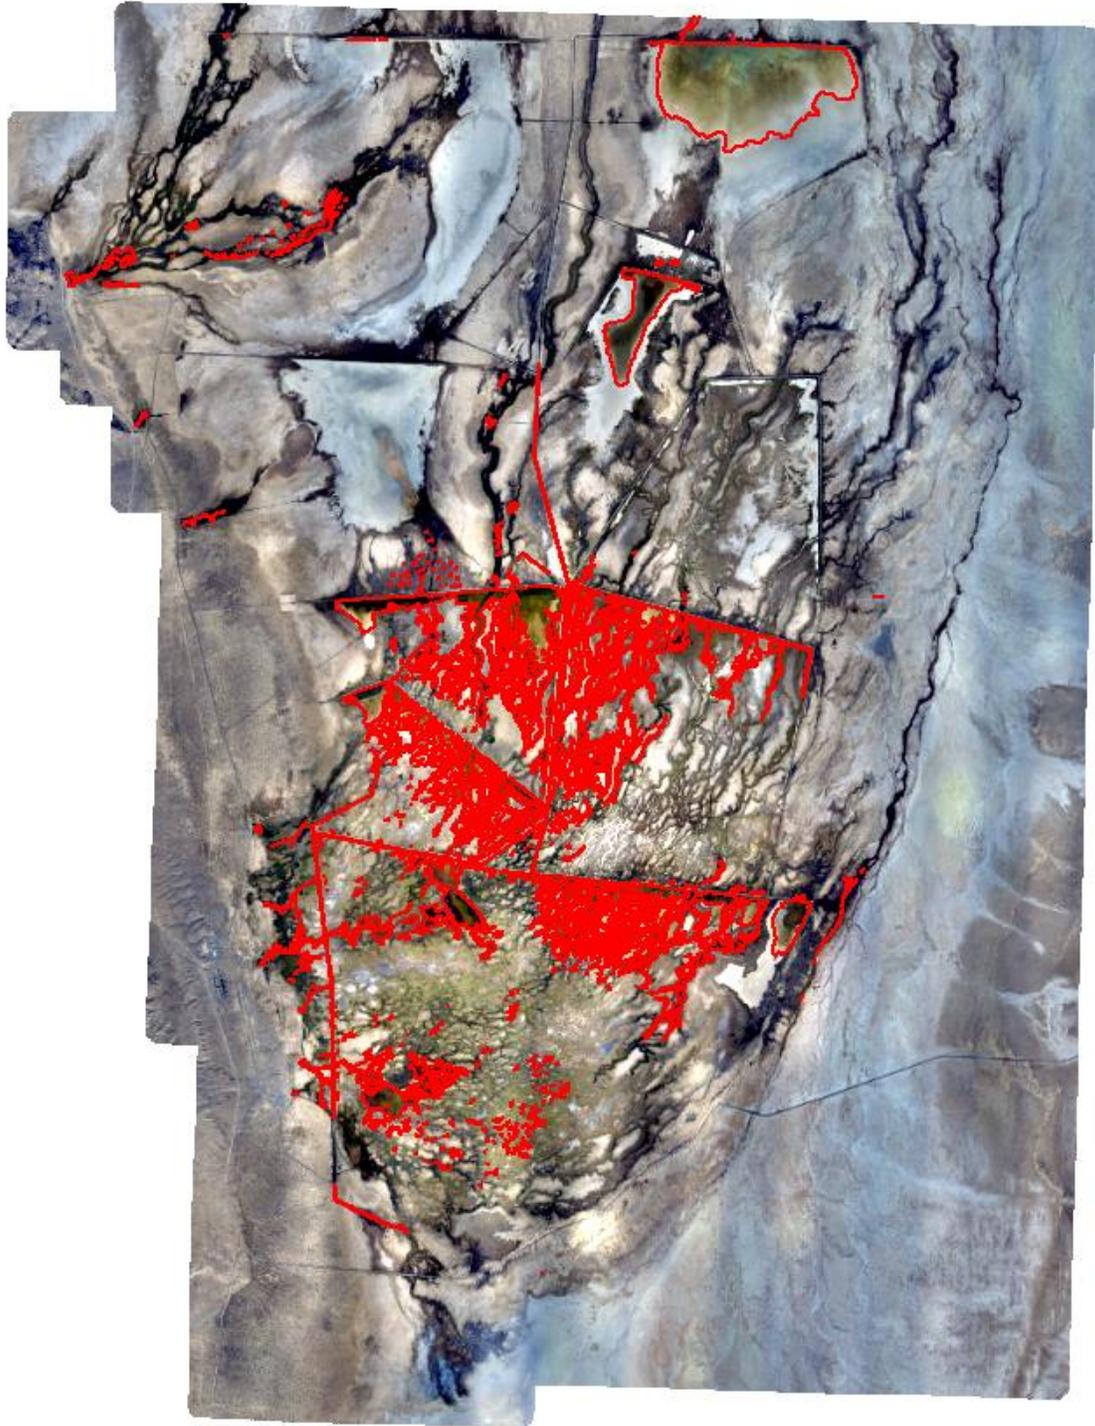
Figure 13. Final set of refraction extents for the full AOI. The top image has the refraction extents overlaid on top of the DEM, the bottom image the refraction extents overlaid on top of the ortho-imagery.
