IfSAR Quality Assurance (QA) Report

QA Report for Intermap Cells 393, 394, 398,
399, 400, 401, 402, 403, 404, 405, 406, 407,
408, 409, 410, 411, 412, 414, 415, 416, 417,
418, 419, 420, and 421

Produced for U.S. Geologic Survey

Report Date: May 15, 2020

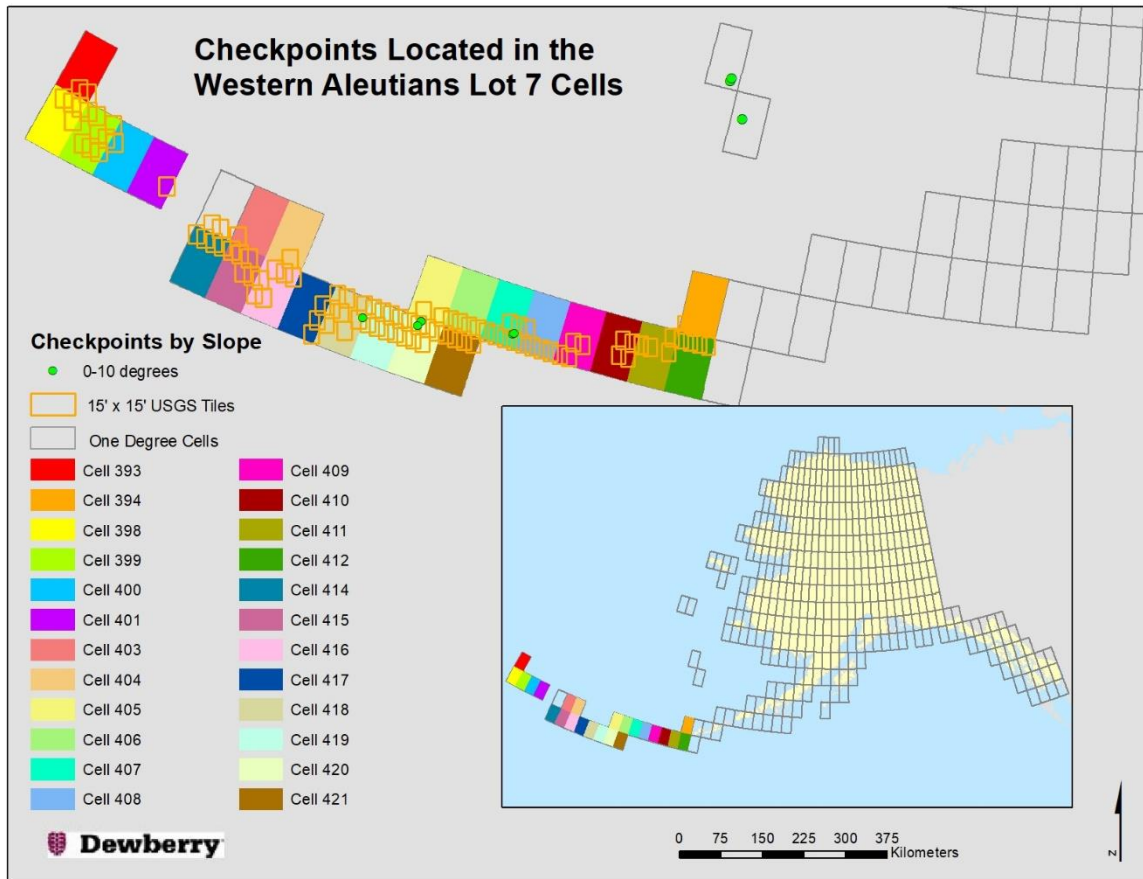
Figure 2 – Checkpoints displayed by slope.

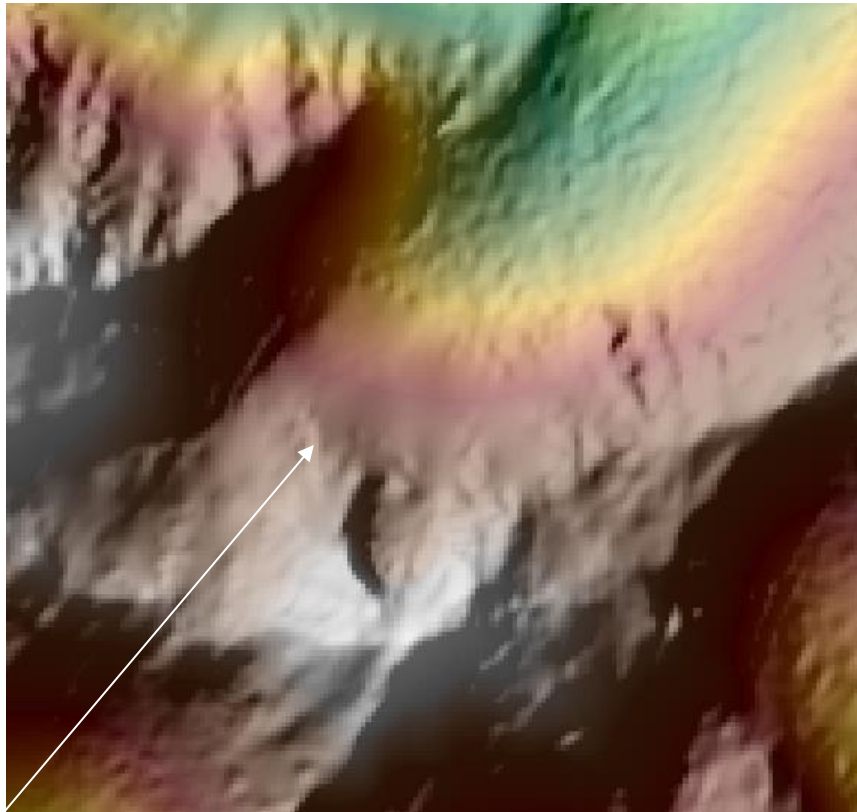
Two conditions that usually occur with IfSAR data is layover and shadow. Layover occurs when the terrain angle is greater than a line perpendicular to the look angle and causes radar signals from the top of the feature to reach the antennae before signals from the bottom of the feature. This causes the feature to “layover” toward the IfSAR sensor. As described in Intermap's Product Handbook, the previously compressed regions are stretched during the production process to better represent the terrain. This may cause areas of layover to appear blurred as areas of higher terrain have been “pulled” back to their correct position. If there is no valid elevation in regions of layover, these areas are filled through interpolation or ancillary data and will be represented with a void mask. However, many of these layover areas contain valid elevation information due to overlapping data from other swaths or flight lines. An example is shown below.

Figure 3- Tile N5245E17300P from cell 399. Some areas of layover may appear 'blurred', but valid elevations exist in these areas.

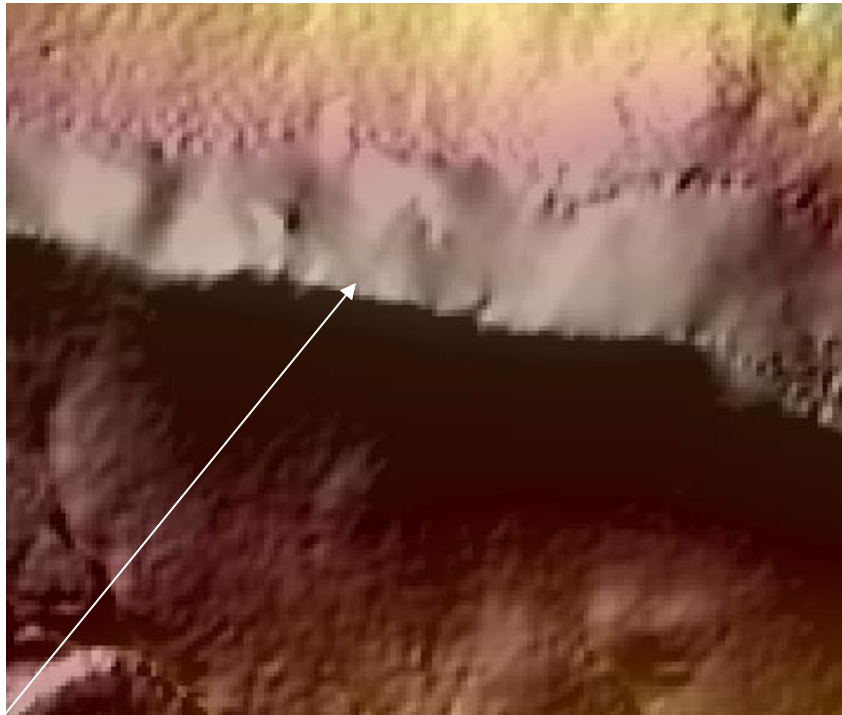
Radar shadow occurs when the radar signal cannot reach a portion of terrain because it is obscured by other parts of the terrain (such as the side of a mountain facing away from the IfSAR sensor). Both layover and shadow can prohibit the mapping of elevation data and result in voids. In an effort to reduce voids, Intermap acquired multiple look angles in areas of steep terrain by flying additional flight lines or swaths. The amount of void areas is well within project specifications with no 15' tile exceeding the 5% void area limit. No cell within Western Aleutians Lot 7 cells had void areas greater than 0.78%. The majority of voids located within the Western Aleutians Lot 7 cells used the NED as the fill source. The interpolation used to fill some void areas cause a loss of definition in the surface. This is expected and generally occurs in areas of very steep terrain, in the $>30^\circ$ slope category. An example is shown below.

Figure 4 - Tiles N5145E17945P and N5145E17930P from cell 416. Loss of surface definition is generally present in areas of steep terrain where interpolation methods were used to fill void areas.

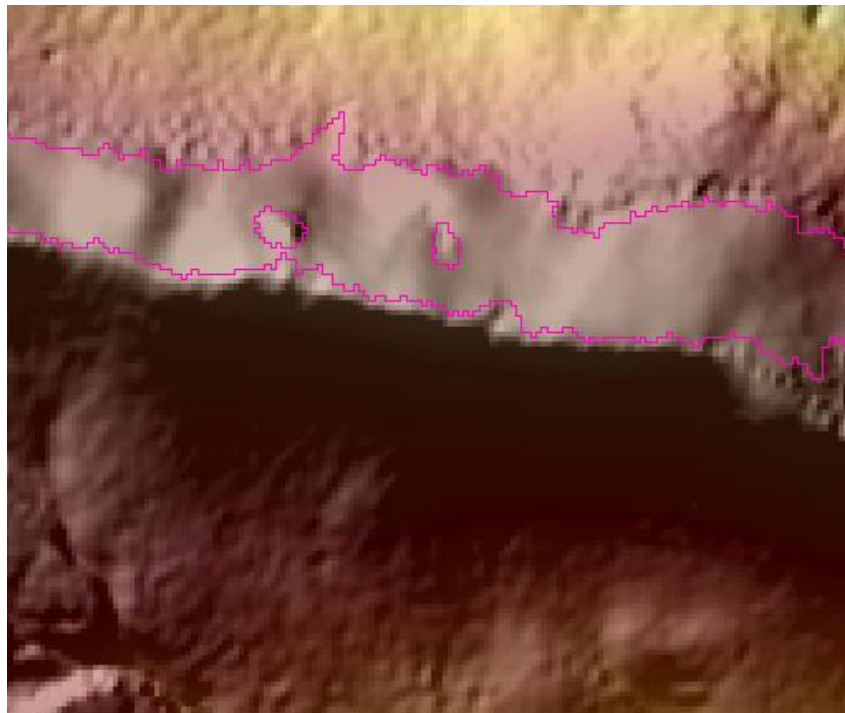
Figure 5 - Tiles N5145E17945P and N5145E17930P from cell 416. Void areas are identified with a void mask (in pink). No individual cell in Western Aleutians Lot 7 cells had void areas greater than 0.78% of the cell area.

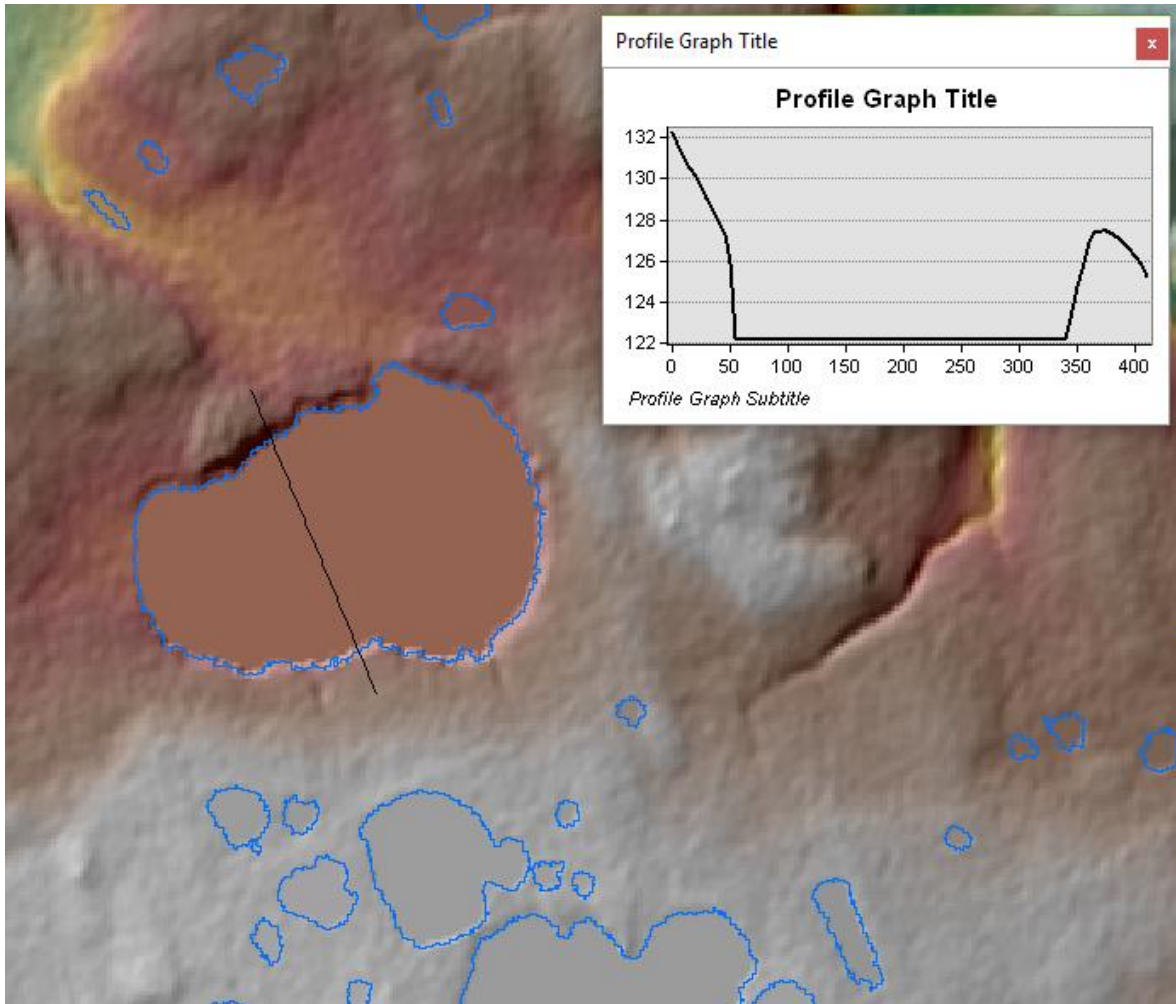
All features that were collected as part of the hydrologic mask have been flattened in both the DTMs and DSMs. All waterbody and linear hydrographic features that are flattened in the DTMs and DSMs are at an elevation that is either just at or below the surrounding terrain. An example is shown below.

Figure 6 - Tiles N5145W17715P and N5145W17730P from cell 419. All features captured as part of the hydrologic mask are flattened in both the DSMs and DTMs.

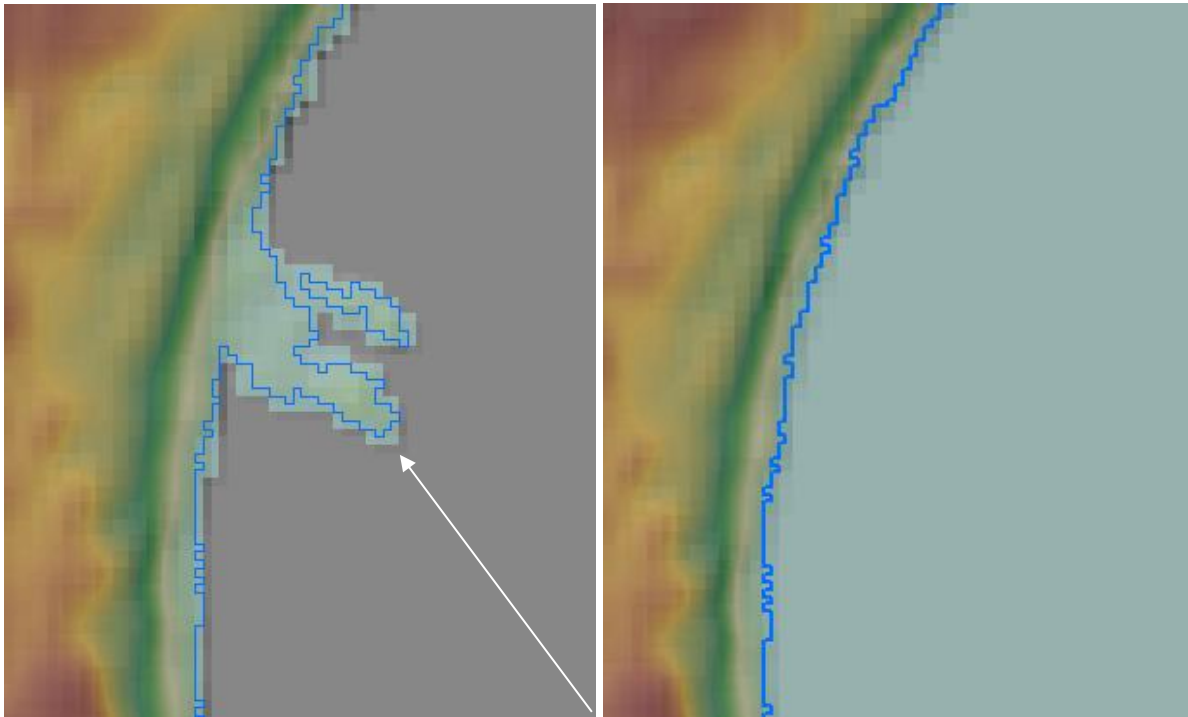
Piers, docks, and bridges should be fully modeled in the DSMs, but hydro-flattened in the DTMs. The hydro mask should match the DTMs to represent all areas hydro-flattened in the DTMs. Seven (7) areas were identified in the first delivery where docks or piers were either not modeled properly in the DSMs or were included in the hydro mask, causing the feature to not be flattened or modeled properly in the corresponding DTM and DSM. The piers were included in the hydro mask (flattened in the DTMs) and modeled properly in the DSMs by Intermap in the second delivery. Examples are shown below.

Figure 7 - Tiles N5245E17315P and N5245E17300P from cell 399. The DTM from the first delivery is shown on the left while the corrected DTM from the second delivery is shown on the right. Intermap hydro-flattened these piers/docks in the DTM and updated the hydro mask (blue) to reflect areas of the DTM that were hydro-flattened.

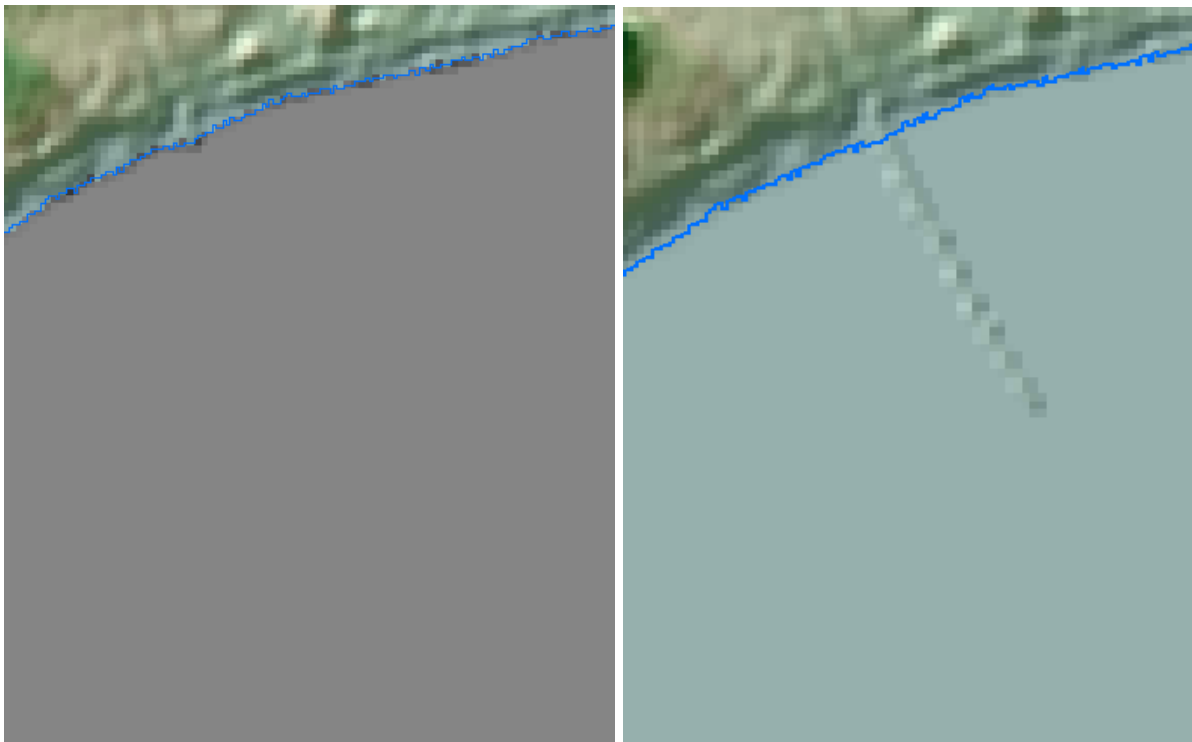
Figure 8 - Tile N5145E17730P from cell 414. The DSM from the first delivery is shown on the left while the corrected DSM from the second delivery is shown on the right. Several piers/docks in the first delivery were properly hydro-flattened in the DTMs, however, they were not modeled in the DSMs. Intermap addressed these piers/docks in the second delivery.

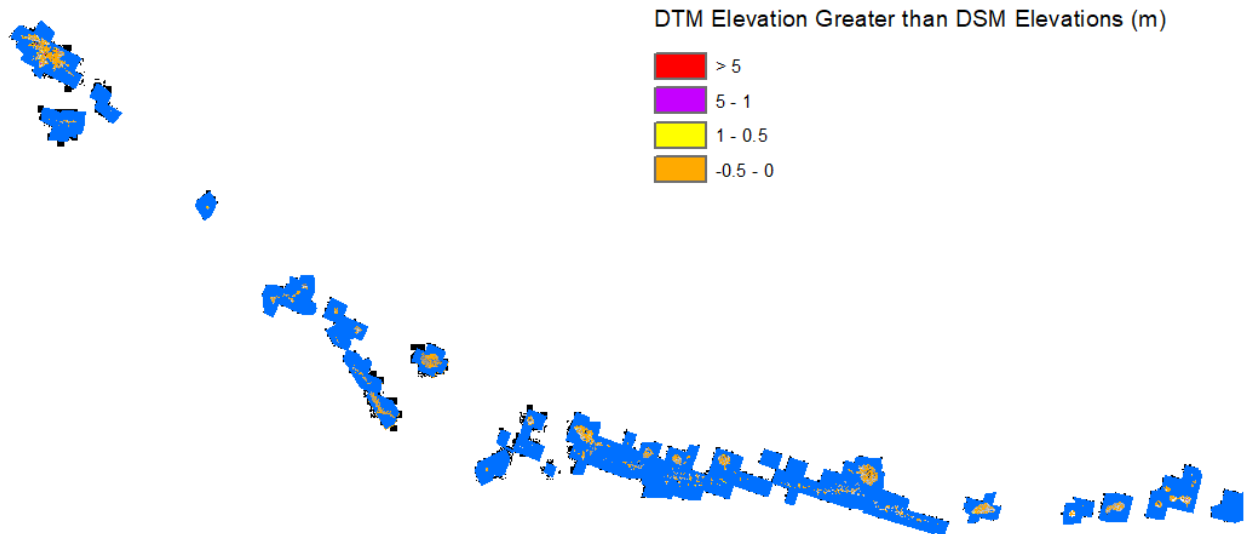
For the Western Aleutians Lot 7 (393, 394, 398, 399, 400, 401, 402, 403, 404, 405, 406, 407, 408, 409, 410, 411, 412, 414, 415, 416, 417, 418, 419, 420, and 421), Dewberry subtracted the DTM surface from the DSM surface. There are locations across the cells where DTM elevations are slightly higher than the DSM elevations. However, the overwhelming majority of locations where the DTM is higher than the DSM have differences less than 50 cm (see image below). Additionally, while speckled throughout the cells, the areas of higher DTM elevations are not contiguous and represent Intermap’s explanation of undulating radar noise. The few locations where DTM elevations are higher than DSM elevations by more than 50 cm generally occur in

very steep terrain, in interpolated areas identified by the void mask, and along steep hydrographic embankments.

Figure 9 - DSM/DTM difference raster for Western Aleutians Lot 7 cells 393, 394, 398, 399, 400, 401, 402, 403, 404, 405, 406, 407, 408, 409, 410, 411, 412, 414, 415, 416, 417, 418, 419, 420, and 421 is overlaid on ORIs, showing locations where the DTM elevations are higher than DSM elevations at the same xy location (5 m raster pixel). There are locations speckled throughout these cells where DTM elevations are higher than DSM elevations; this is a known and expected phenomenon with this IfSAR technology. The vast majority of areas where the DTM is higher in elevation than the DSM are by 50 cm or less.

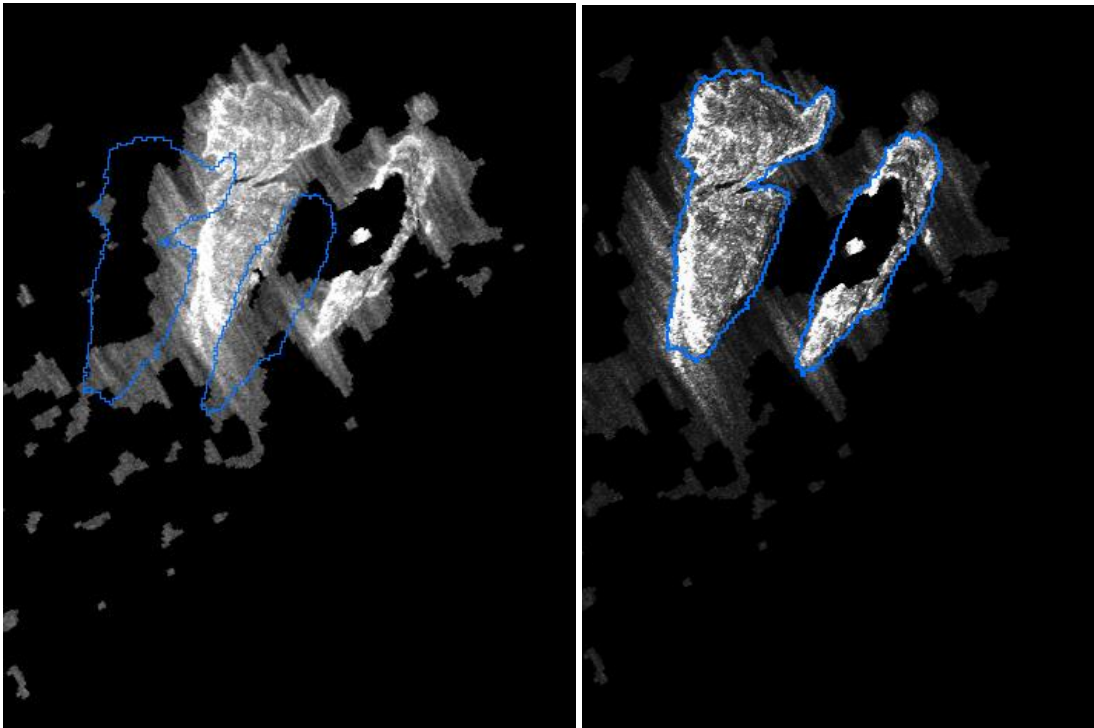
One (1) issue was identified in the first delivery where the ORI appeared shifted relative to the hydro mask. Intermap reviewed the area and determined that the shift was caused by an error in the ORI data. The affected ORIs were reprocessed for the second delivery and the shift was corrected. An example is shown below.

Figure 10 – Tiles N5130E17845P and N5130E17830P from cell 415. The ORI from the first delivery appeared shifted relative to the hydro mask (left image). This area was reviewed by Intermap and reprocessed to correct the shift for the second delivery.

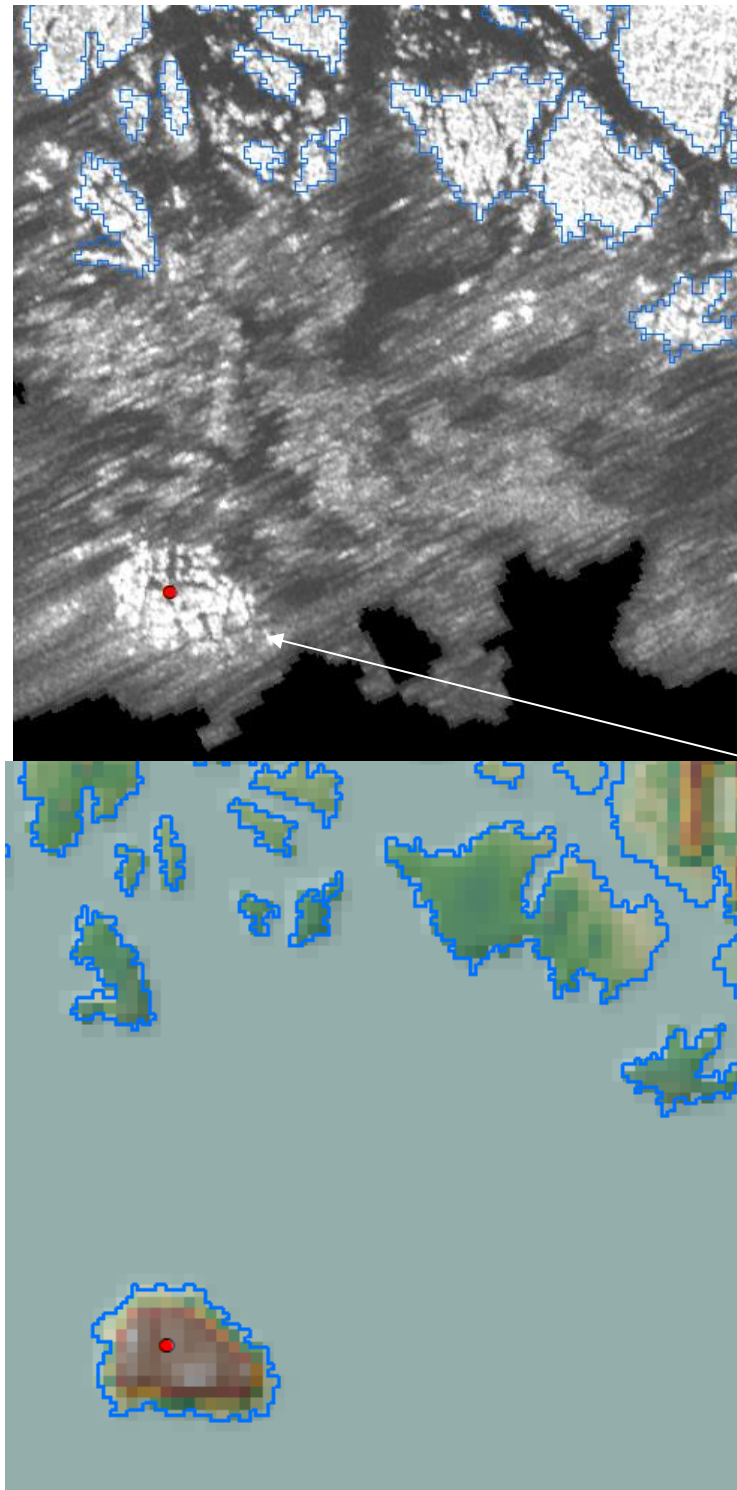
Twenty-four (24) areas were identified in the first delivery that required further investigation by Intermap to determine if valid land features were included in the hydro mask and flattened in the DTMs/DSMs. An example is shown below.

Figure 11 – Tile N5115w17915P from cell 417. Valid land features were included in the hydro mask and flattened in the DTMs/DSM in the first delivery (top image). Intermap excluded these land features from the hydro mask and modeled them properly in the DTM and DSM in the second delivery (bottom image).

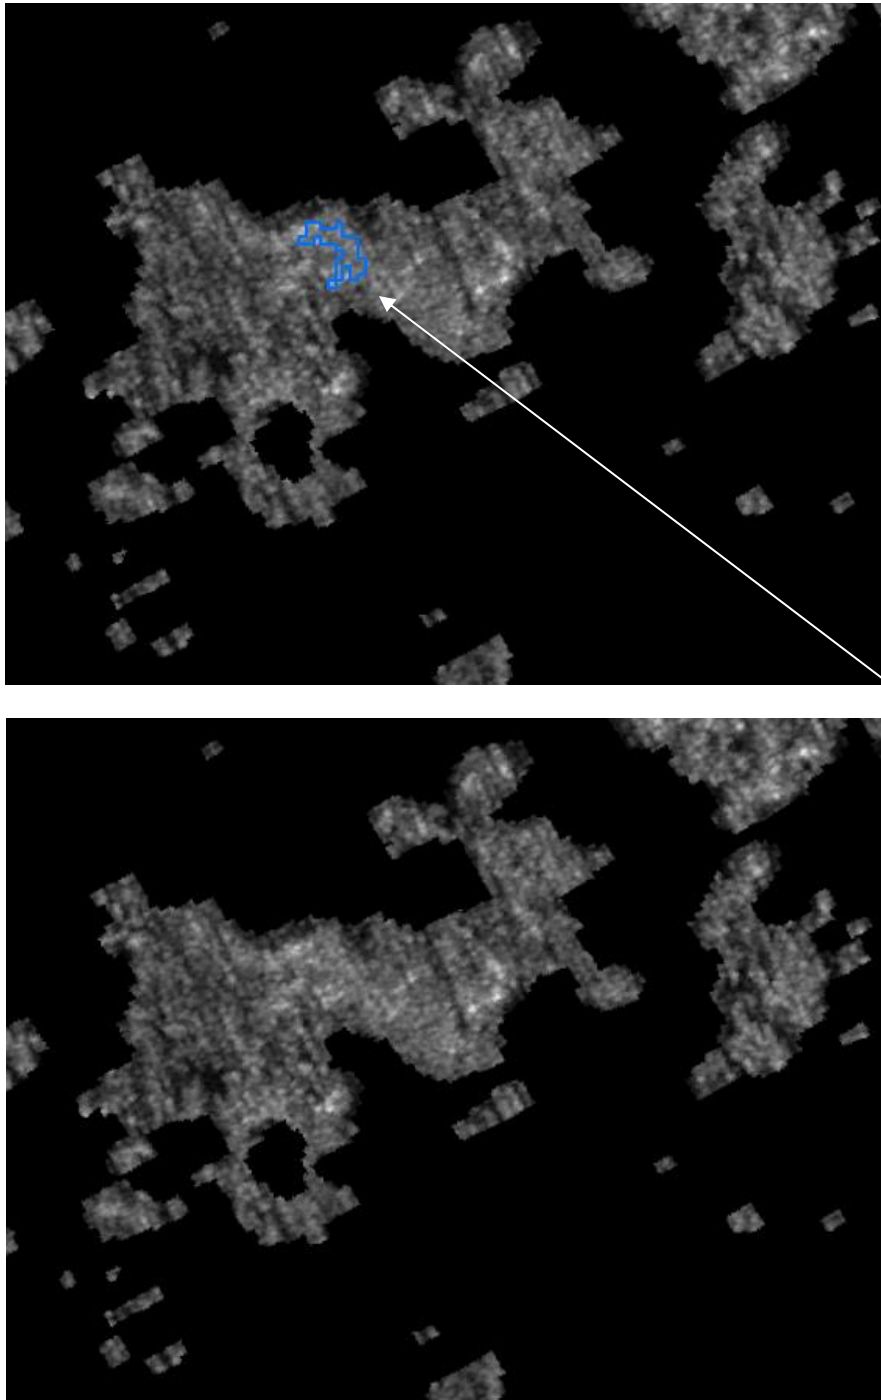
Four (4) issues were identified where small islands collected in the hydro mask required further verification. These features show no valid land in the corresponding ORIs. Intermap reviewed the features and found no valid land. The hydro mask, DTMs, and DSMs were adjusted in the second delivery to address the small polygons. An example is shown below.

Figure 12 – Tiles N5115E17915P and N5115E17900P from cell 416. In the first delivery, small islands were collected in the hydro mask that required further verification to determine if there was valid

land in these locations (top image). Intermap determined the small islands were not valid and the hydro mask was adjusted in the second delivery (bottom image).
