CHECK POINT DOCUMENTATION REPORT

Date: <u>11-18-19</u>	Time: <u>8:50</u> ⊠ a.m. □	p.m. Employee Name:	Ryan Daniel	
Job Name: <u>Florida Peninsula</u>	r Lidar	Point ID:	NVA_29_AP	
State: FL Latitud	le: <u>30° 20' 27.55293" N</u>	⊠ + □ – Longit	ude: <u>83° 02′ 46.81594″</u>	+ 🛛 –

Address and/or Intersection: 60th St. and 147th Rd intersection. Live Oak, FL

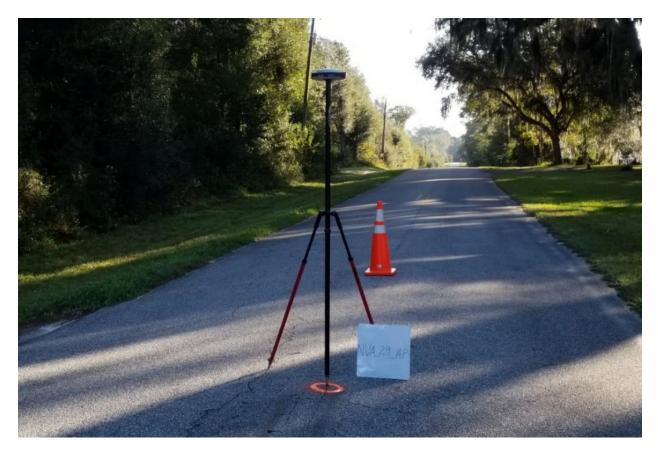
Description of Point: <u>Set PK nail in centerline of 60th St. about 0.3 miles</u> East of 60th St. and 147th Rd. intersection Sketch or Image of Area
