# **Dewberry** GROUND CONTROL POINT DOCUMENTATION REPORT

Date: <u>12/27/18</u>	Time: 11:55	_⊠ a.m. □ p.m. Employee Name: <u>Andrew Strickland</u>	
Job Name: <u>Florida Pe</u>	eninsular LiDAR	Point ID: (GCP QSI 36) 60027	
State: FL	Latitude: 30°21'46.43311"N	⊠ + □ – Longitude: <u>81°23'54.33146"</u> W	+⊠ –

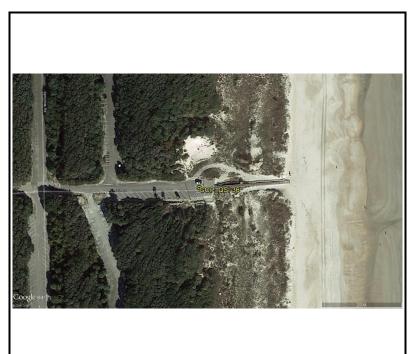
Picture(s) of Area & Setup

Address and/or Intersection: <u>35<sup>th</sup> Street in Kathryn Abbey Hanna Park near boardwalk to beach</u>

SET LG Mag N&D "TRAV PT LB 8011" in the PI of stripping
