# Leica Geosystems Leica TerrainMapper-LN Calibration Certificate

<b>Product</b>	Leica TerrainMapper-LN
<b>Serial Number</b>	91511
<b>Date</b>	03 July 2019
<b>Inspector</b>	Mark O'Neal

<b>Product</b>	Leica TerrainMapper-LN
<b>Serial Number</b>	91513
<b>Date</b>	25 February 2019
<b>Inspector</b>	Xu Wang

<b>Product</b>	Leica TerrainMapper-LN
<b>Serial Number</b>	91515
<b>Date</b>	27 June 2019
<b>Inspector</b>	Mark O'Neal

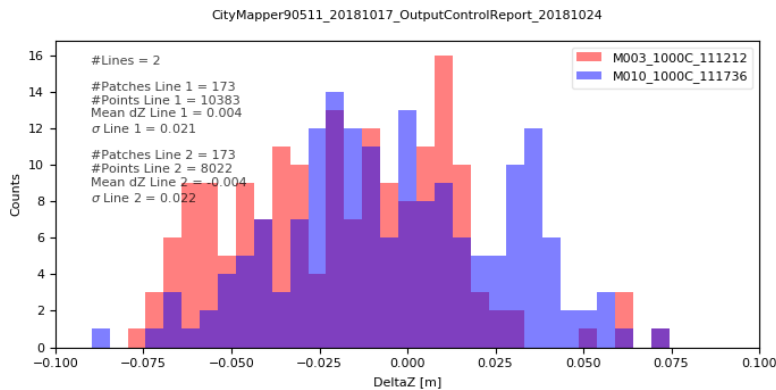
Figure 1 Vertical distance to ground control points at 1000 m AGL.

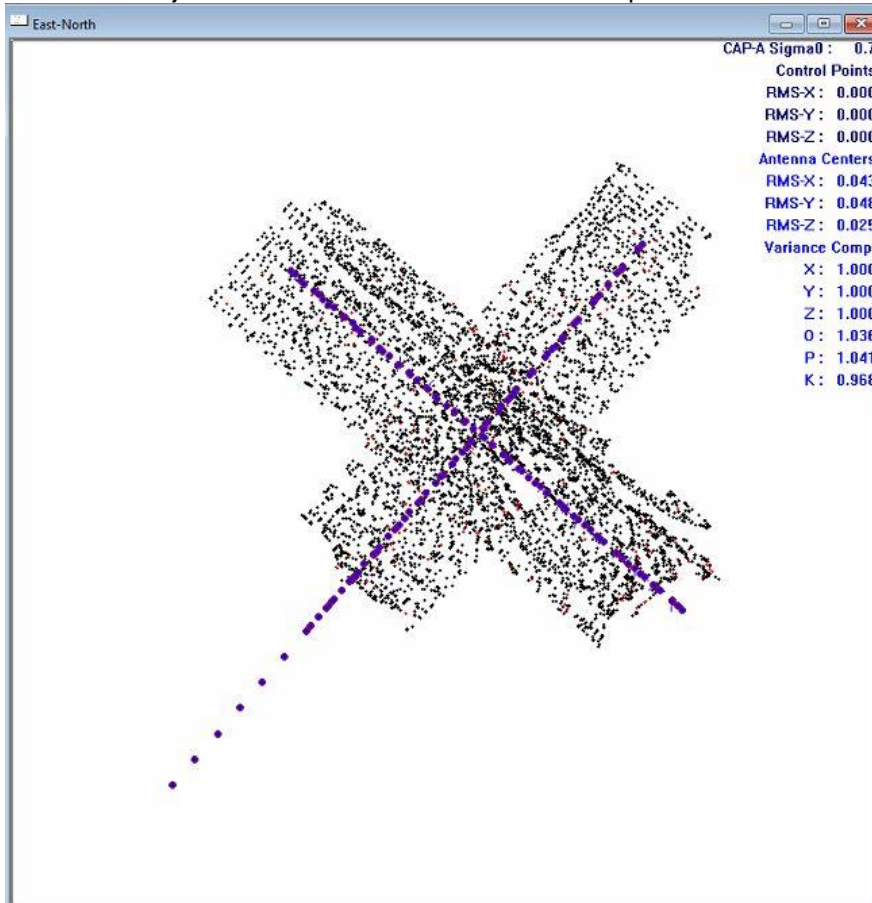
Resulting sigma naught of bundle adjustment:

0.0007

Final bundle adjustment results after elimination of tie point blunders:

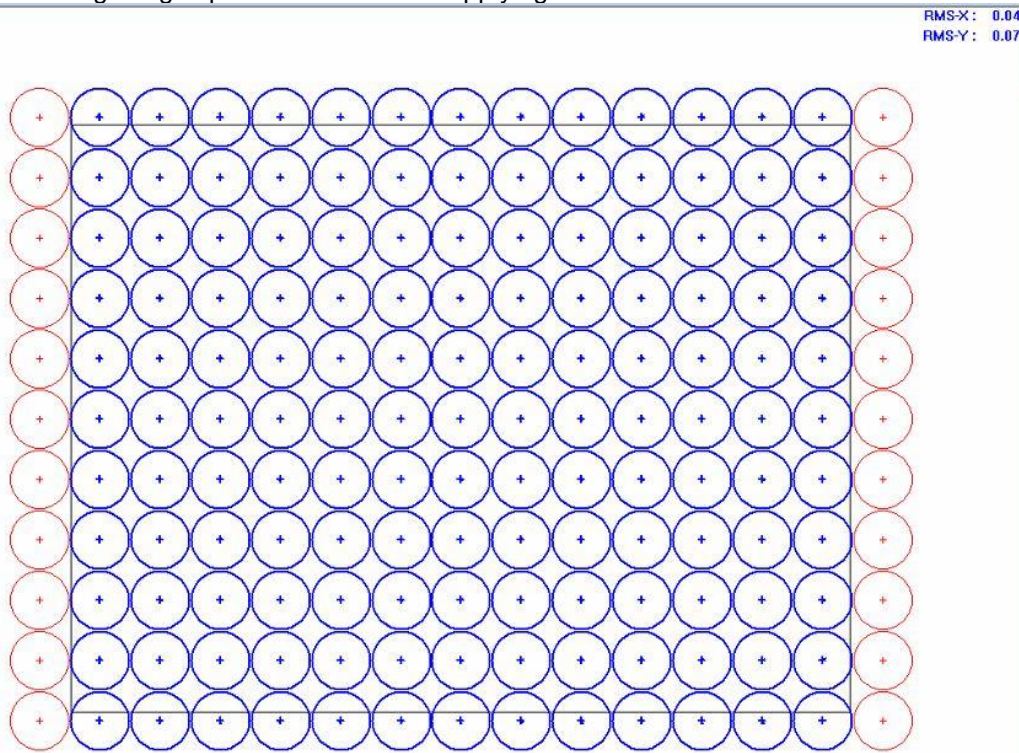
Remaining image space residuals after applying the calibration results

Radius of circles is 0.0007 mm

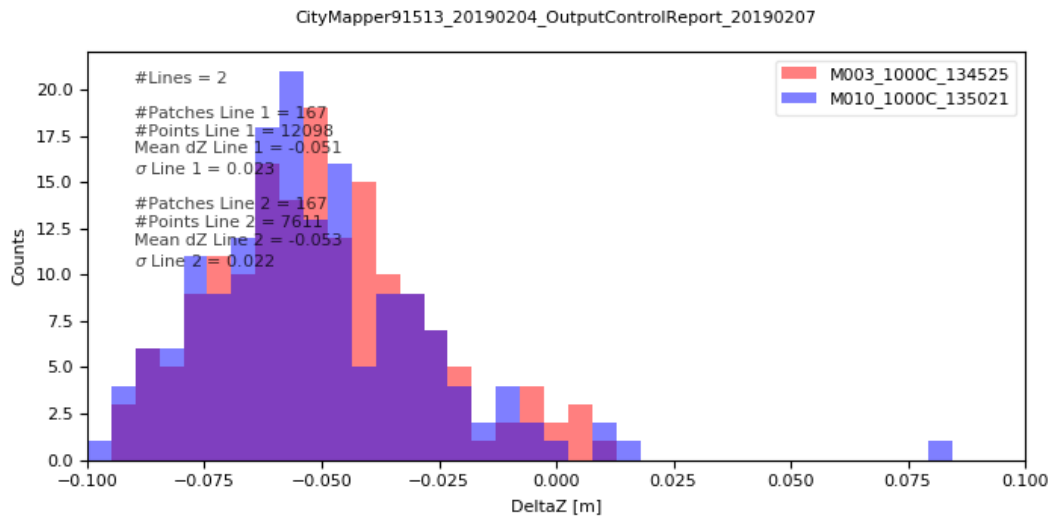
Figure 1 Vertical distance to ground control points at 1000 m AGL.

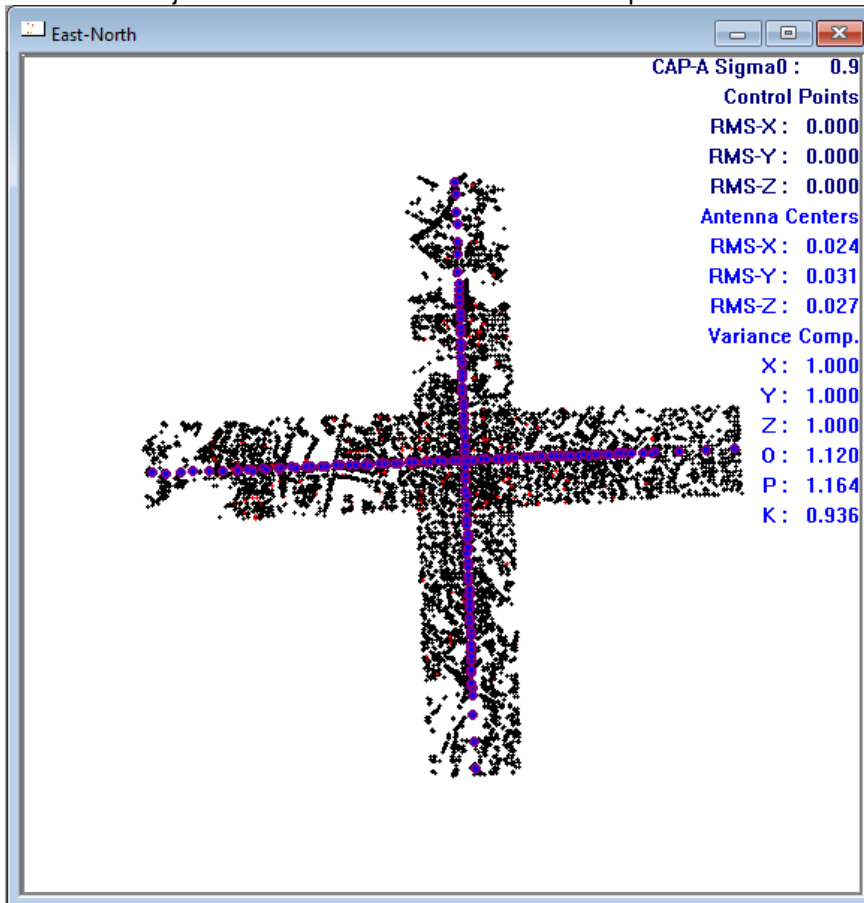
Resulting sigma naught of bundle adjustment:

0.0010

Final bundle adjustment results after elimination of tie point blunders:

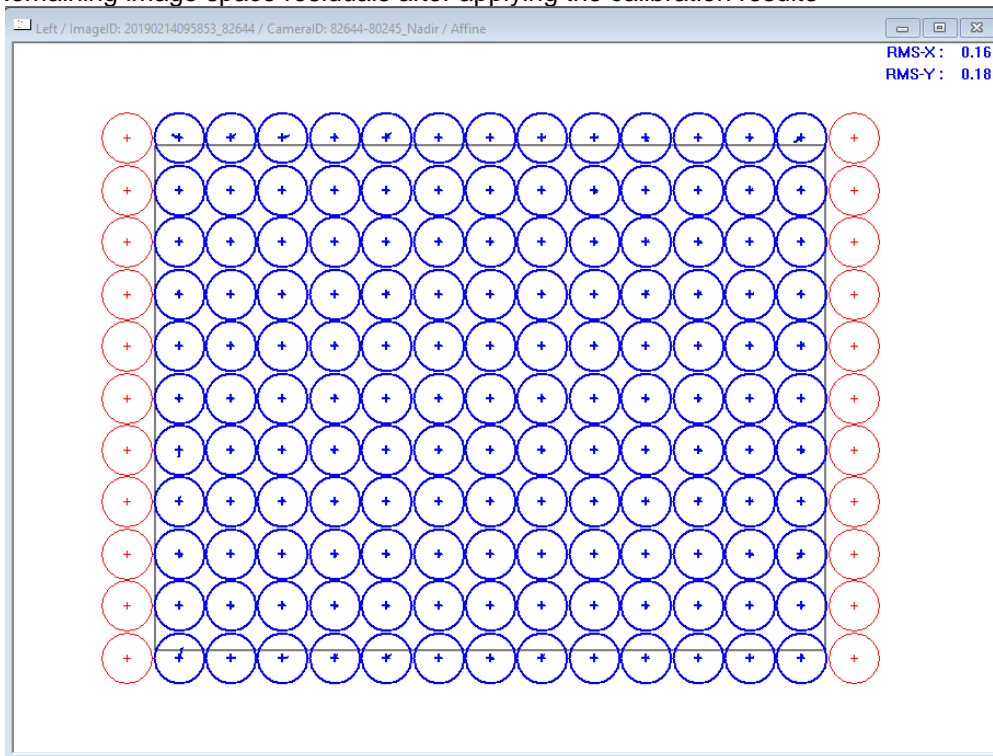
Remaining image space residuals after applying the calibration results

Radius of circles is 0.0010 mm

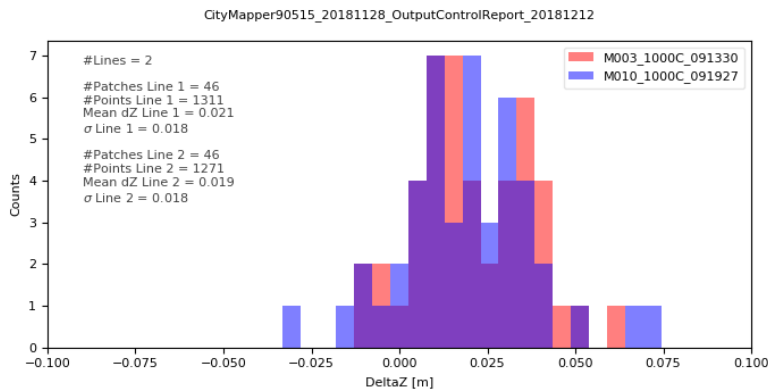
Figure 1 Vertical distance to ground control points at 1000 m AGL.

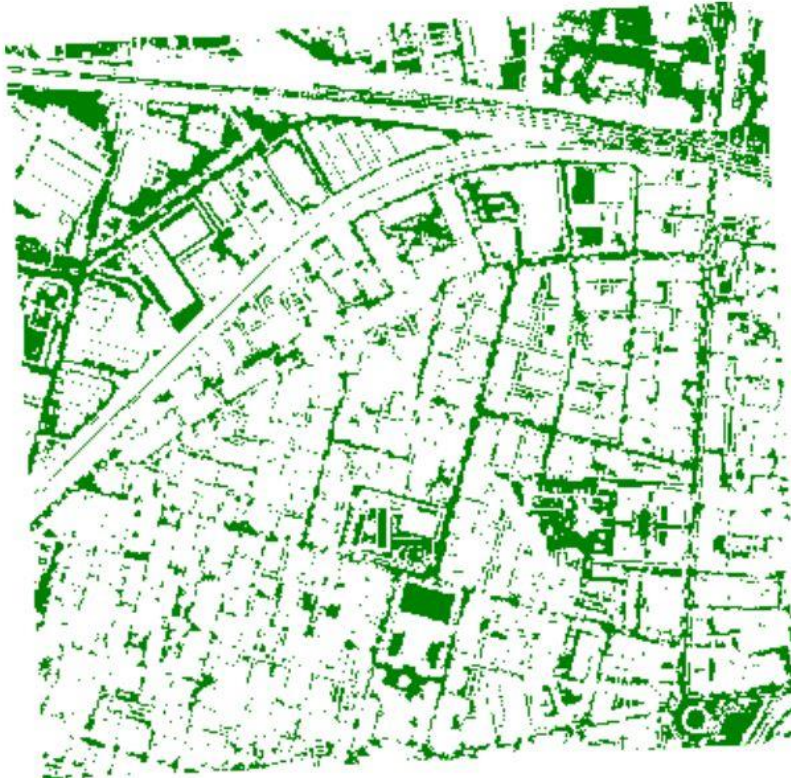
29588 valid patches with size of 2 m found. Only patches with standard deviation < 0.05 m and minimum of 5 points are included.

Color	Limits [m]	Number of patches	Proportion of total number of patches [%]
Dark Green	<=0.04	29546	99.86
Bright Green	0.04-0.07	38	0.13
Yellow	0.07-0.1	1	0.00
Red	>0.1	3	0.01

Figure 3 Vertical difference between two perpendicular lines at 1000 m AGL.

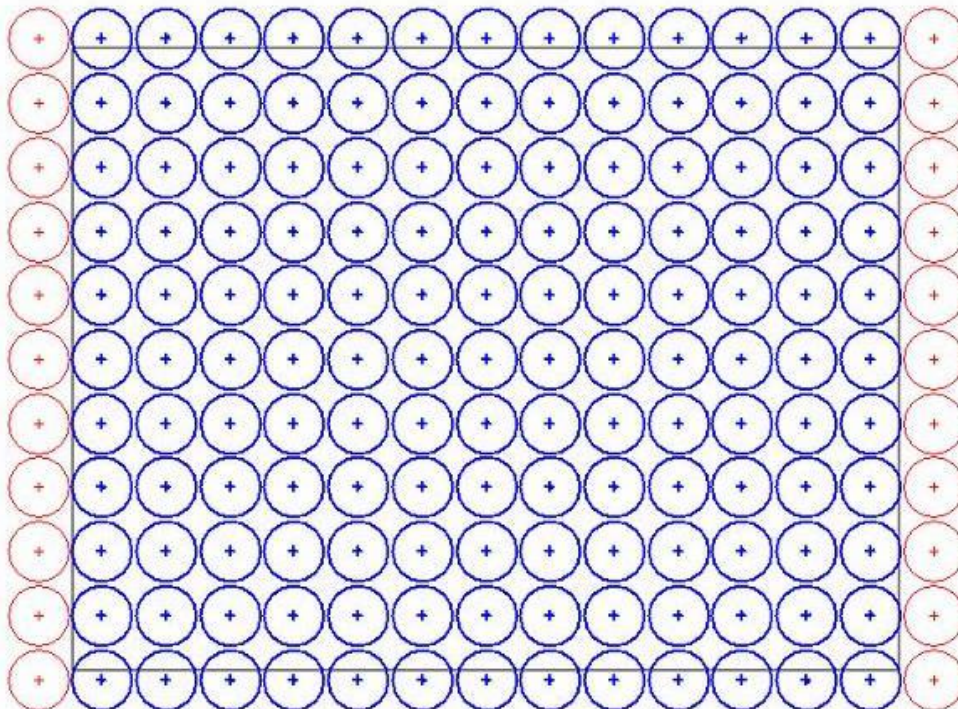
Remaining image space residuals after applying the calibration results

RMS-X: 0.06  
RMS-Y: 0.06

Radius of circles is 0.0007 mm
