# Leica Geosystems Leica TerrainMapper-LN Calibration Certificate

<b>Product</b>	Leica TerrainMapper-LN
<b>Serial Number</b>	91511
<b>Date</b>	03 July 2019
<b>Inspector</b>	Mark O'Neal

<b>Product</b>	Leica TerrainMapper-LN
<b>Serial Number</b>	91513
<b>Date</b>	25 February 2019
<b>Inspector</b>	Xu Wang

<b>Product</b>	Leica TerrainMapper-LN
<b>Serial Number</b>	91515
<b>Date</b>	27 June 2019
<b>Inspector</b>	Mark O'Neal

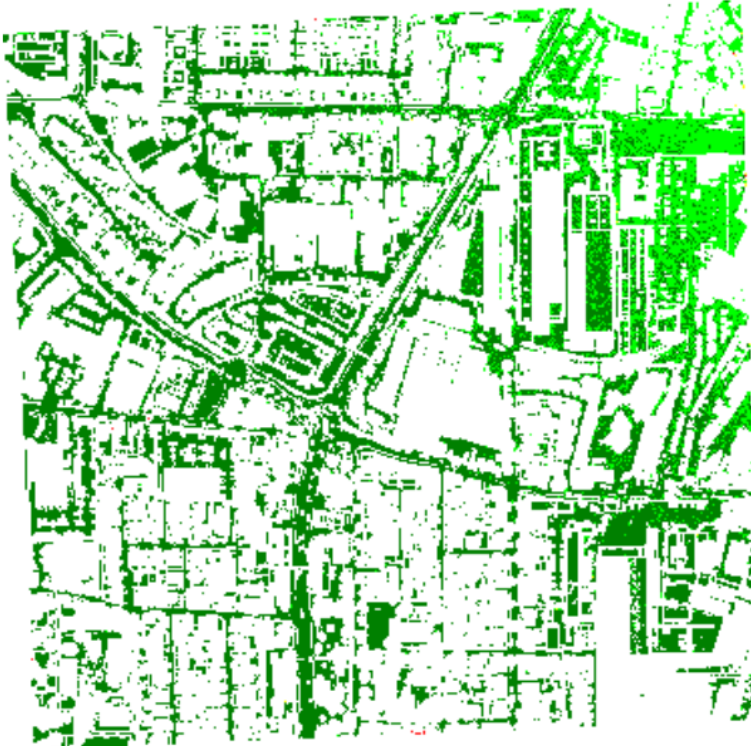
39940 valid patches with size of 2 m found. Only patches with standard deviation < 0.05 m and minimum of 5 points are included.

Color	Limits [m]	Number of patches	Proportion of total number of patches [%]
Dark Green	<=0.04	32066	80.29
Light Green	0.04-0.07	7841	19.63
Yellow	0.07-0.1	21	0.05
Red	>0.1	12	0.03

Figure 3 Vertical difference between two perpendicular lines at 1000 m AGL.

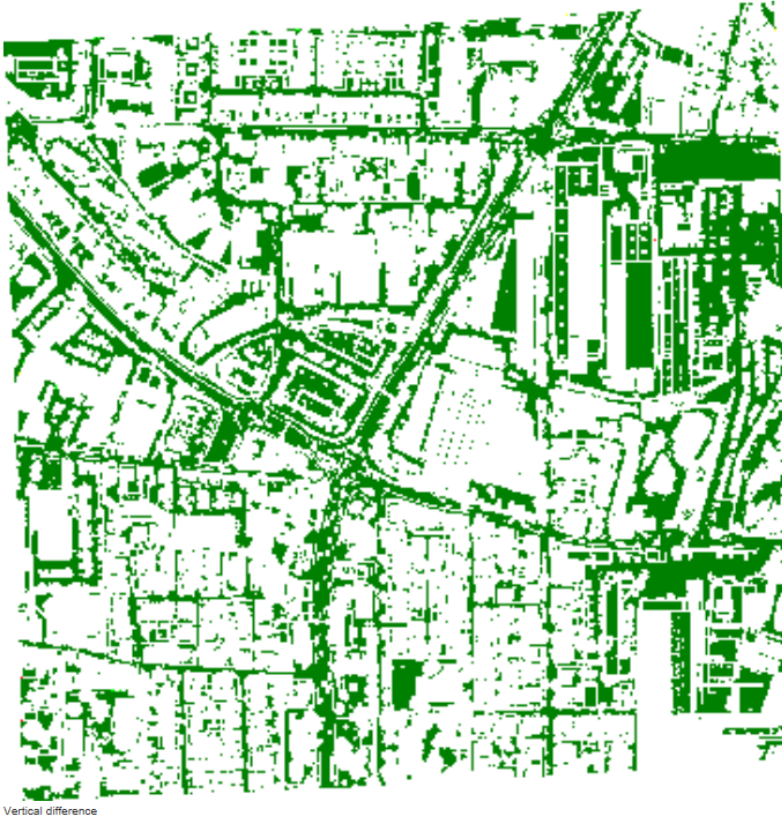
41041 valid patches with size of 2 m found. Only patches with standard deviation < 0.05 m and minimum of 5 points are included.

Color	Limits [m]	Number of patches	Proportion of total number of patches [%]
Dark Green	<=0.04	41014	99.93
Light Green	0.04-0.07	20	0.05
Yellow	0.07-0.1	4	0.01
Red	>0.1	3	0.01

Figure 3 Vertical difference between two perpendicular lines at 1000 m AGL.

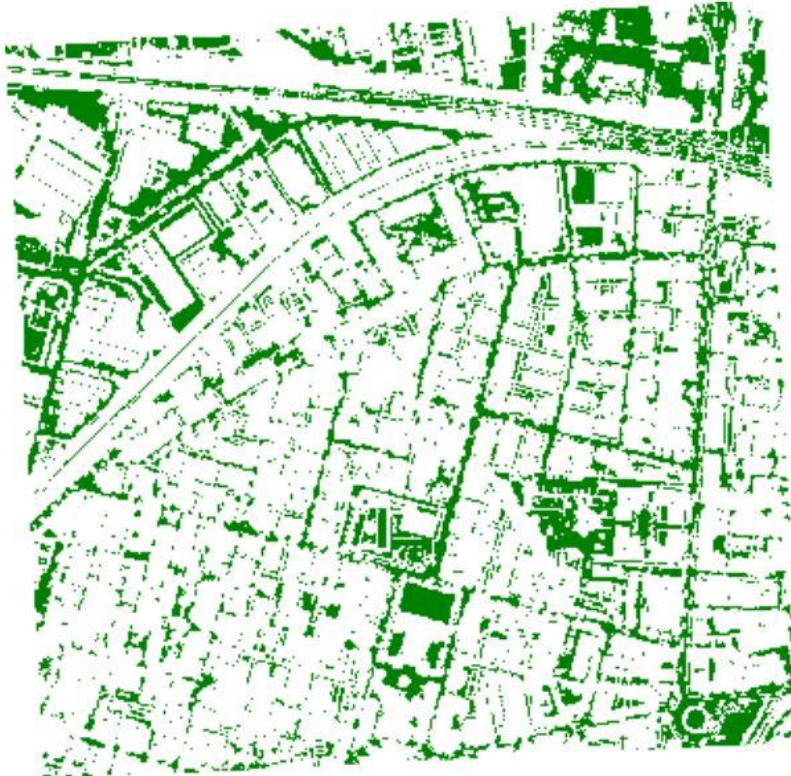
29588 valid patches with size of 2 m found. Only patches with standard deviation < 0.05 m and minimum of 5 points are included.

Color	Limits [m]	Number of patches	Proportion of total number of patches [%]
Dark Green	<=0.04	29546	99.86
Bright Green	0.04-0.07	38	0.13
Yellow	0.07-0.1	1	0.00
Red	>0.1	3	0.01

Figure 3 Vertical difference between two perpendicular lines at 1000 m AGL.

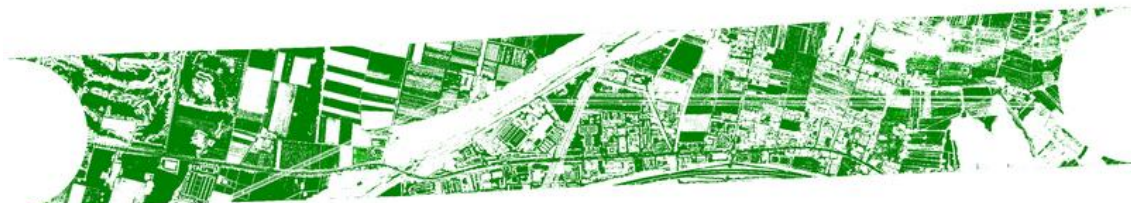
377750 valid patches with size of 2 m found. Only patches with standard deviation < 0.05 m and minimum of 5 points are included.

Color	Limits [m]	Number of patches	Proportion of total number of patches [%]
Dark Green	$\leq 0.04$	372019	98.48
Bright Green	0.04-0.07	5529	1.46
Yellow	0.07-0.1	169	0.04
Red	$> 0.1$	33	0.01

Figure 2 Vertical difference between forward and backward scan at 1000 m AGL.
