## LiDAR Quality Assessment Report

KS\_Area3-Lot4-ButlerCo\_2012

KS\_25 COUNTIES LIDAR #1

January 13-April 17, 2012

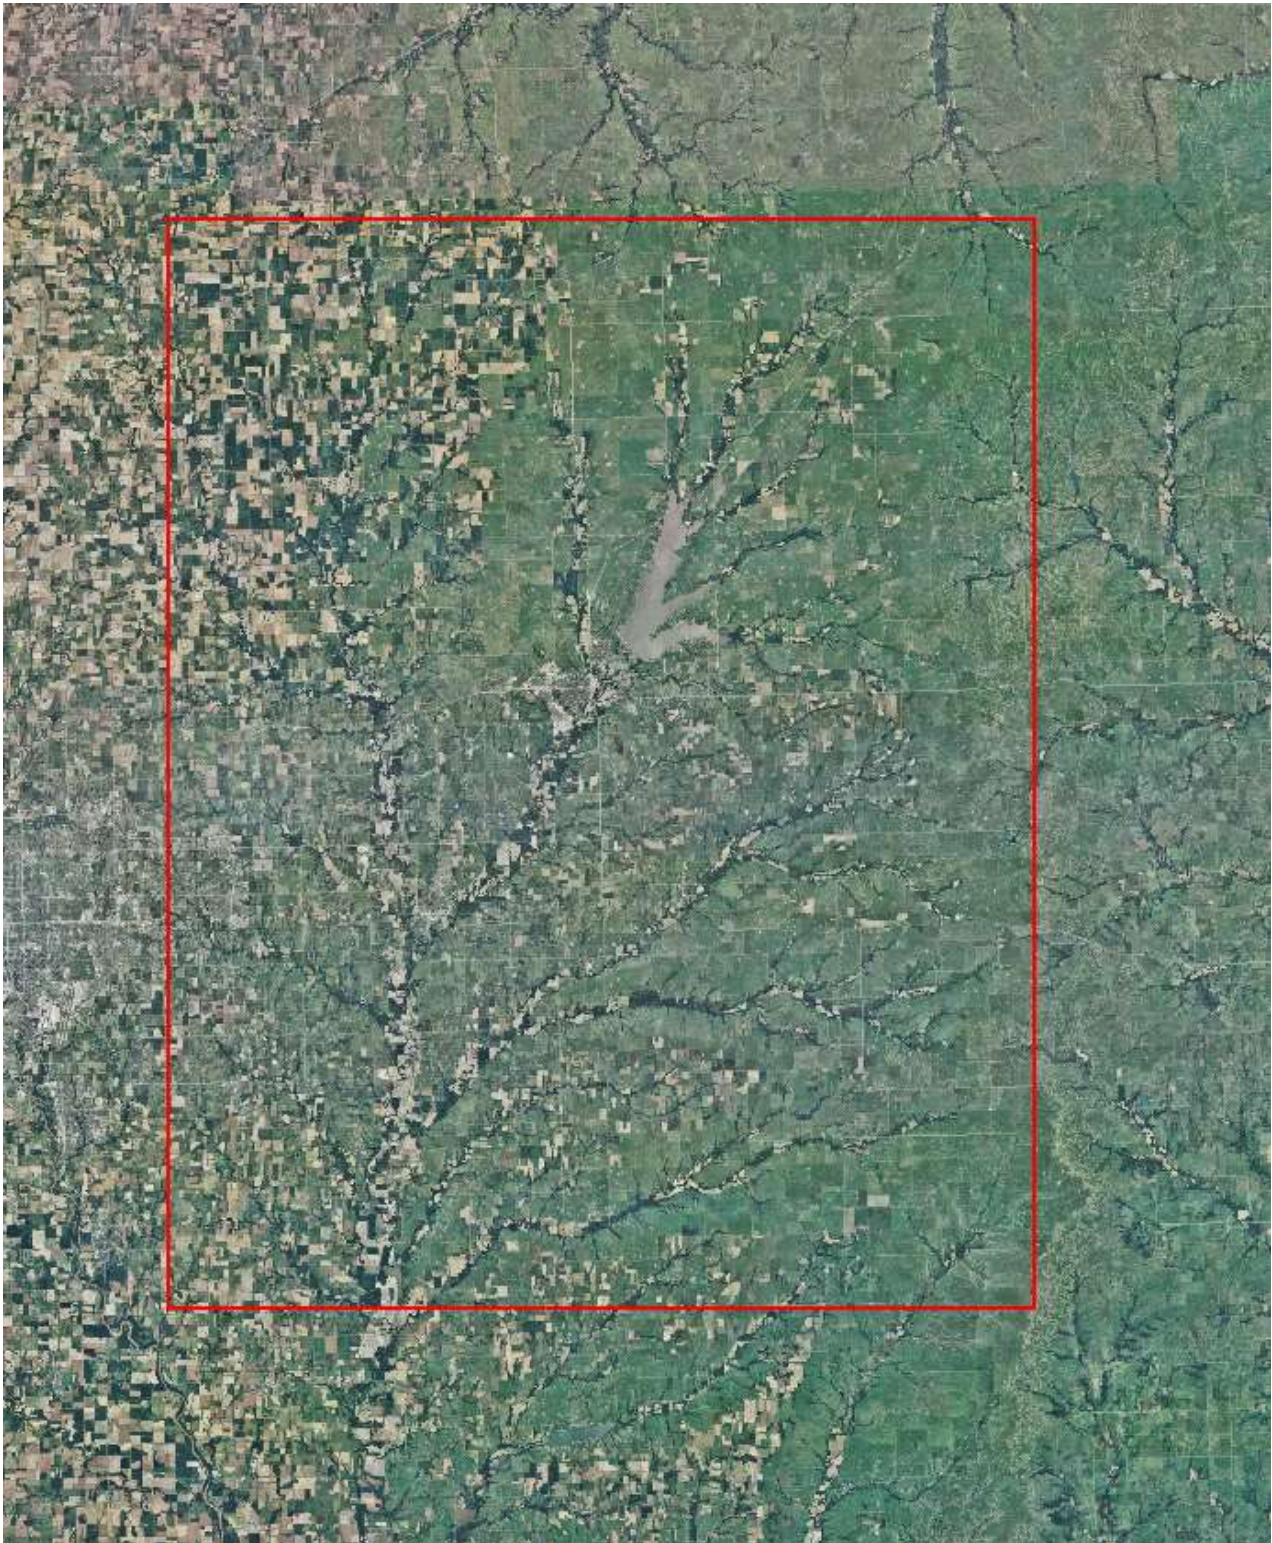
Project Extent image?

The project is 3 areas consisting of 5 lots: Area 1 as one lot, Area 2 as one lot and Area 3 as four lots. Area 3 Kansas will consist of the Northeast area (in two lots) including Brown, Doniphan, Jackson, Leavenworth, Nemaha, Pottawatomie, Webaunsee, and Wyandotte counties; the Southeast including Cherokee, Crawford, Linn and Bourbon counties; and Butler County. Areas were defined and supplied by Kansas Department of Administration and includes approximately 9700 square miles for analysis. This report covers Butler Co. Lot 4 which is 1737.5 sq. miles.

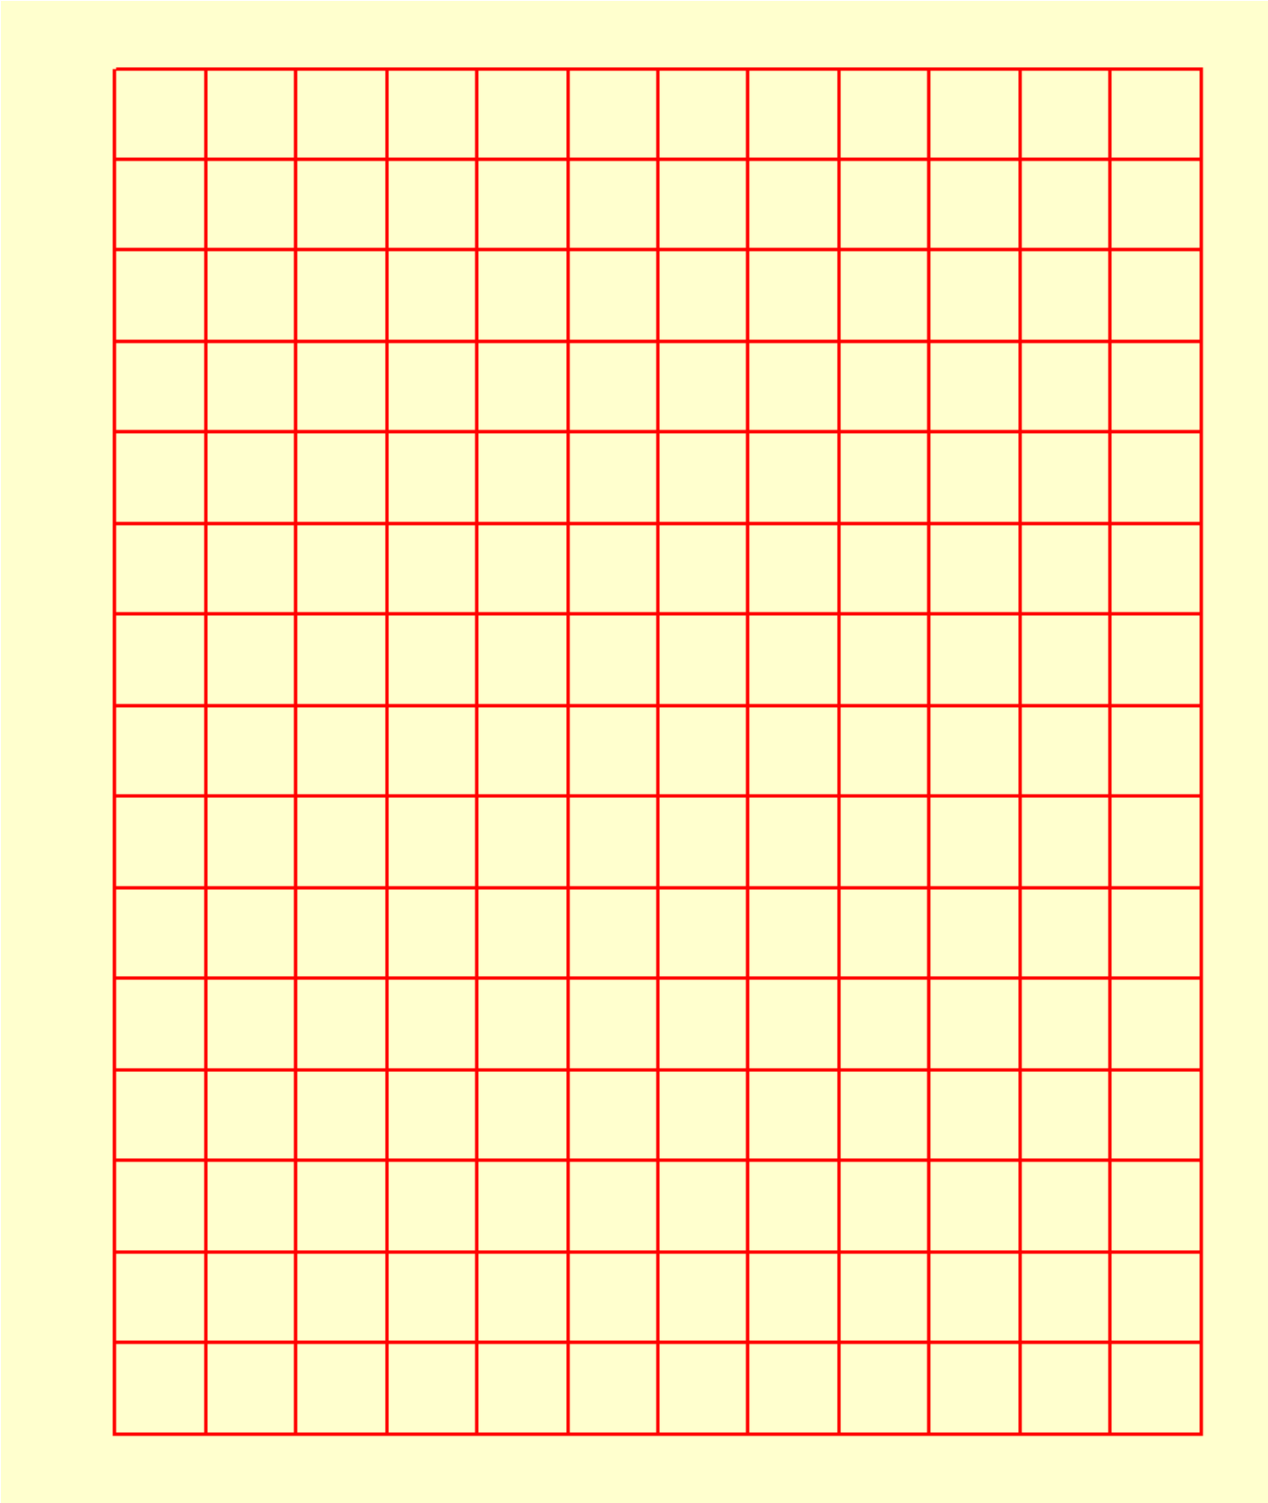
Project Tiling Scheme image?

5000 x 5000

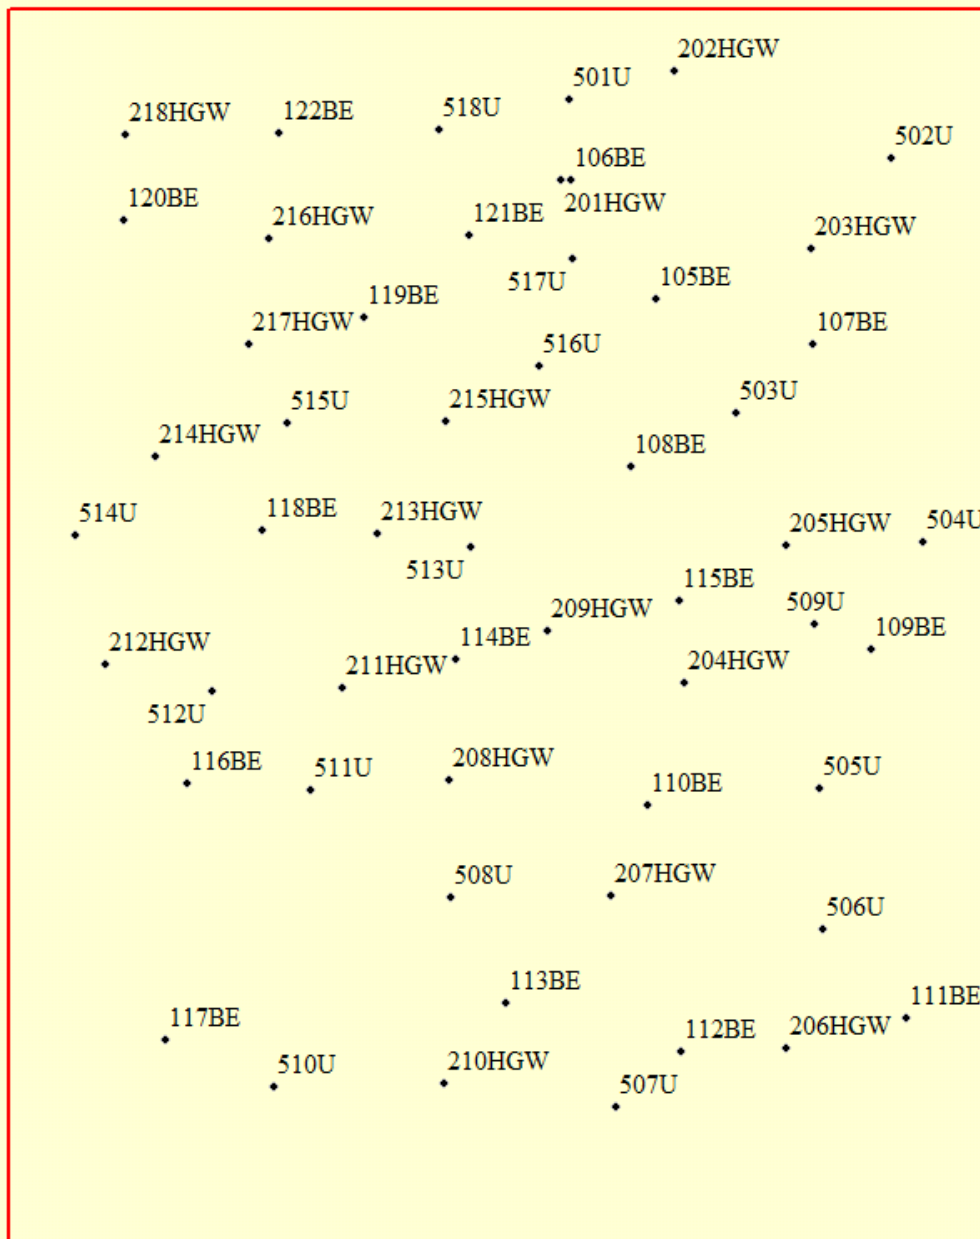
- Checkpoint Distribution Image?

There are a minimum of 20 checkpoints for each land cover class represented. Points within each class are uniformly distributed throughout the dataset. USGS was not able to locate independent checkpoints for this analysis. USGS does not accept at this time the quality of the checkpoint data for these LiDAR datasets.

Independent/Blind check points are not listed as a deliverable to NGTOC.
