LiDAR Quality Assessment Report

SD_Missouri River Lidar Dewberry_2016_D16 - Block 4

NGTOC
2018-06-13
Sarah Klaas

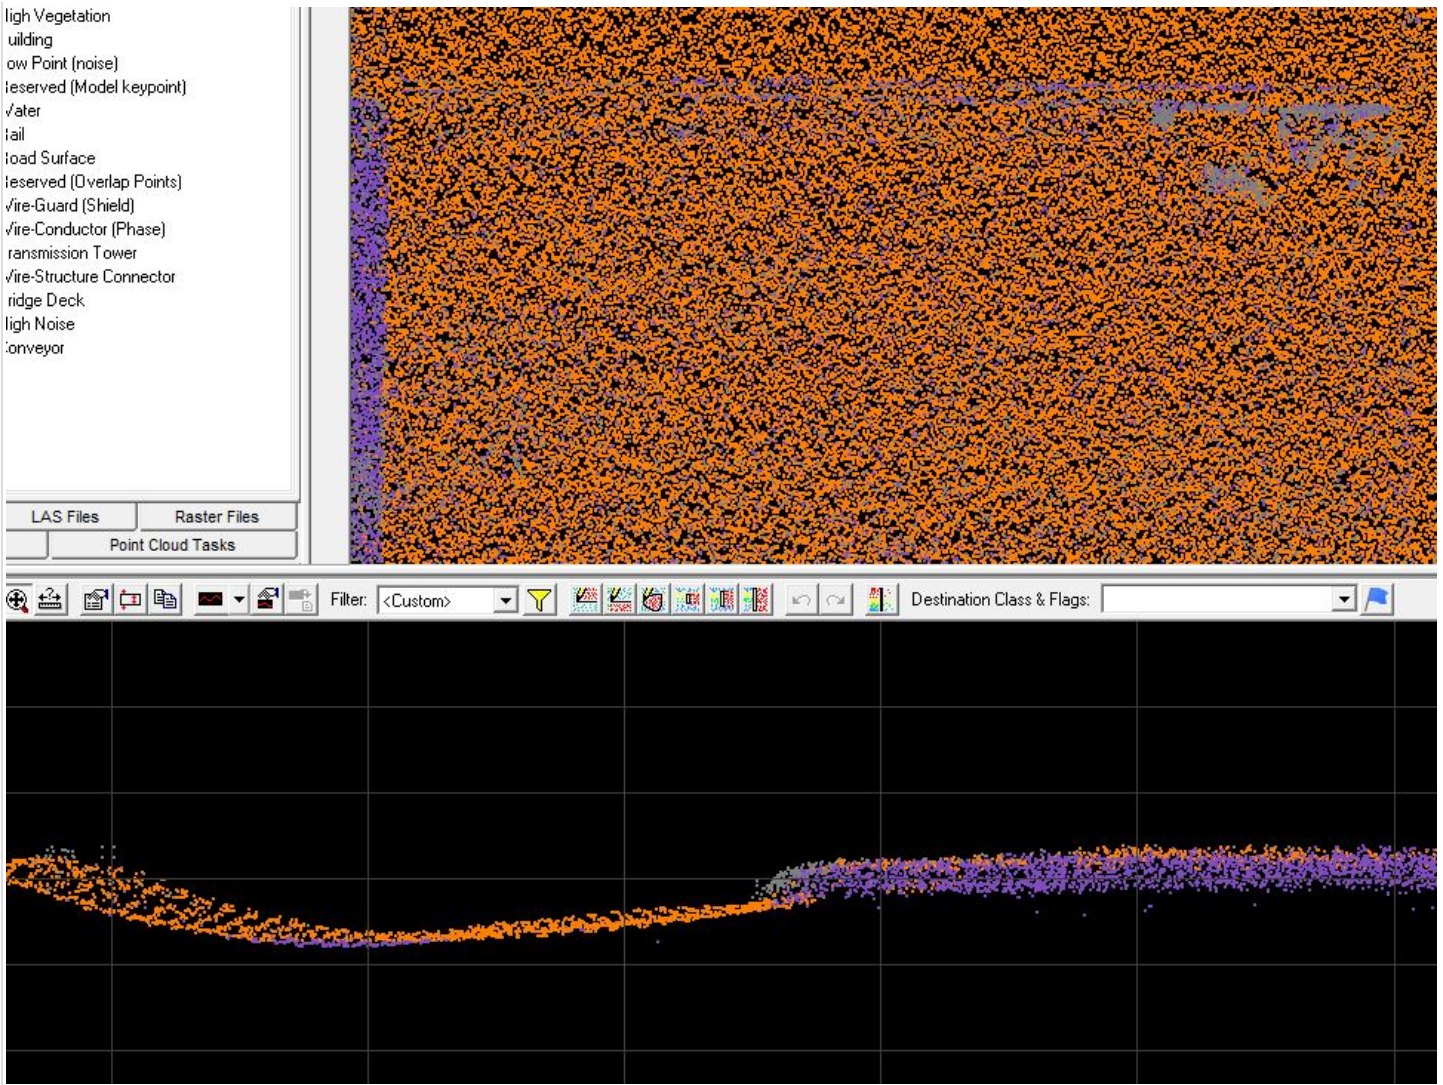
Possible classification issue: ground and low noise points in areas where there could be vegetation in fields. It is not certain that the ground points are actual ground. (6/13/2018)

Not Corrected (9/20/2018)

Based on this review, the USGS does not accept classified/tiled LiDAR data.

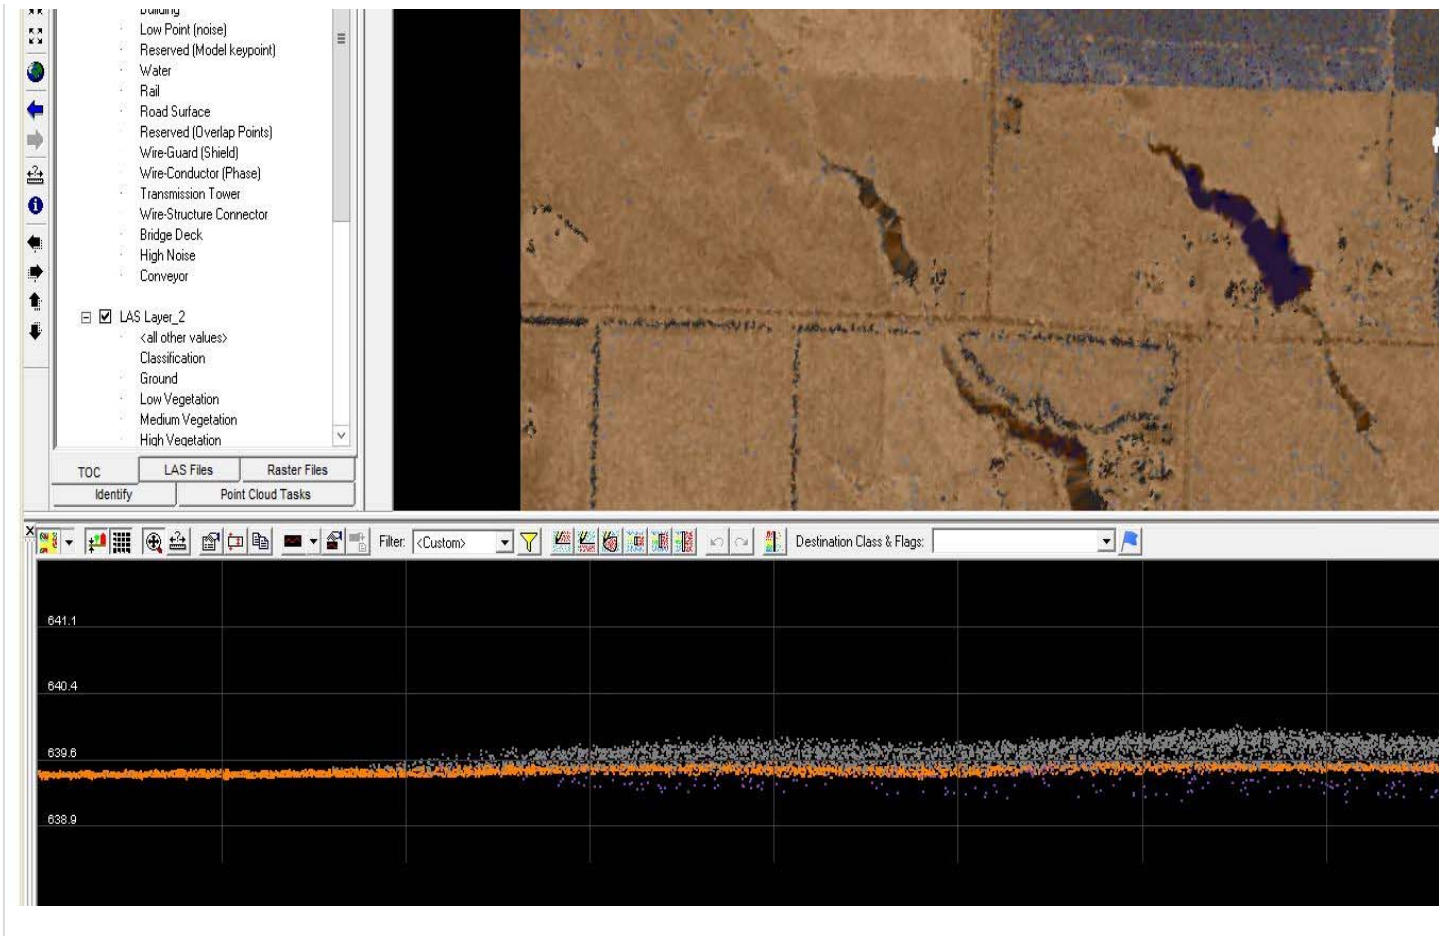
Example of a similar area in another block where the classification of the ground points looks correct.

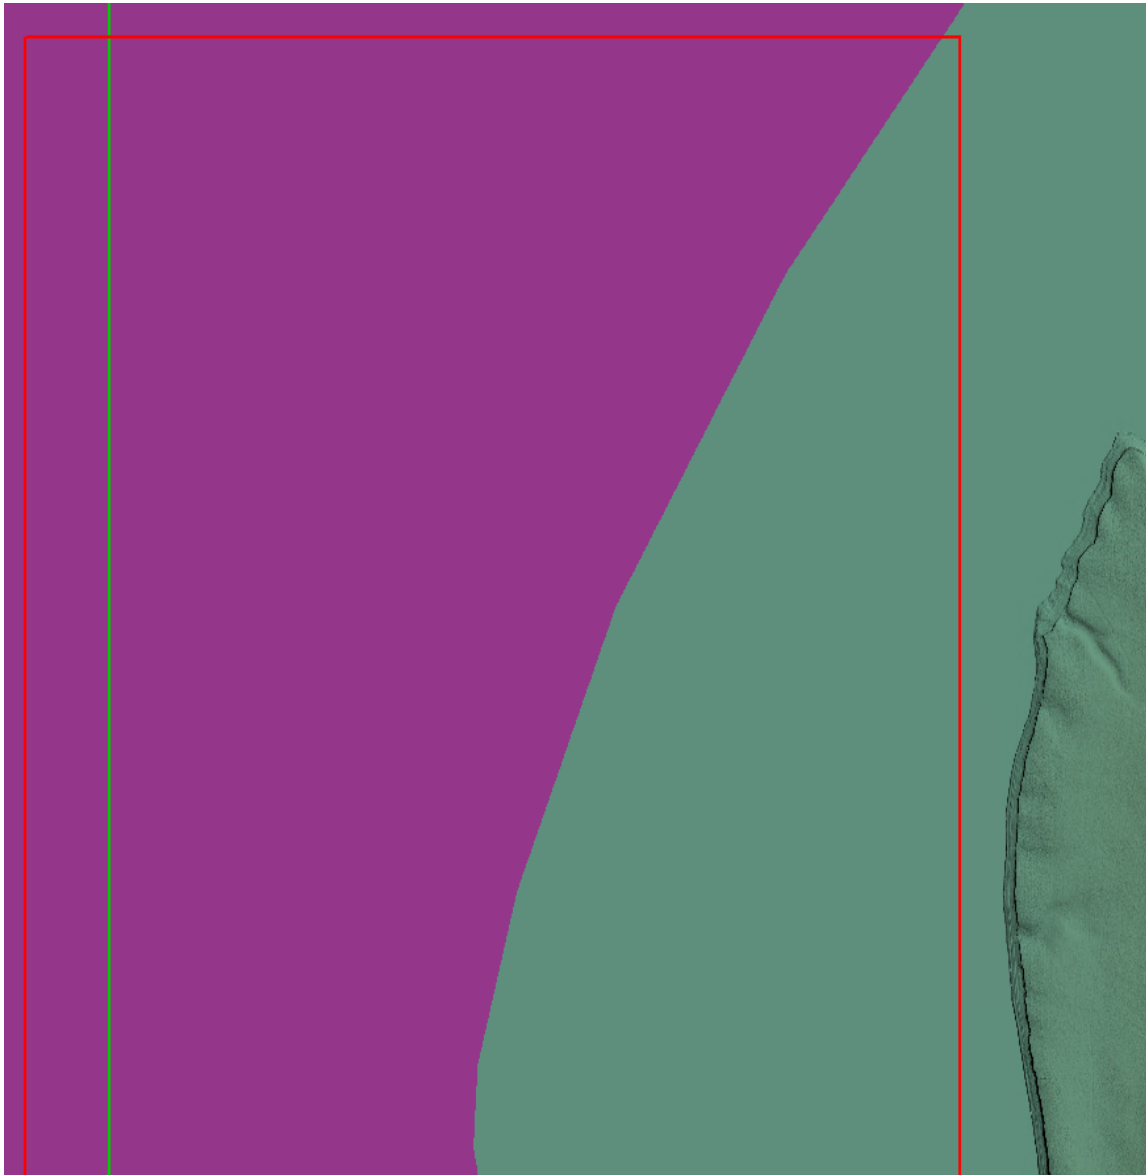
Data does not extend out to the project boundary along the entire East and West extents of Block 4. (6/13/2018)

Dewberry states the data does extend to the project boundary but USGS was not delivered this boundary shapefile and can only judge based on the delivery block diagram shapefile that was delivered. Please deliver the project boundary shapefile that was used to create your data boundaries. (9/20/2018)

Project Boundary was downloaded from PTS. Data delivered cover this AOI.

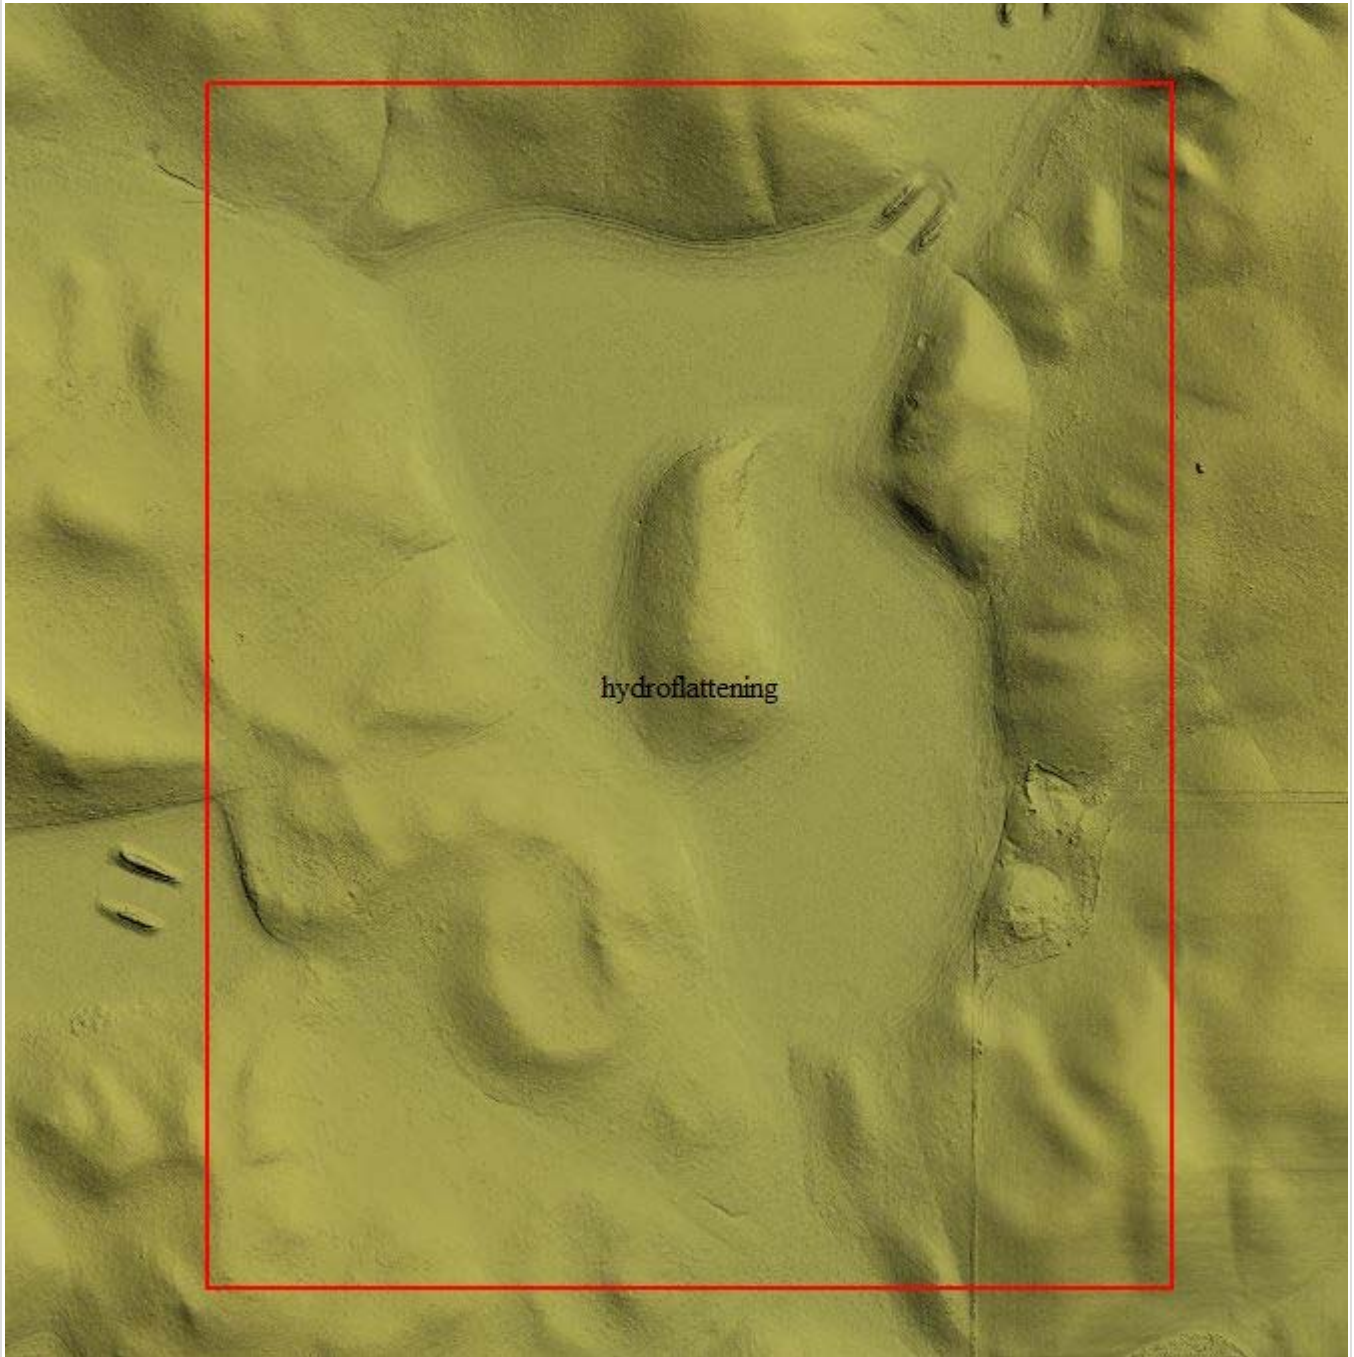
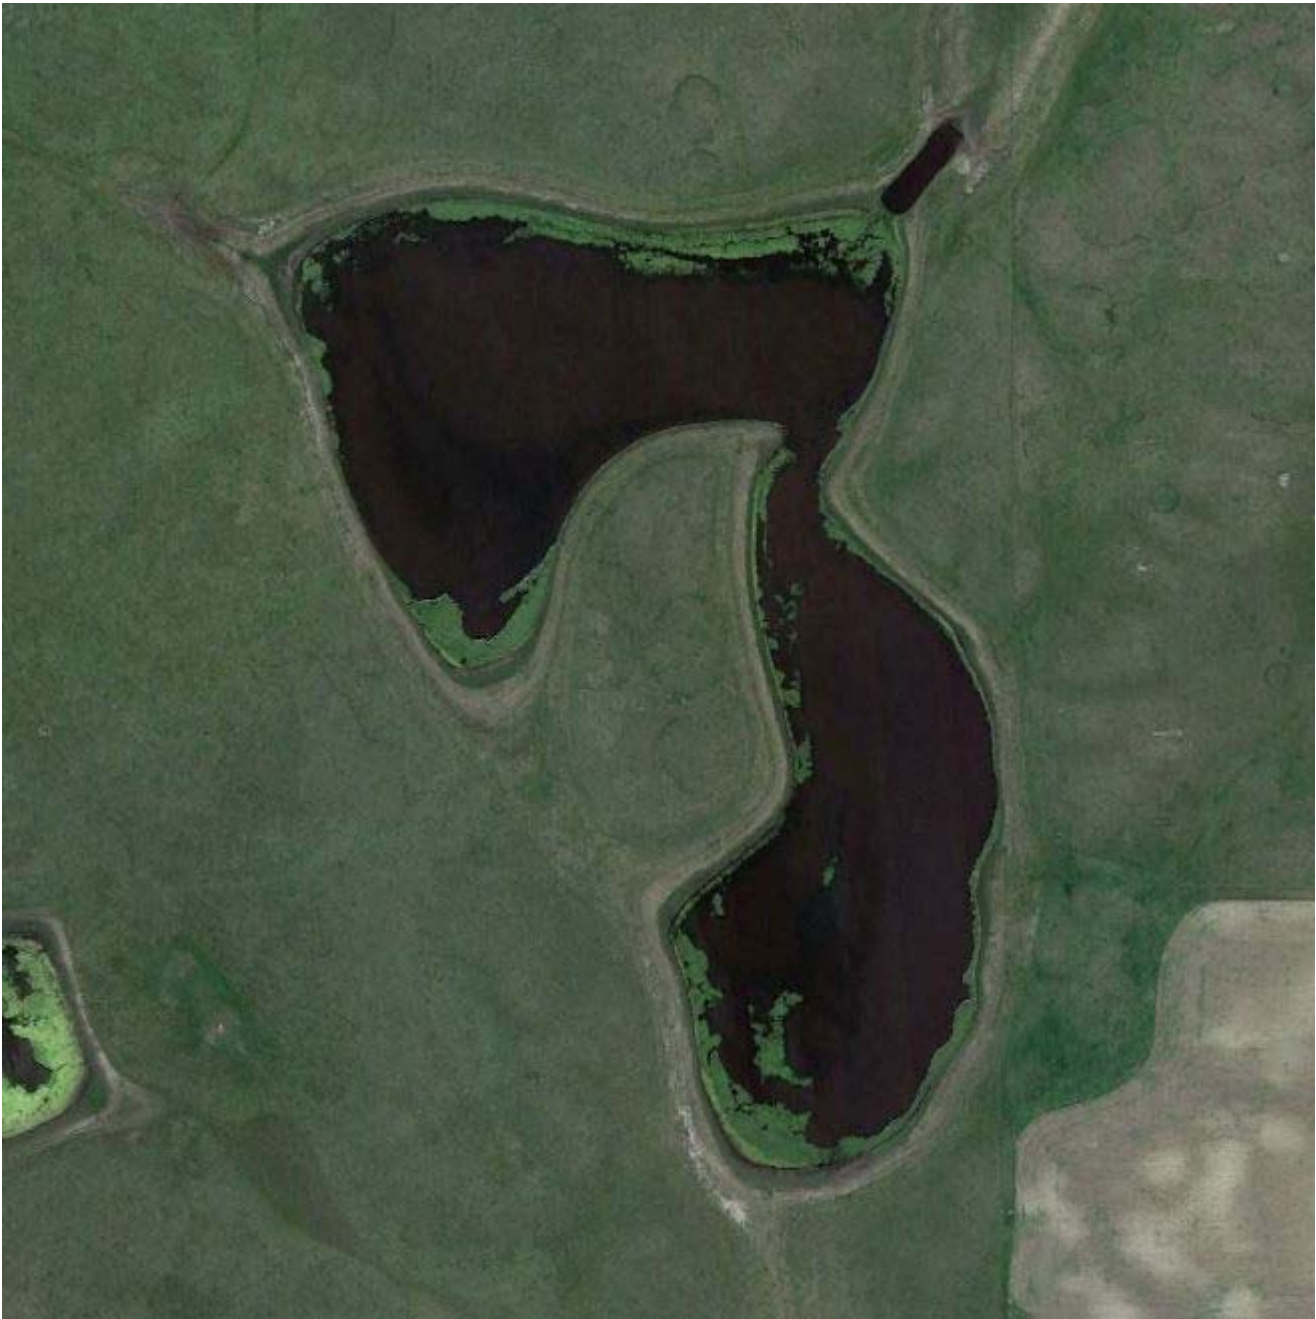
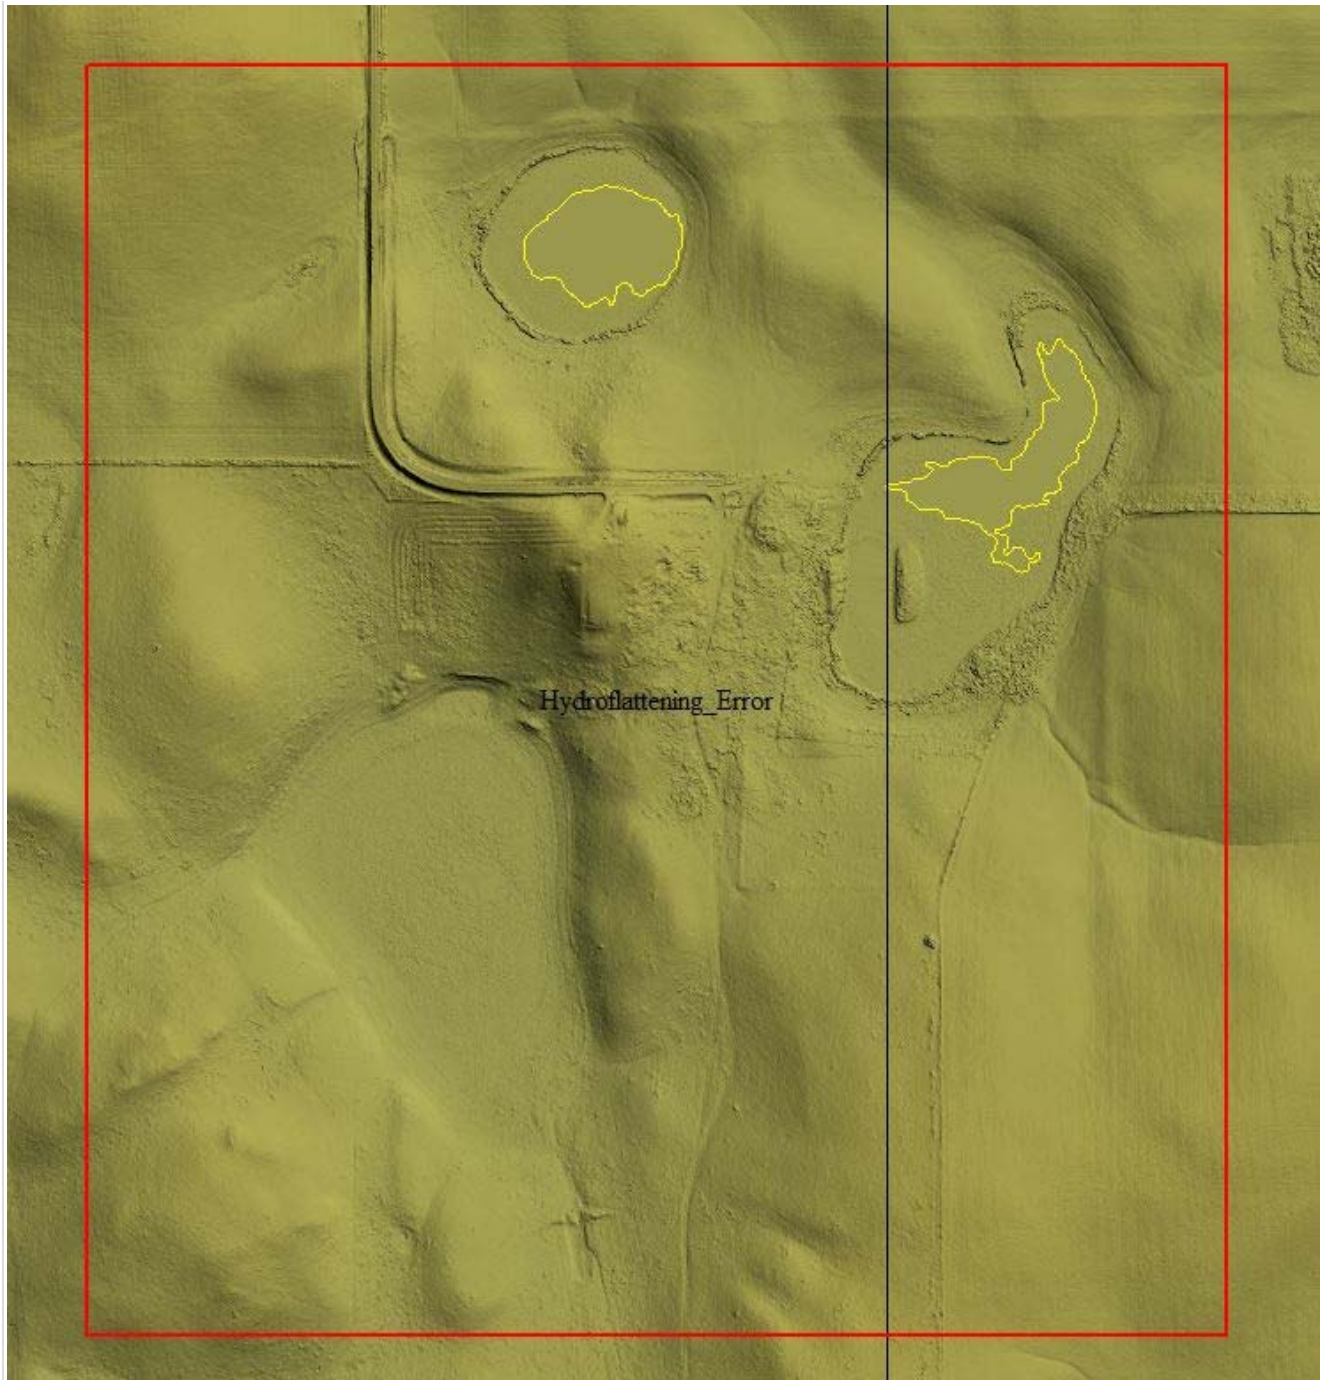
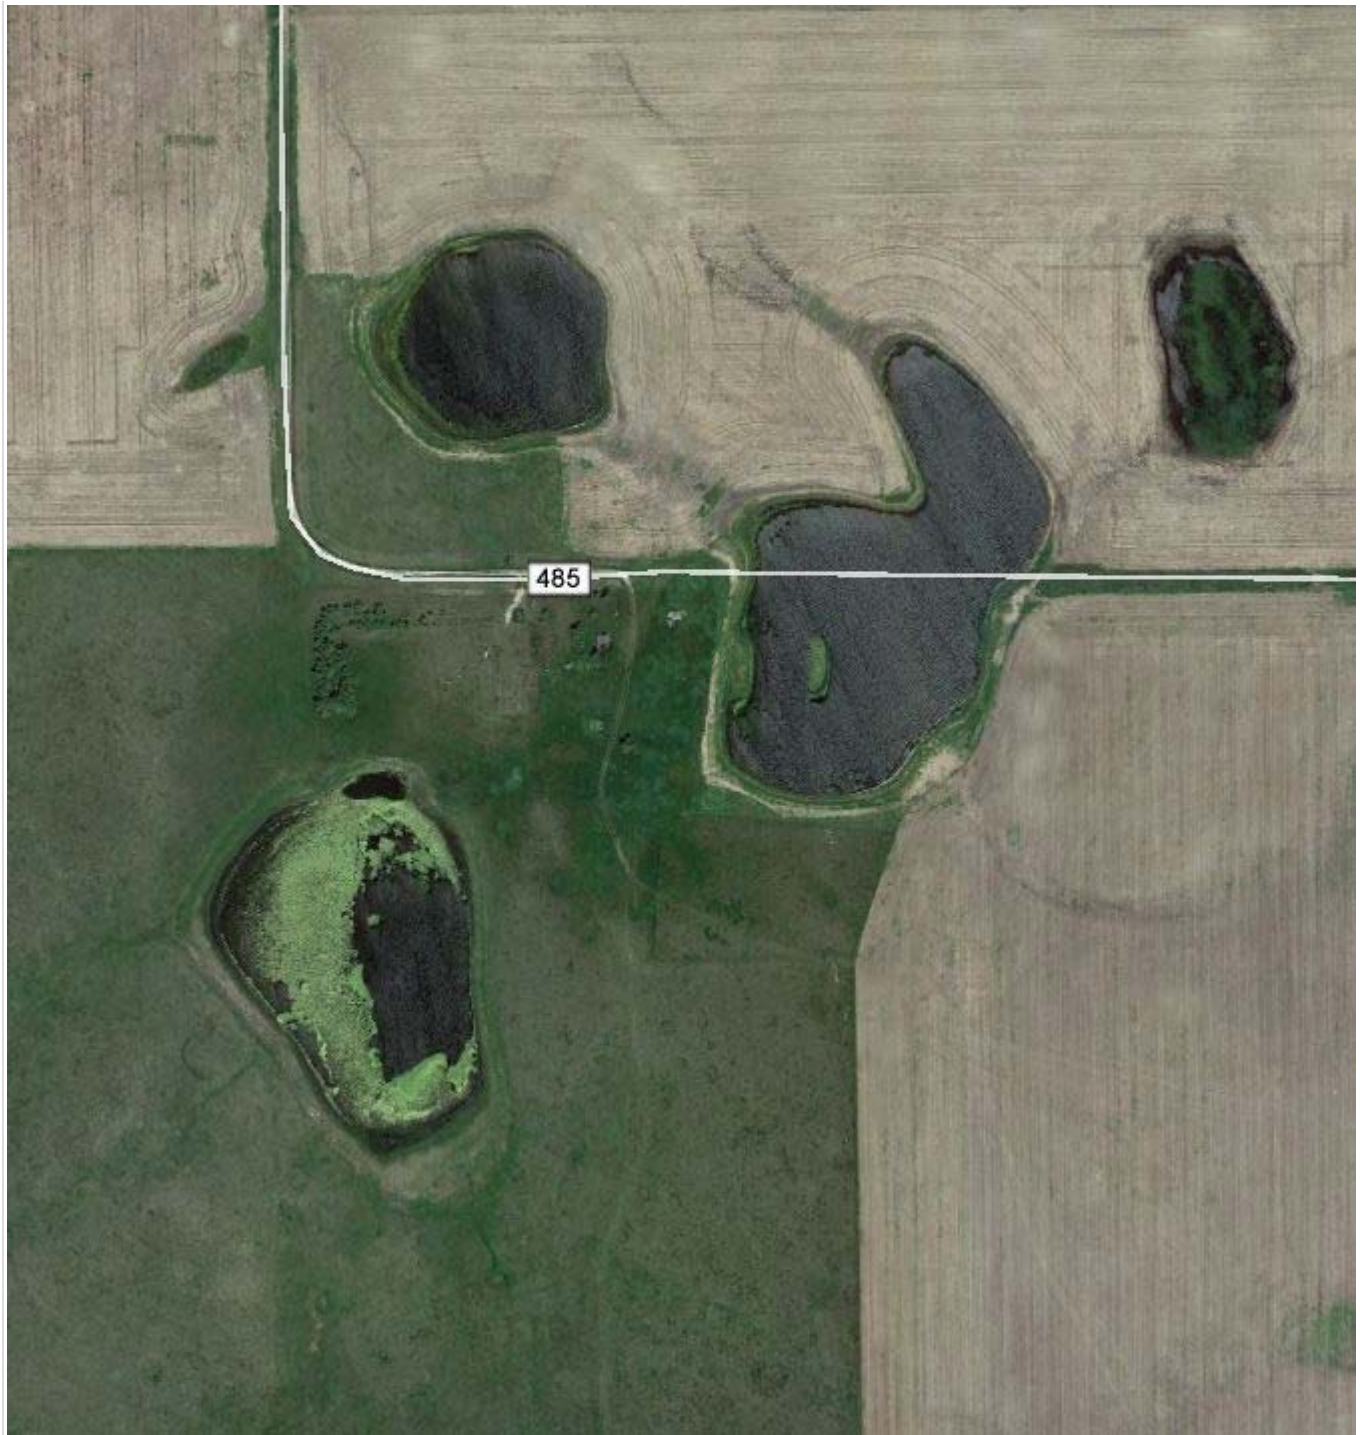
7 hydroflattening errors were found in block 4, waterbodies greater than 2 acres are not hydroflattened. Examples of this type of error can be seen below. (6/13/18)

Corrected (9/20/2018)

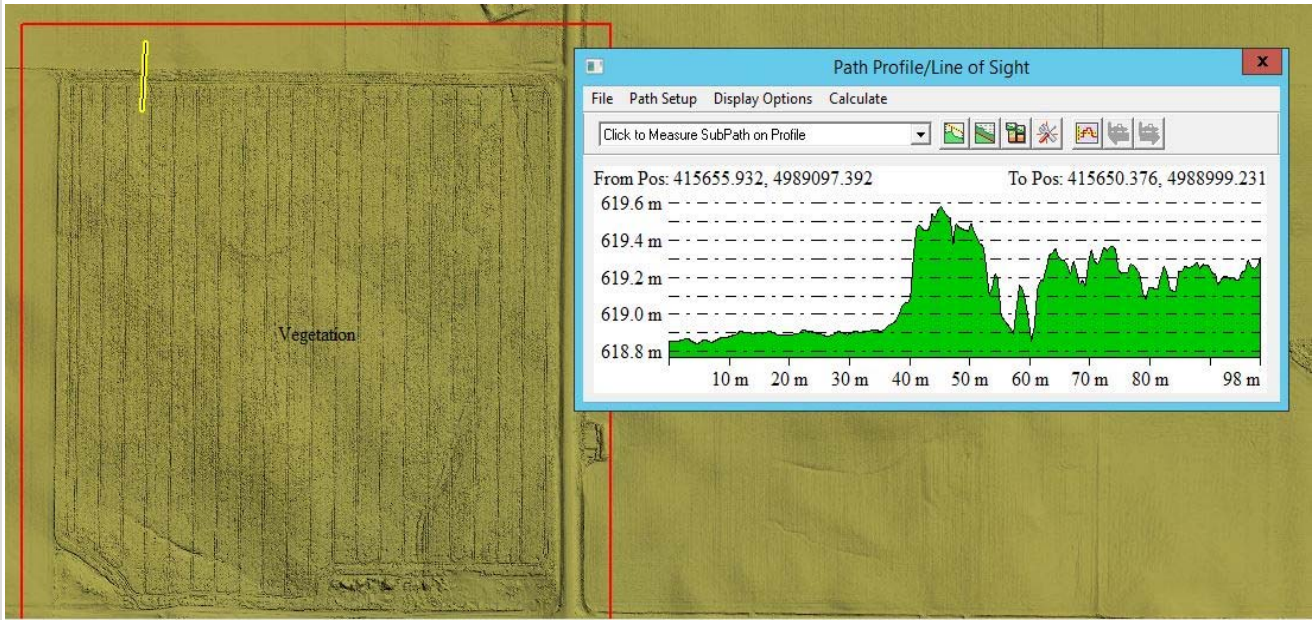
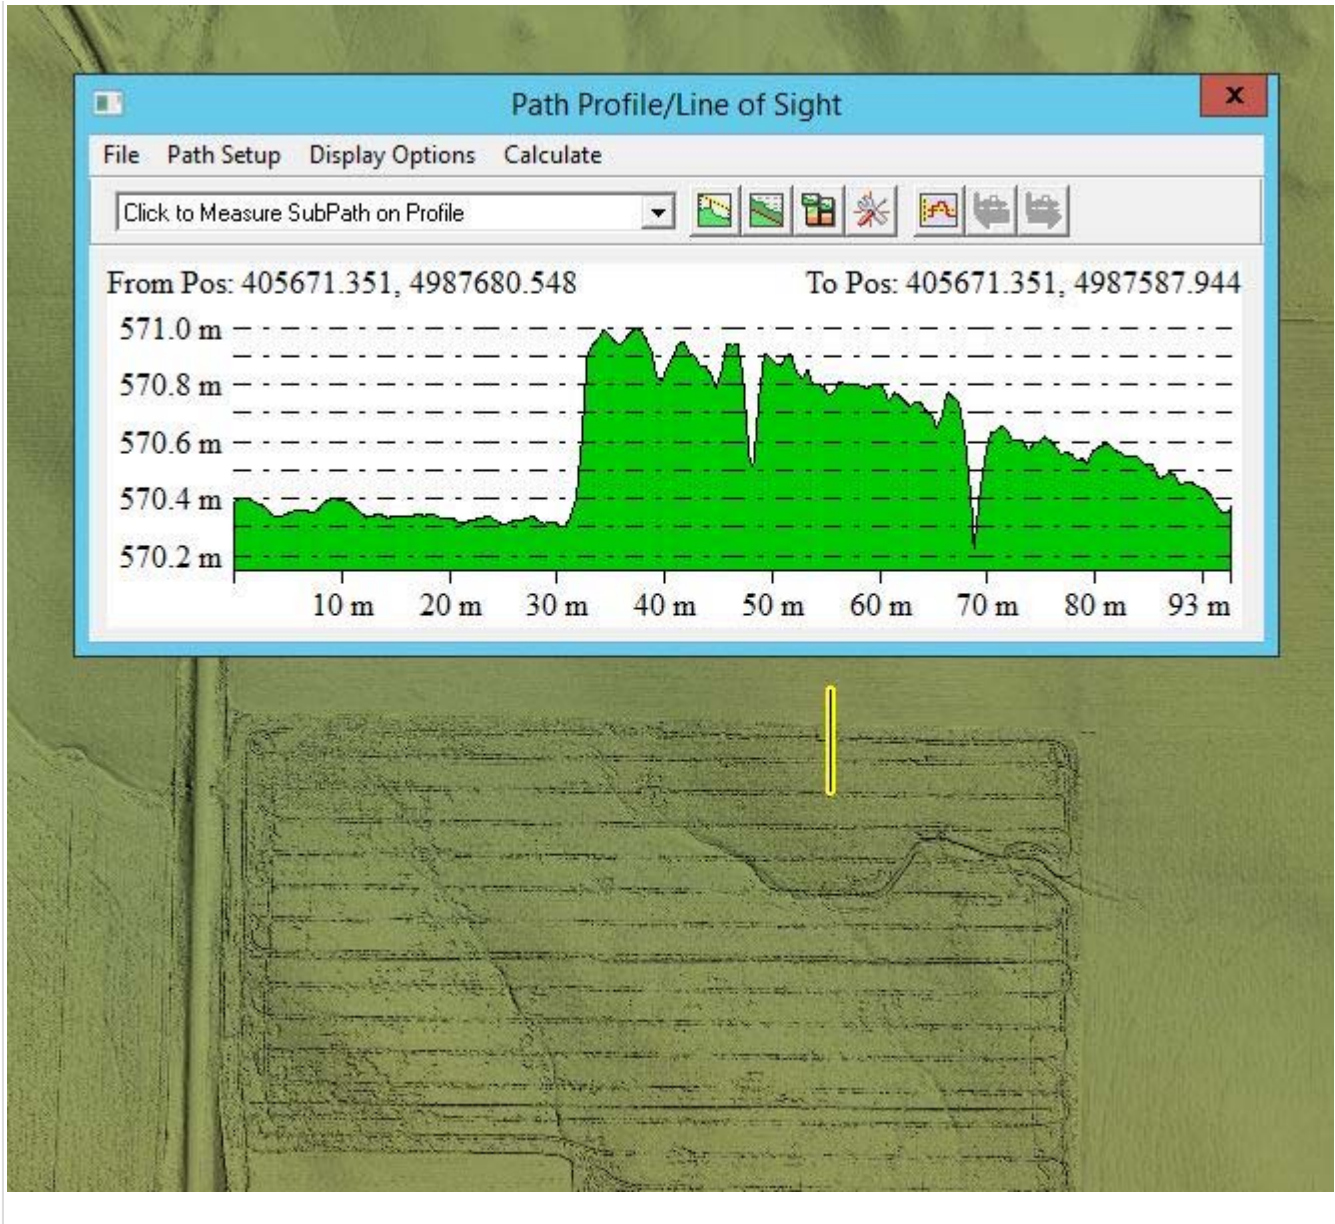
3 errors related to 1 meter tall vegetation in the DEM were found in Block 4, examples can be seen

below. (6/13/2018) **Not Corrected (9/20/2018)**

Based on this review, the USGS does not accept the DEM tiles.
