TX West Central QL2 Lidar Project

Report Produced for U.S. Geological Survey

USGS Contract: G16PC00020

Report Date: 8/14/2019

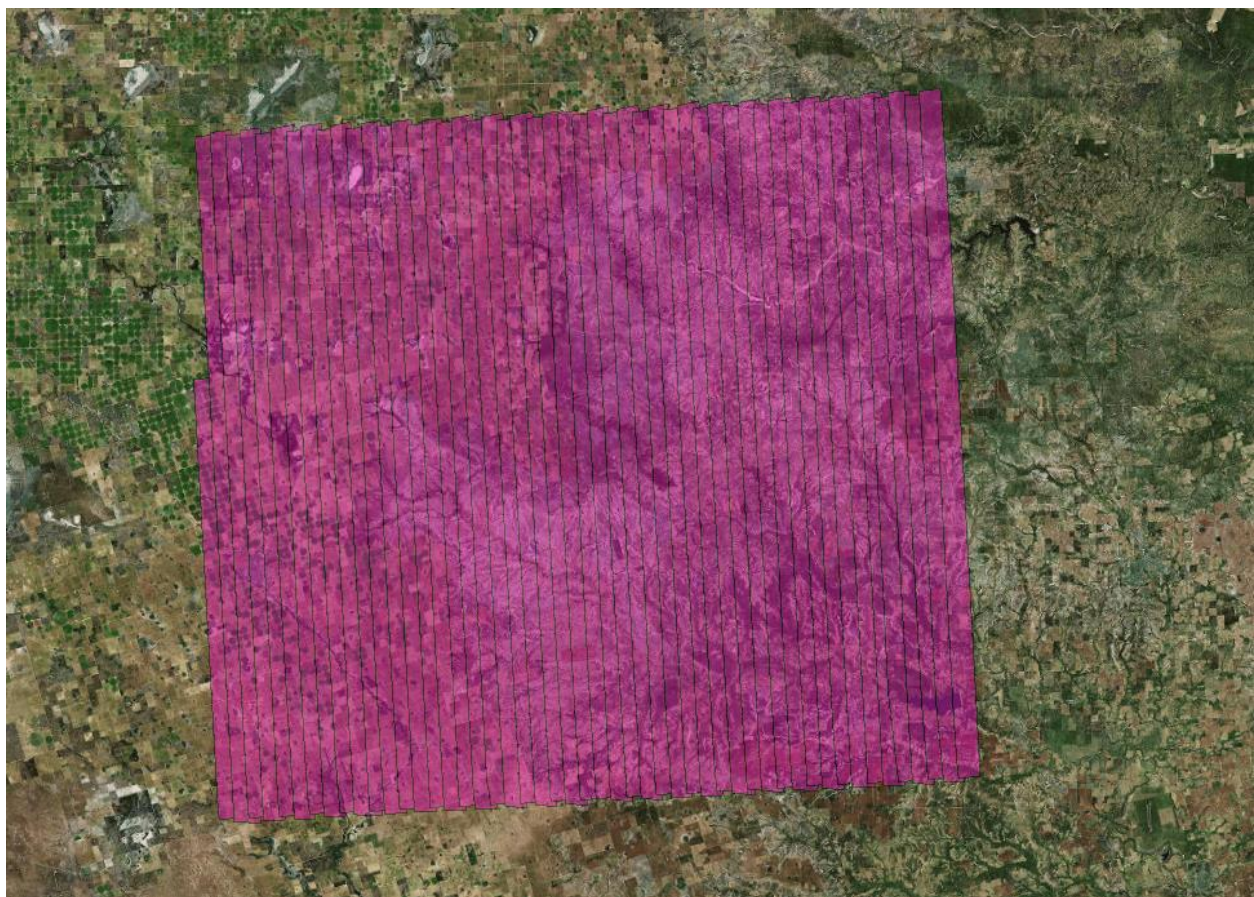
Figure 19 – Lidar swath output showing complete coverage for delivery Block 06.

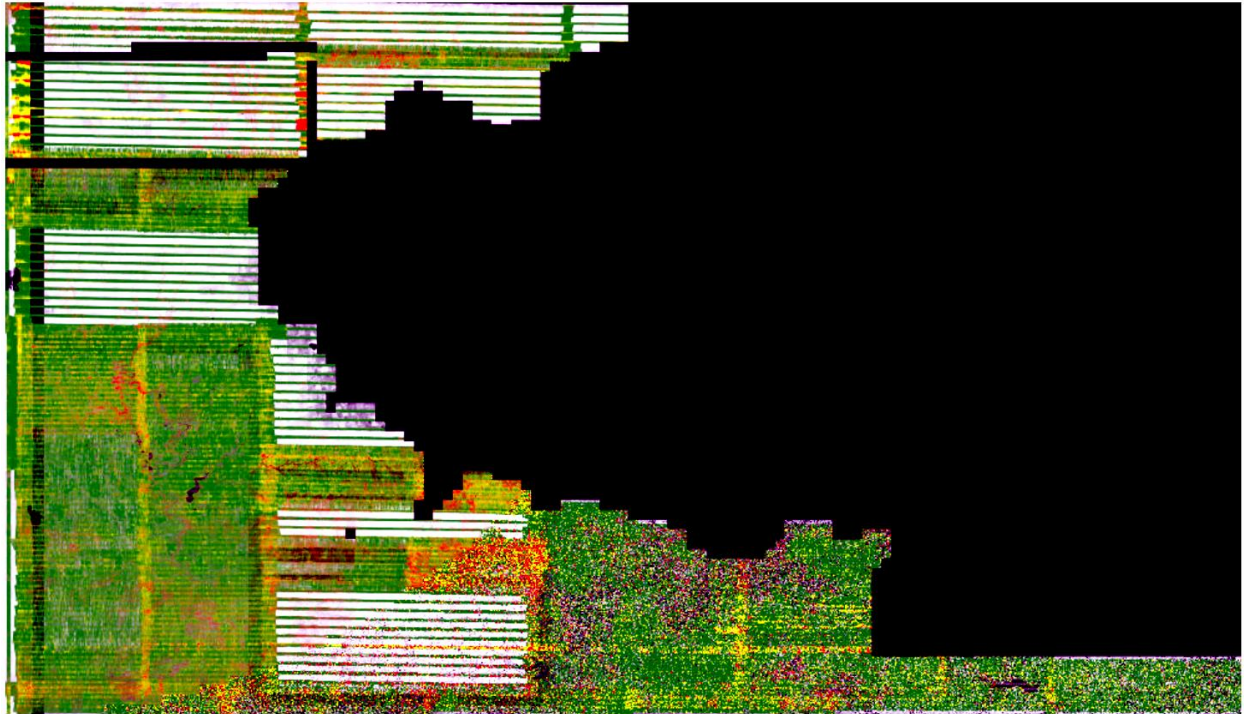
Figure 49– Single return DZ Orthos of delivery Block 11 for the TX West Central Lidar project. Inter-swath relative accuracy passes specifications.

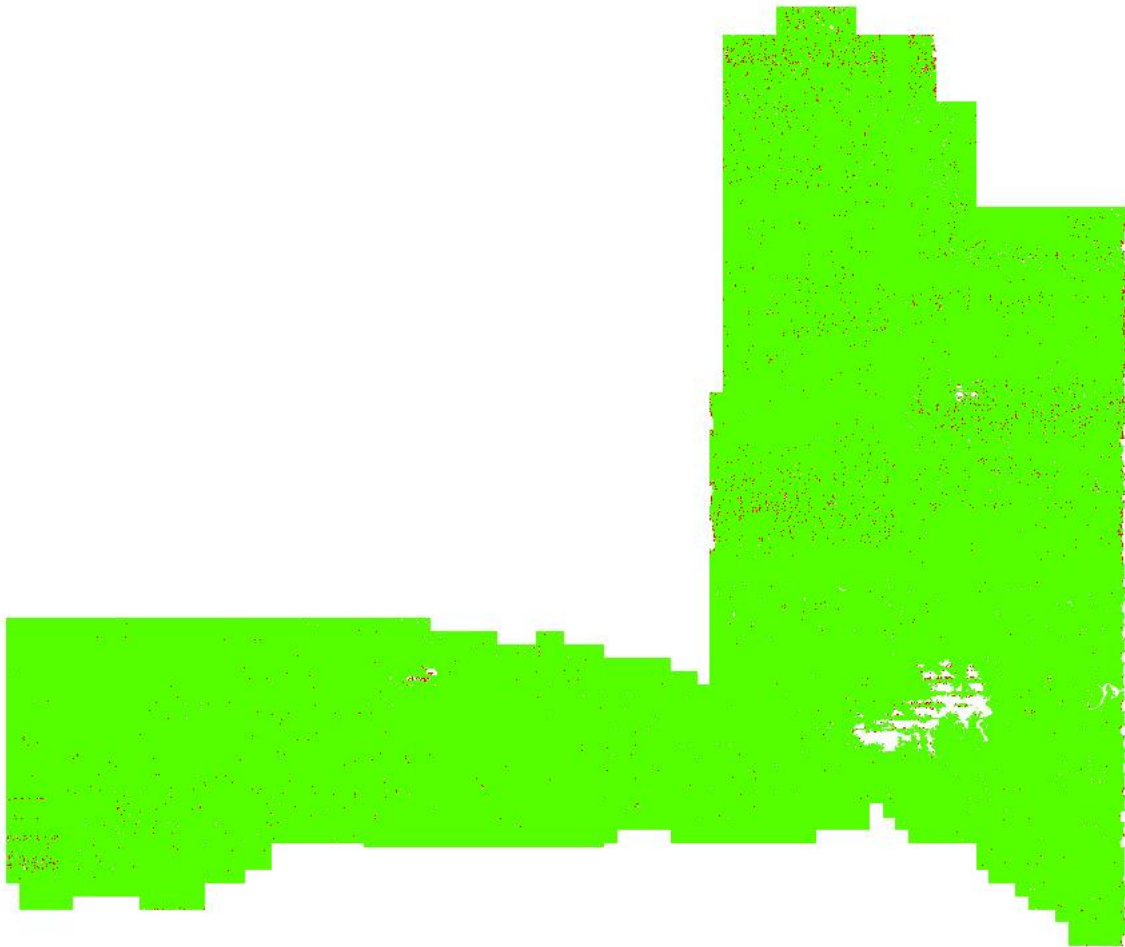
Figure 67– 1-square meter density grid for Block 13. There are some 1-meter cells that do not contain 2 points per square meter (red areas) due to the irregular spacing of lidar point cloud data. Most 1-square meter cells contain at least 2 points per square meter (green areas) showing there are no systematic density issues. When density is viewed/analyzed by representative 1-square kilometer areas, density passes with no issues.

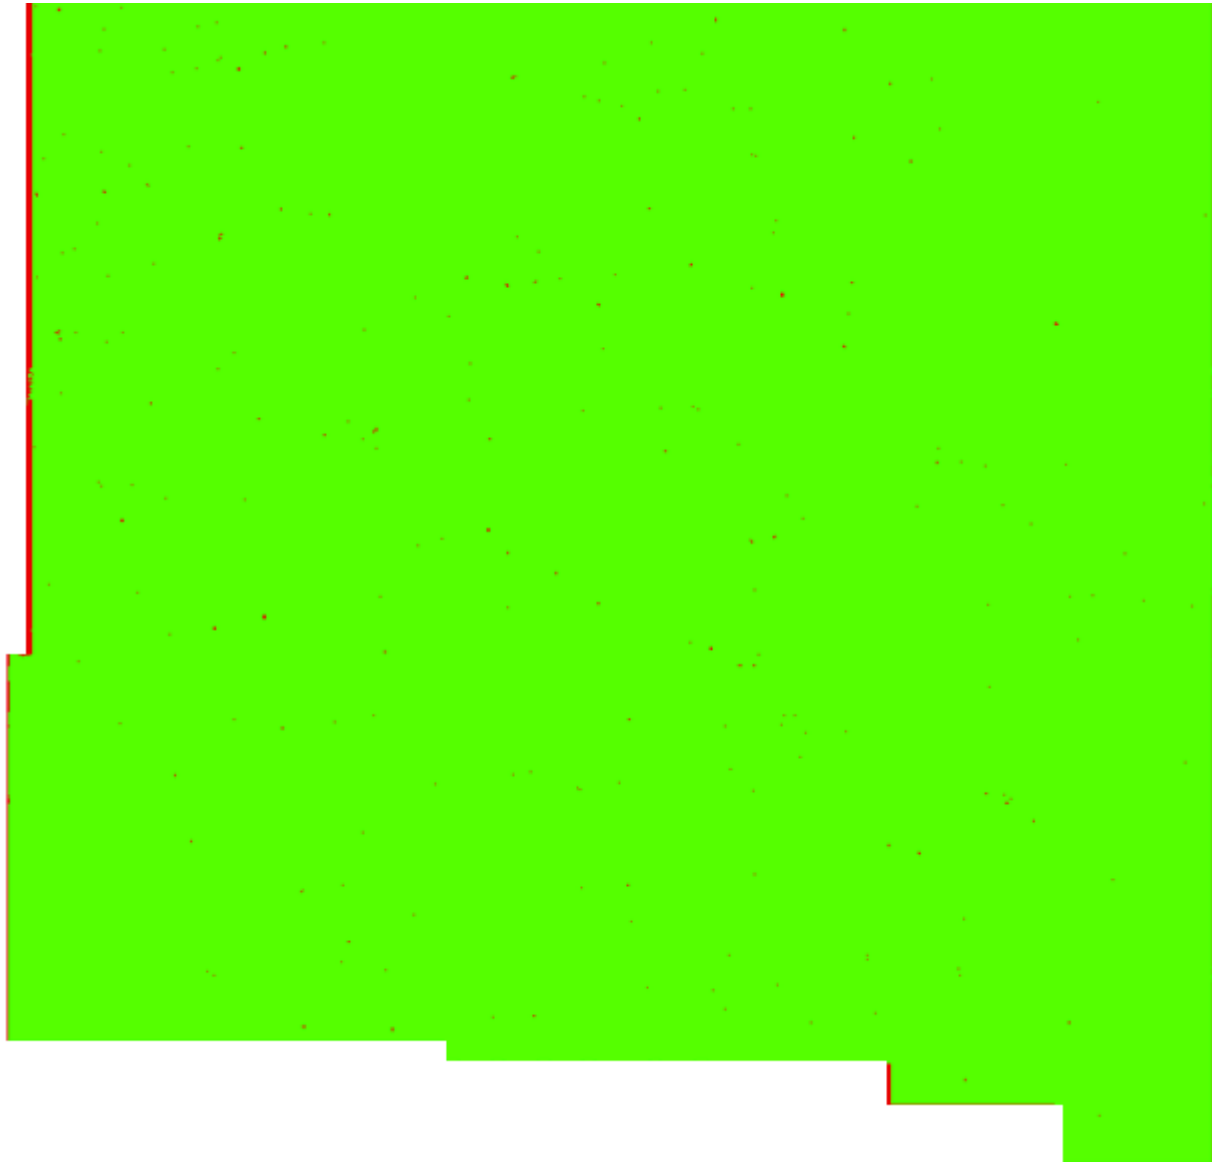
Figure 76– Spatial Distribution for Block 08. All cells (2*NPS cellsize) containing at least one lidar point are colored green. Cells that do not contain a lidar point, including water bodies which are acceptable NoData area, are colored red. Without removing acceptable NoData areas due to water, at least 98% of cells contain at least one lidar point.

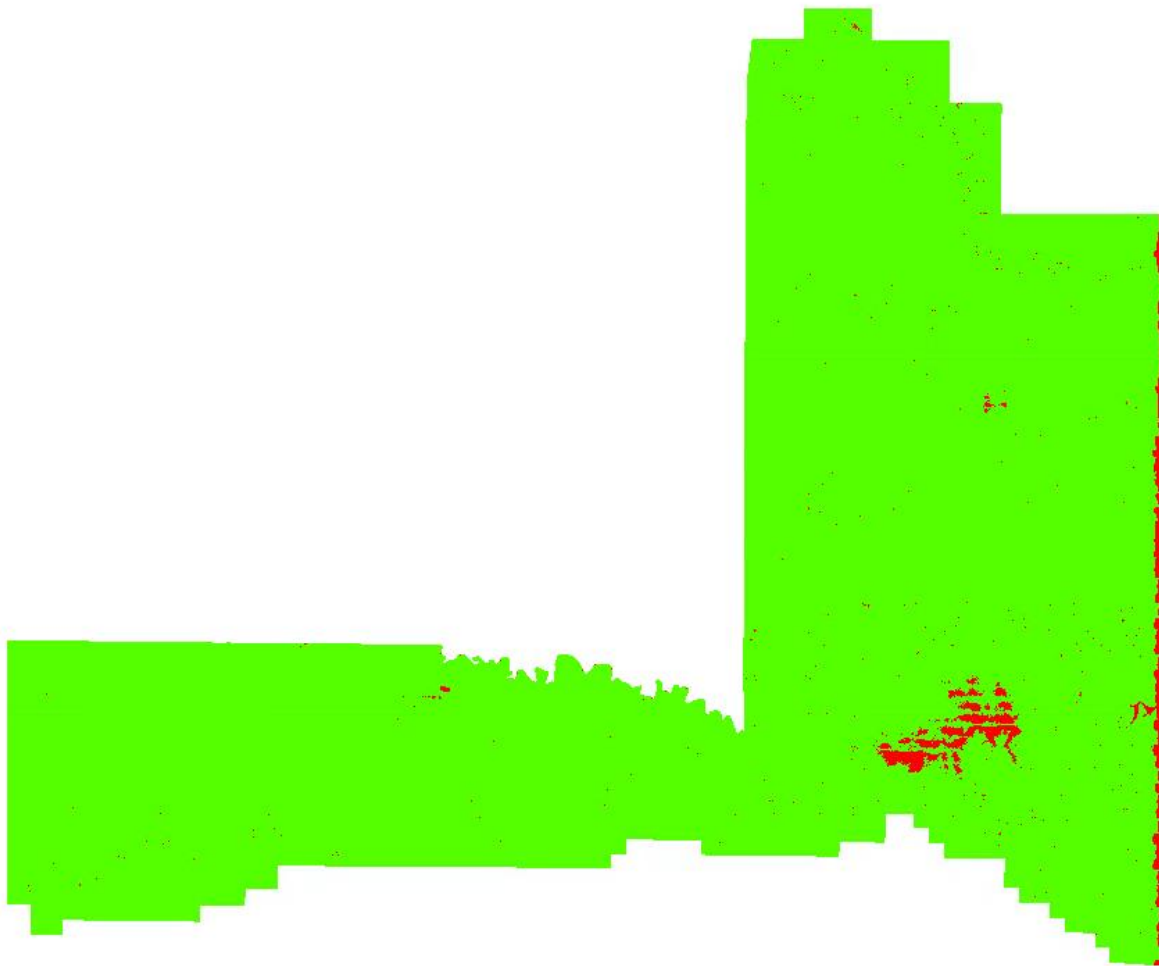
Figure 81– Spatial Distribution for Block 13. All cells (2*NPS cellsize) containing at least one lidar point are colored green. Cells that do not contain a lidar point, including water bodies which are acceptable NoData area, are colored red. Without removing acceptable NoData areas due to water, at least 98% of cells contain at least one lidar point.

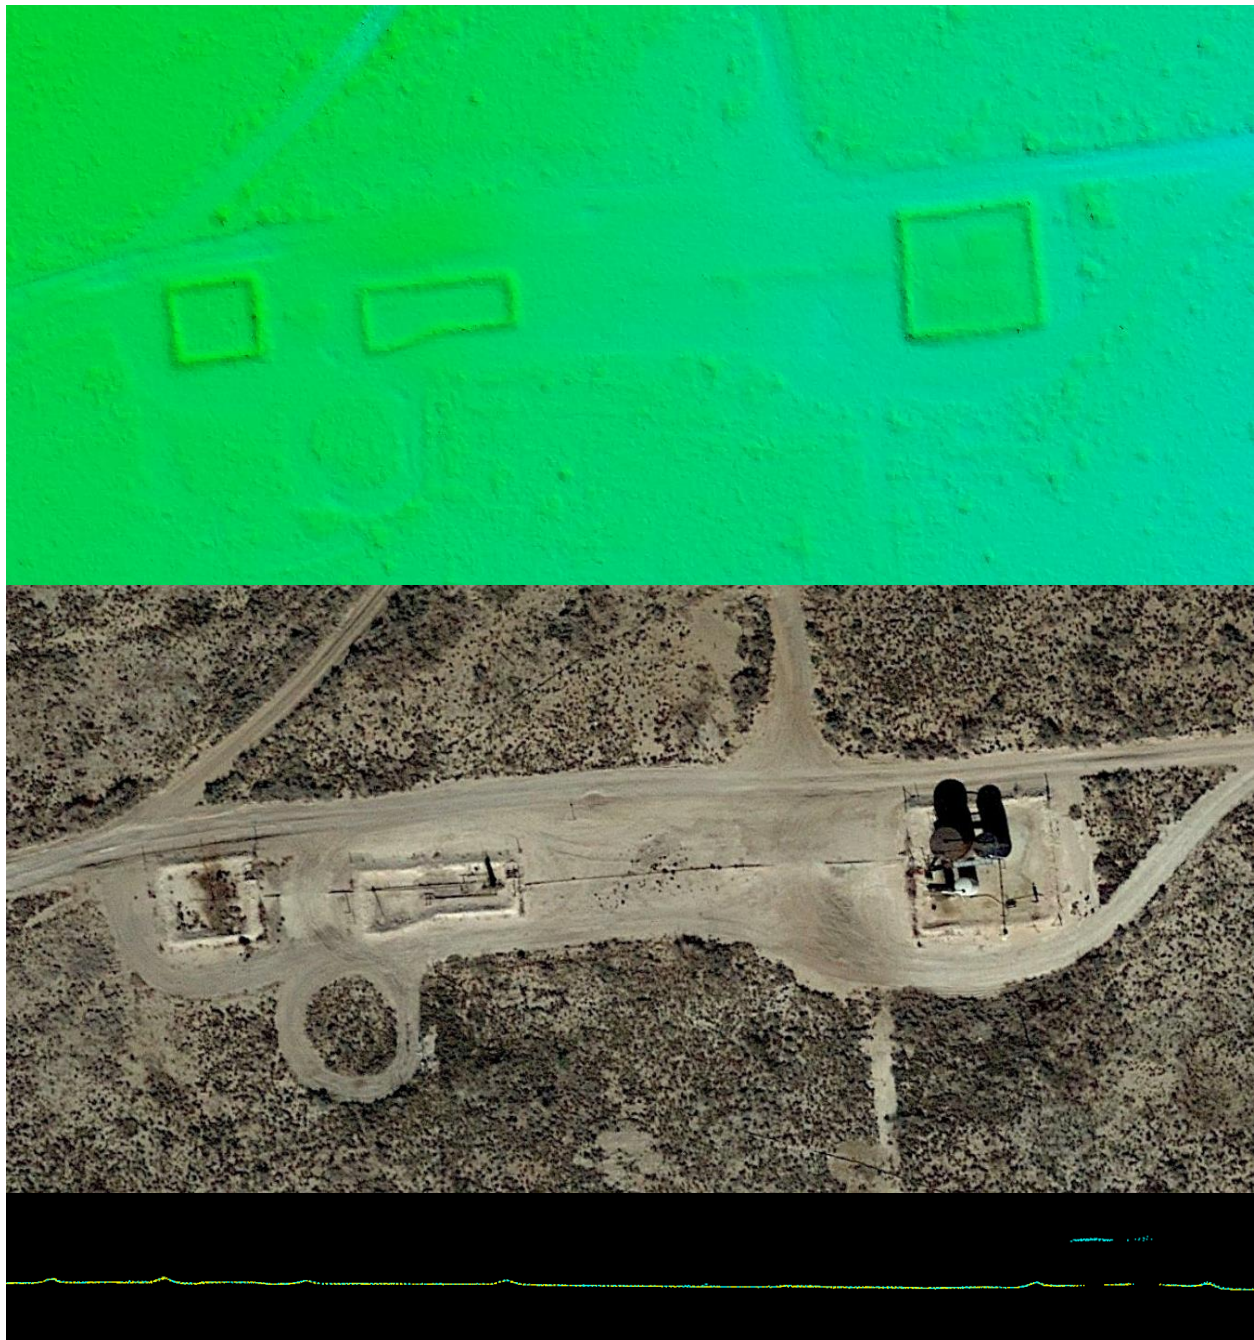
Figure 93 – Tile 13SGR110445. The top view is a tin surface that shows the berms created, the image in the middle shows the working structures in the area and a profile with the points colored by class (class 1=cyan, class 2=yellow) is shown in the bottom view.

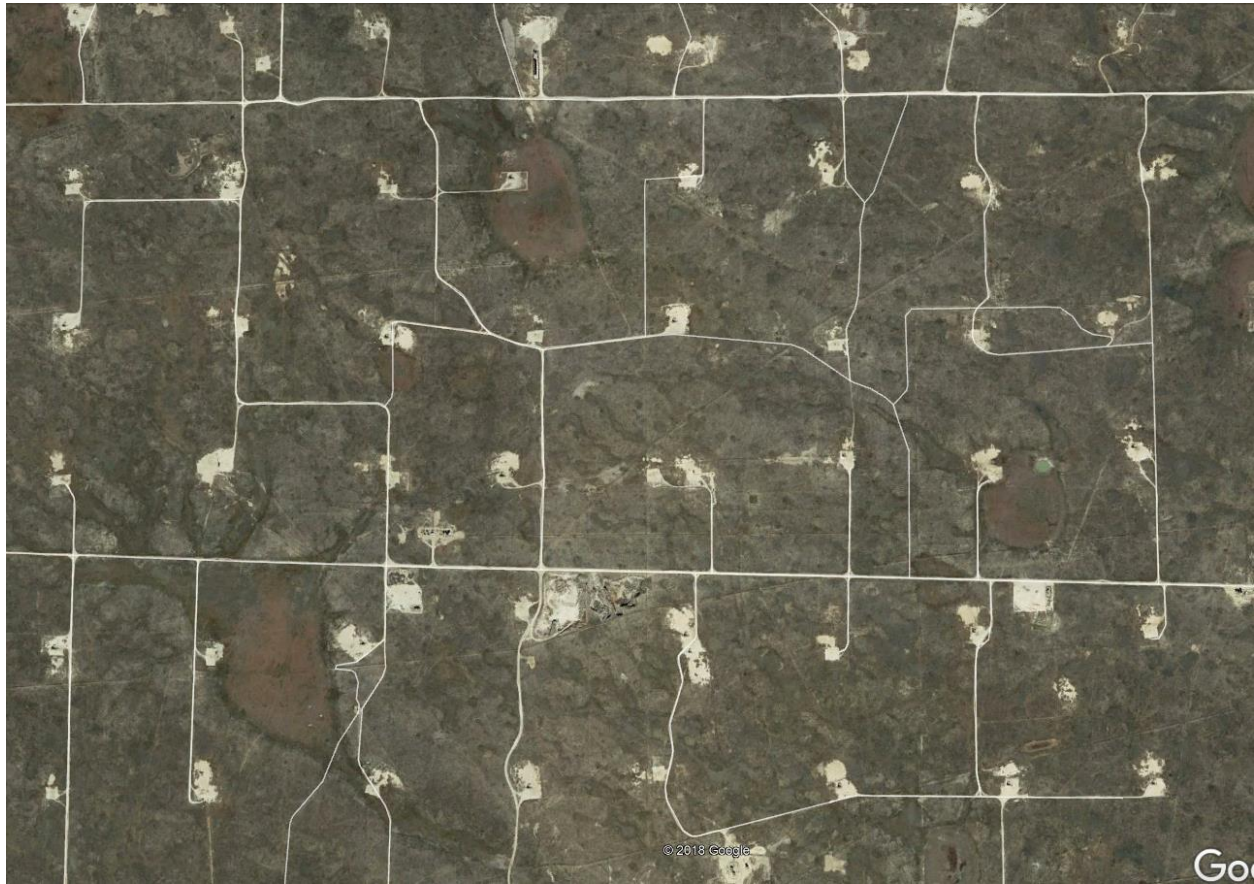
Figure 94 – The image above shows a wide area of oil production that is common throughout the TX West Central Lidar project.

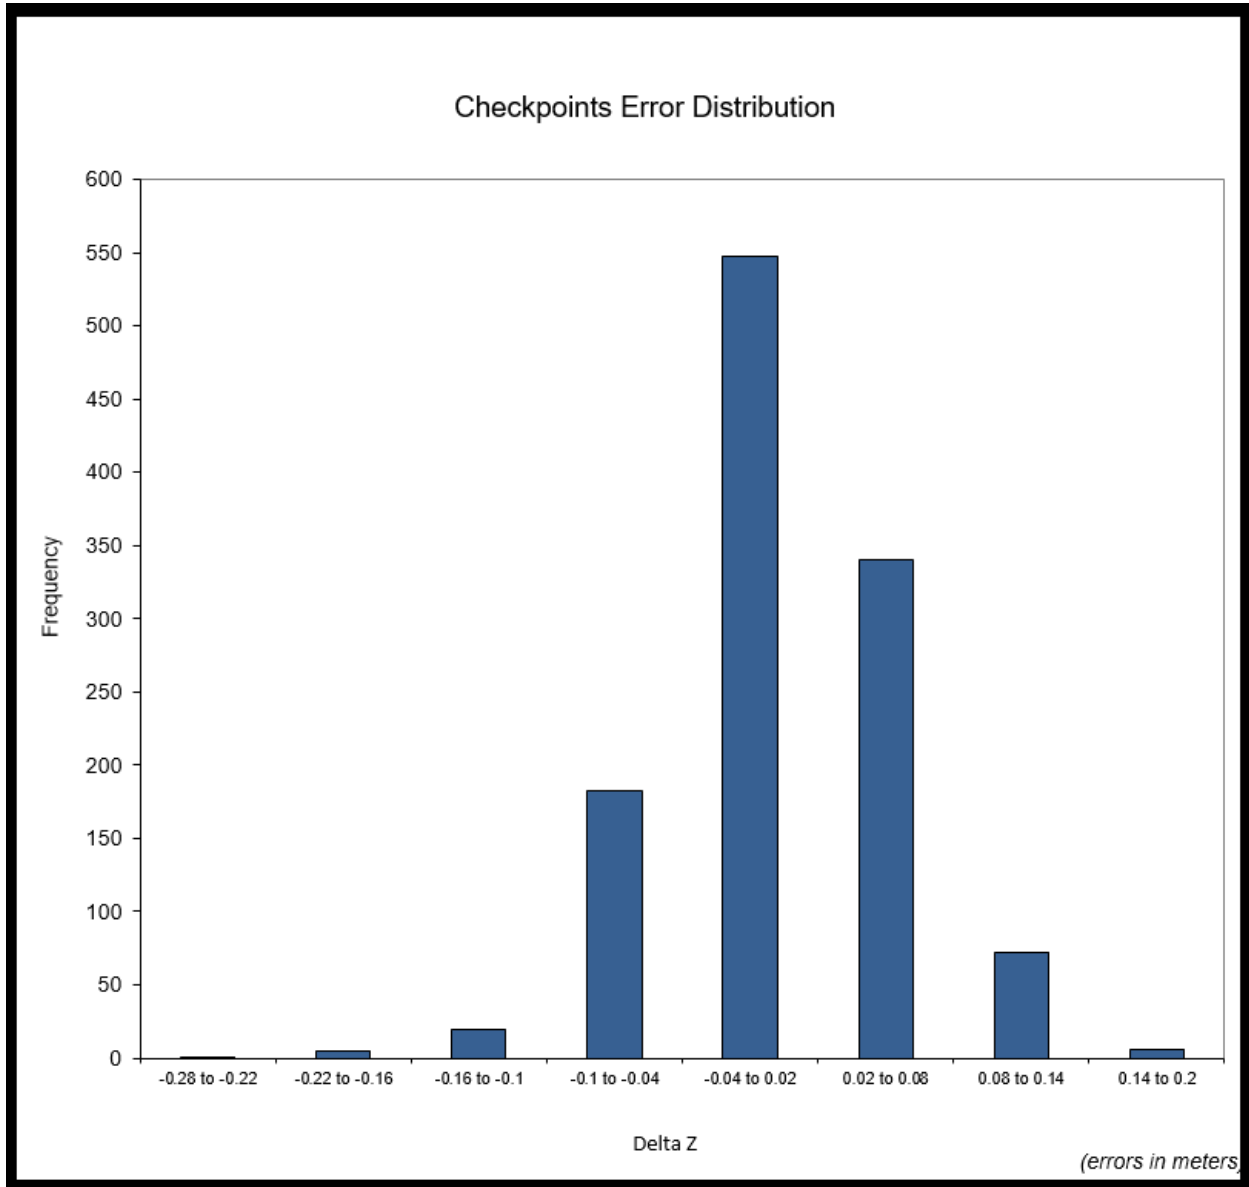
Figure 97 – Histogram of Elevation Discrepancies with errors in meters
