# **Matanuska-Susitna Borough LiDAR & Imagery Project Quality Assurance Report Point Mackenzie Block**

**Written by Rick Guritz**

**Alaska Satellite Facility**

**April 15, 2012**

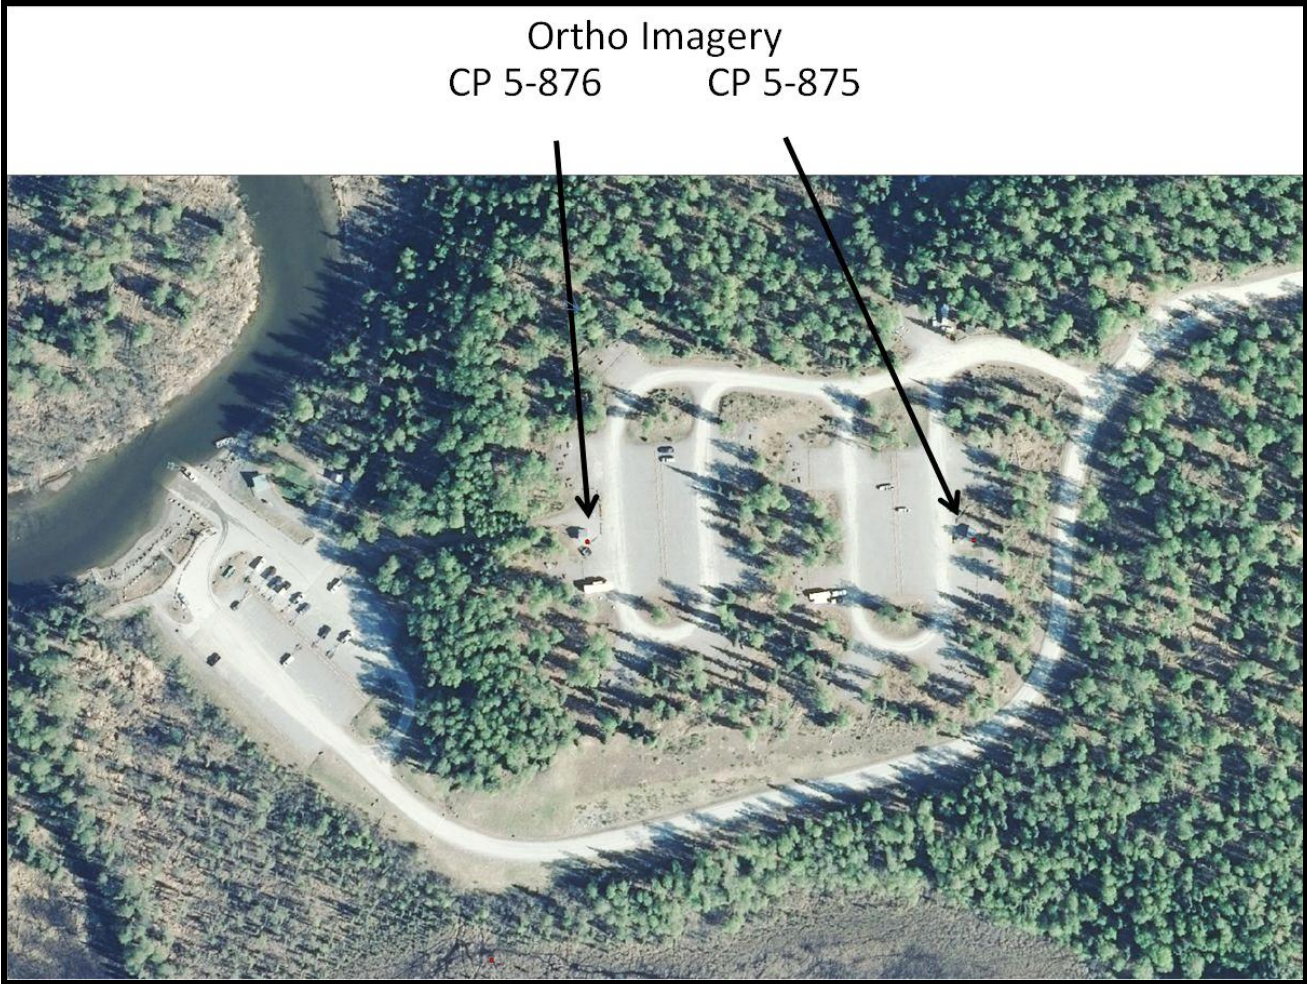
Figure 3, Ortho imagery with arrows pointing out two checkpoint locations in imagery.

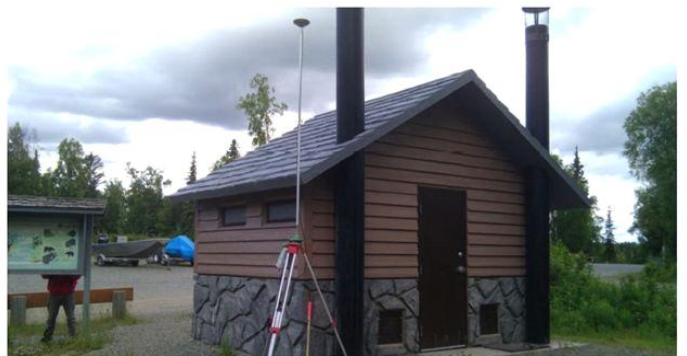
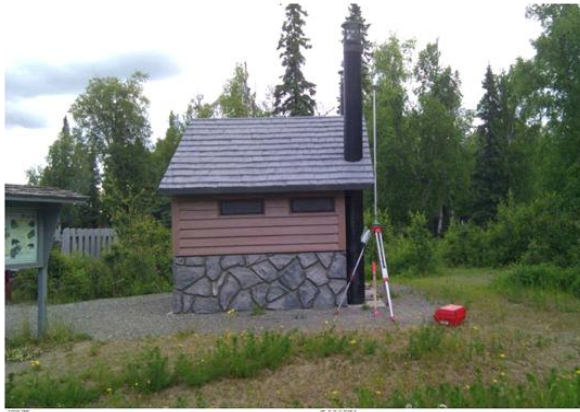
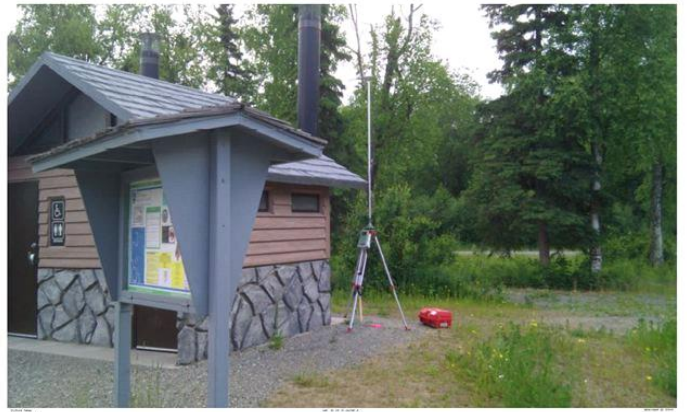
# CP 5-875 Contractor Pictures

Figure 5, Checkpoint survey contractor pictures of CP 5-875 at corner of outhouse.

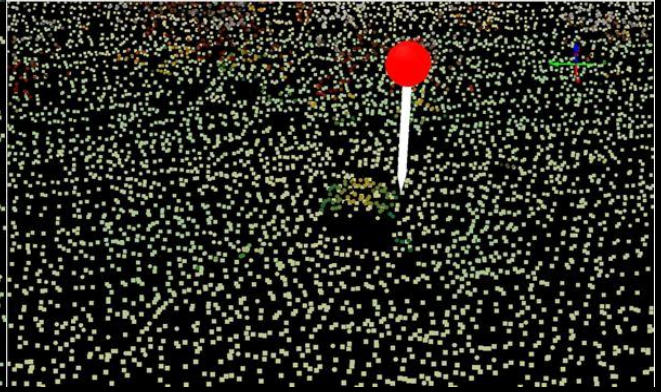
CP 5-875  
LiDAR Analysis with QTM

Good Alignment of point 5-875 with SE corner of outhouse roof.

Figure 6, LiDAR point cloud assessment with QTM marking checkpoint location.

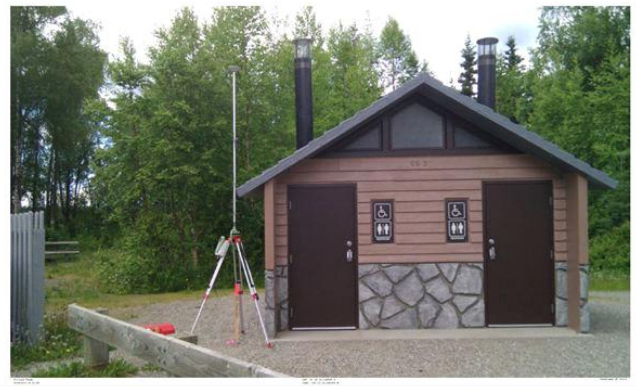
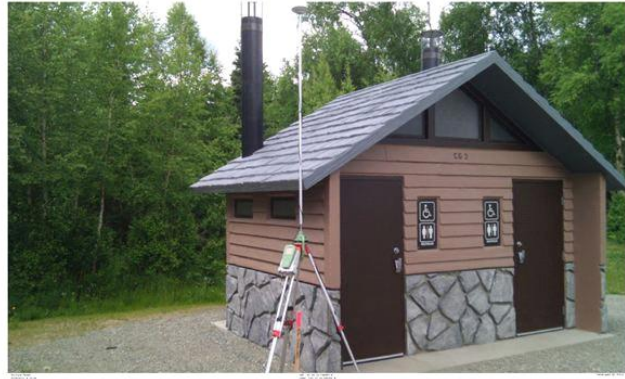
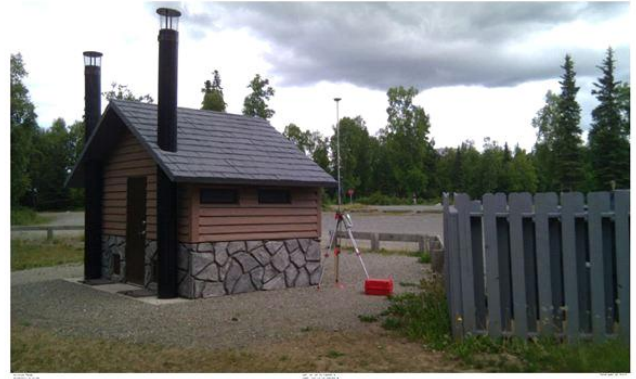
# CP 5-876 Contractor Pictures

Figure 7, Checkpoint Survey contractor pictures of CP 5-876 at corner of outhouse.

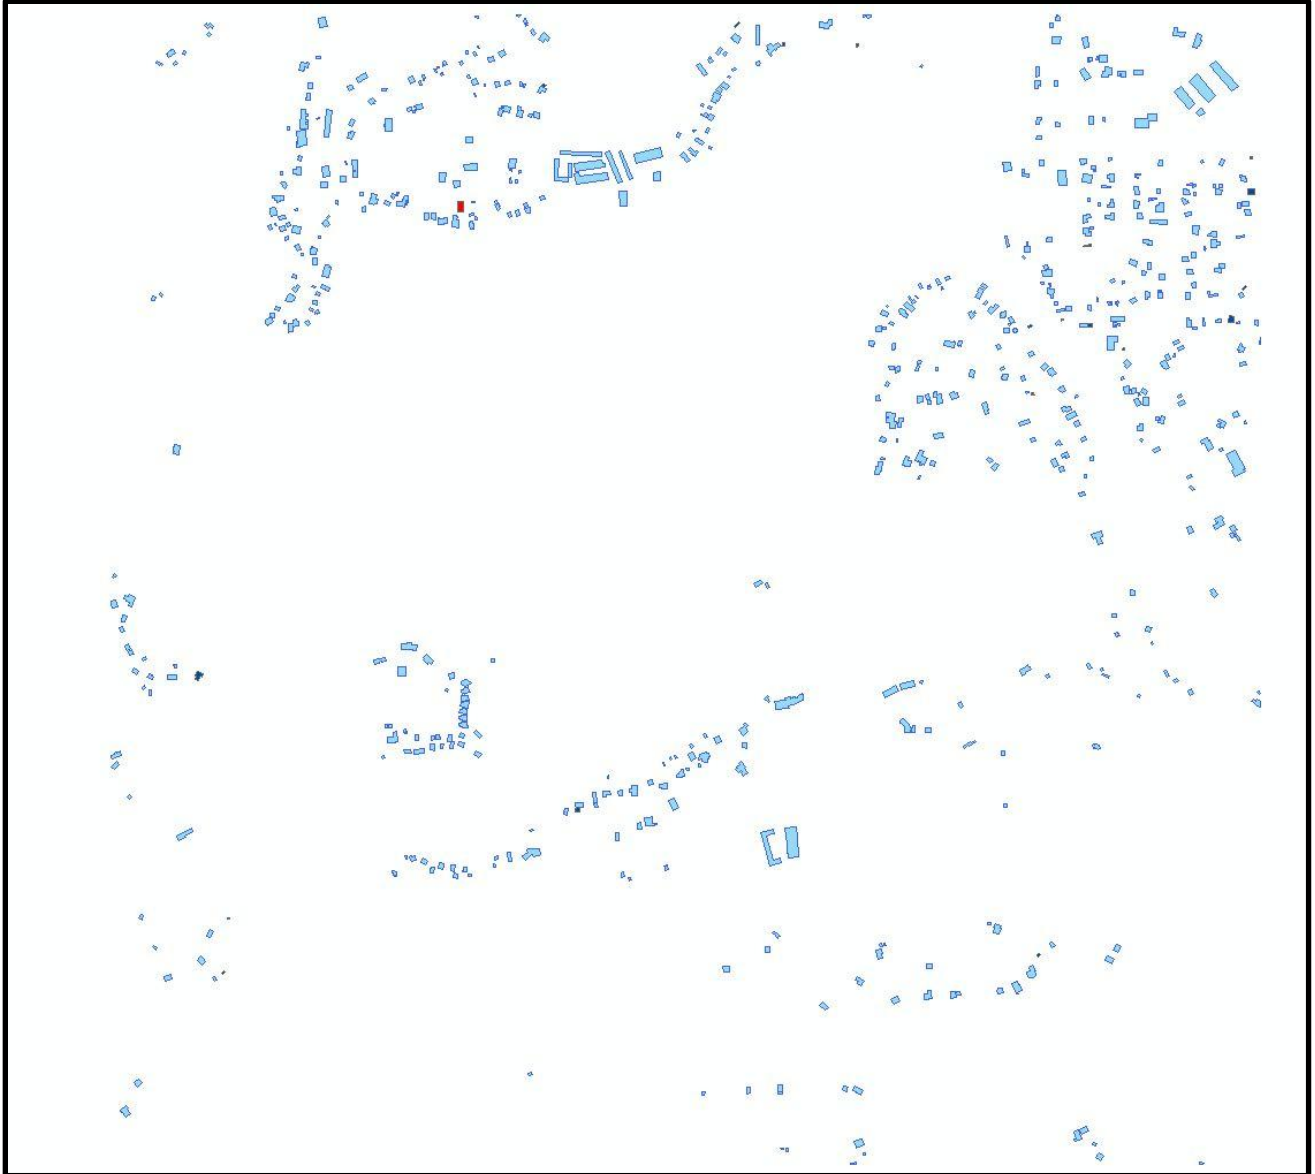
Figure 40, Building Analysis Results (Lt.Blue – Correct, Red – Incorrect, Dark Blue – Added)
